Project Name :

Hedgerow appraisal and arboricultural assessment at Broomfield, Midleton, Co. Cork

Date : 15th September 2023

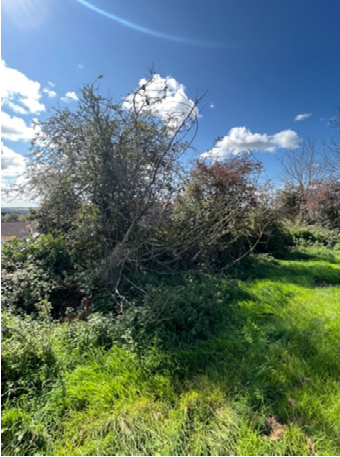
Fig 1: Hedgerow 1

Hedge No.	Coordinates	Species	Height	Width	Age	Condition	Comments	Recommendations	Category Grading
1	51.9256794°N -8.1757167°W 51.9256081°N -8.1760497°W	Hawthorn (<i>Crataegus monogyna</i>), elder (<i>Sambucus nigra</i>), bramble (<i>Rubus fruticosus</i>), stinging nettle (<i>Urtica dioica</i>), ivy (<i>hedera ilex</i>)	4 m	3 m	M	Poor	Poorly shaped hedge that is decimated due to loss of elm trees (70% of hedge), where some stems are in-situ; 3 no. hawthorn trees at the edge of the field boundary on a small raised earth ditch; all trees are in poor condition with poorly shaped canopies; dense field layer of stinging nettle, bramble and some elder coming through as an understorey	Plant new hawthorn whips to create a continuous cover and hedgerow that can be maintained every two years when whips grow to be strong plants	Historical -1 Species diversity - 2 Ground flora - 2 Structure - 1 Habitat Connectivity -1 Landscape - 2

As noted, many of the hedgerows are in poor condition. Hedges 1, 2 and 5 for example contain a few small hawthorns, while much of the hedgerow is comprised of small dead elms. They have a poor balance between understorey species (i.e. hawthorn, blackthorn, elder) and field layer species (i.e. stinging nettle, bramble, ivy) on this site. This imbalance is partially due to the elm suckers and recent demise of the ash. Additional field layer species are emerging through the recent gaps in hedgerows. Some people would refer to these plants as weeds (defined as a plant that is growing where it is not wanted). But this native wild flora is welcome as they add to the diversity of the plant species and have their place within the ecosystem and the natural composition of our country's hedgerows. However, long term improvement to these requires management to improve biodiversity. This could take the form of heavy intervention or full removal and replacement. Either solution will lead to an improved hedgerow environment with negligible loss.

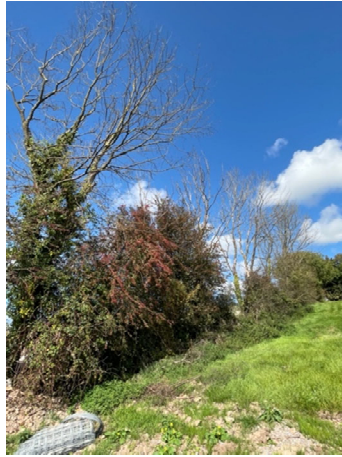
Fig 2: Hedgerow 2

Hedge No.	Coordinates	Species	Height	Width	Age	Condition	Comments	Recommendations	Category Grading
2	51.9256081°N -8.1760497°W 51.9256081°N -8.1760497°W	Wych elm (<i>Ulmus glabra</i>) hawthorn (<i>Crataegus monogyna</i>), ash (<i>Fraxinus excelsior</i>), grey willow (<i>Salix cinerea</i>), bramble (<i>Rubus fruticosus</i>), stinging nettle (<i>Urtica dioica</i>), wild rose (<i>Rosa canina</i>) ivy (<i>hedera ilex</i>)	4 m	3 m	M	Poor	Low quality semi-mature/ mature hedge, 19 no. dead elm trees, 4 no. healthy hawthorn trees at southern end, 1 no. mature ash severely infected with ash dieback, grey willow saplings emerging in understorey; a 19m segment removed during recent road works; hedgerow looks poor and is broken up by the dead specimens; where present, the field layer is dense with good coverage	Fell the dead elms as a matter of urgency and dying ash within 1 year; regenerate the majority of hedgerow with native species to include hawthorn whips and allow to grow dense and layered	Historical -1 Species diversity - 4 Ground flora - 3 Structure - 3 Habitat Connectivity -2 Landscape - 2

Recent road works disturbed a 19m section of Hedge 2, which has led to unearthing of seeds leading to a proliferation of growth in field layer species. This can also be said of hedgerow 5. These emerging layers are good indicators of the native seed bank on site. Any hedgerow improvement should utilise this existing soil and seed bank.

There are a small number of ash trees along the western boundary (Hedges 2 and 5) and all are exhibiting advanced stages of Ash Dieback disease. Two of them are large, mature trees. However, they have advanced far enough with ash dieback that the trees cannot recover and it is recommended that they be removed in the near future, regardless of development.

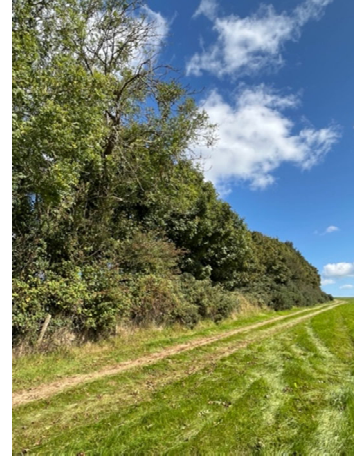
Fig 3: Hedgerow 3

Hedge No.	Coordinates	Species	Height	Width	Age	Condition	Comments	Recommendations	Category Grading
3	51.9266700°N -8.1758639°W 51.9267451°N -8.1743797°W	Hawthorn (<i>Crataegus monogyna</i>), gorse (<i>Ulex europaeus</i>), bramble (<i>Rubus fruticosus</i>), stinging nettle (<i>Urtica dioica</i>), bracken (<i>Pteridium aquilinum</i>), ivy (<i>Hedera ilex</i>)	4 m	3 m	M	Fair	A moderate quality hedgerow consisting of primarily understorey species (hawthorn, blackthorn, elder) and a thick field layer; growing in concert with a high-canopy double row of sycamores located 2m to the north (Hedgerow 7); root systems would be integrated with Hedgerow 7, but unlikely to venture too far south due to the tall ditch embankment	Plant new whips of blackthorn and hawthorn in among the bramble and try to encourage these species to fill out and add structure to the hedgerow, these trees can be maintained in the future as a hedge if need be	Historical –1 Species diversity - 3 Ground flora - 2 Structure - 1 Habitat Connectivity -2 Landscape - 2

Hedge 3 is categorised as 'fair', but is the best example on site of a low growing boundary hedgerow. It is made up of hawthorn, blackthorn, gorse, stinging nettle, bramble and bracken. It grows beneath the overhanging canopy of the sycamores in Hedge 7. The two have grown to have a symbiotic relationship. Combined, they have the potential for quality fauna support. However, they have limited connectivity with other quality hedgerows, limiting their habitat potential.

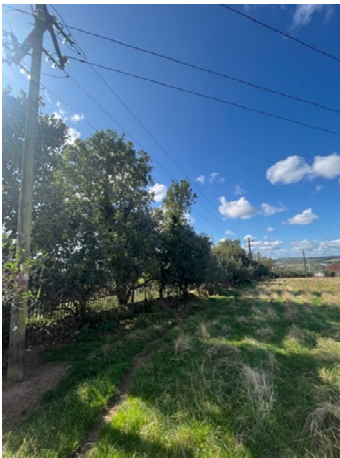
Fig 4: Hedgerow 4

Hedge No.	Coordinates	Species	Height	Width	Age	Condition	Comments	Recommendations	Category Grading
4	51.9276953°N -8.1741993°W 51.9276637°N -8.1754475°W	Blackthorn (<i>Prunus spinosa</i>), wych elm (<i>Ulmus glabra</i>)	4 m	3 m	M	Fair	Line of blackthorn that were planted on a berm 3m north of the water plant perimeter fence; there are 4 no. dead elms at the Western end of the hedgerow and the blackthorn trees are growing as standards (stems) with few stems at ground level, this indicates that the hedgerow is relatively new and the blackthorn were purchased as nursery plants; the trees are healthy, but the line does not resemble a natural indigenous hedgerow in form or species diversity	Remove the dead elm trees; interplant the blackthorn trees with hawthorn and hazel whips that would create a dense hedgerow of mixed species to benefit the natural appearance and diversity of the hedgerow	Historical -1 Species diversity - 1 Ground flora - 0 Structure - 1 Habitat Connectivity -1 Landscape - 2

Hedge 4 along the northern boundary consists of a row of blackthorn bushes that were planted on a low earth mound (berm) that runs East to West. These trees were not 'feathered' when they were purchased and so have stems as 'standards'. This means that they don't really look like they were self-seeded on the site, although a good choice of species and healthy. It is my opinion that this hedgerow could be enhanced by adding more native species in among them to create a more natural look and add to the diversity of species within the hedgerow. Hawthorn and elder are hardy and would adapt well to interplanting.

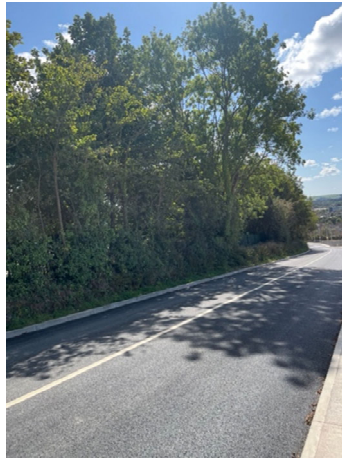
Fig 5: Hedgerow 5

Hedge No.	Coordinates	Species	Height	Width	Age	Condition	Comments	Recommendations	Category Grading
5	51.9273779°N -8.1756400°W 51.9266599°N -8.1758995°W	Wych elm (<i>Ulmus glabra</i>), hawthorn (<i>Crataegus monogyna</i>), ash (<i>Fraxinus excelsior</i>), gorse (<i>Ulex europaeus</i>), bramble (<i>Rubus fruticosus</i>), stinging nettle (<i>Urtica dioica</i>), bracken (<i>Pteridium aquilinum</i>), ivy (<i>Hedera ilex</i>)	5 m	3 m	M	Poor	Hedgerow on sod ditch located outside the treatment facility fence; this hedge has a close relationship to the taller sycamores within Hedgerow 6; at the northern end, a line of young wych elms (suckers) are reaching end of life; 1 no. mature sized ash tree that has been coppiced in the past, resulting in a multi-stemmed tree, is currently leafing out but is showing signs of ash dieback infection; there is a 55m gap between this ash tree and a large ash at the southwest corner; within the gap is a 6m cluster of young hawthorn and a long line of bramble; the ash at the corner is the largest ash on site, but is heavily infected with ash dieback disease	Fell and remove both ash trees and all of the elm trees; replant with hawthorn, blackthorn, and hazel whips to encourage the growth of a short native hedgerow that will act as a good screen and be beneficial for biodiversity	Historical -1 Species diversity - 2 Ground flora - 2 Structure - 1 Habitat Connectivity -2 Landscape - 2

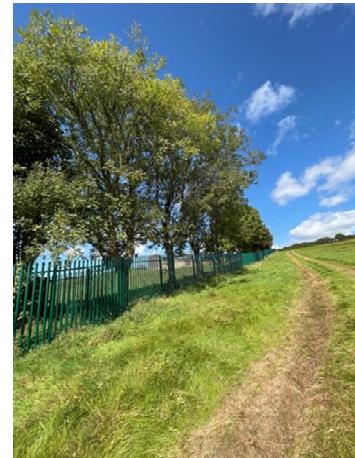
Fig 6: Hedgerow 6

Hedge No.	Coordinates	Species	Height	Crown Spread	Age	Condition	Comments	Recommendations	Category Grading
6	51.9273405°N -8.1755823°W 51.9266971°N -8.1758633°W	Sycamore (<i>Acer pseudoplatanus</i>)	10 m	N 3 m S 3 m E 3 m W 3 m	EM	Fair - Good	A line of evenly spaced sycamore trees that were likely planted to serve as a screen, a fast growing species with large canopies; branches close to the fenceline have been cut back and there is no sign of occlusion (wound closing), still the trees seem healthy with no obvious signs of pathogen attack or poor health, the trees serve their purpose and in time will likely increase their canopy sizes and eventually reach heights of 20m; the sycamores are closely related to Hedgerow no. 5 and influence the growth and character of vegetation in that hedge	No work required presently	B2

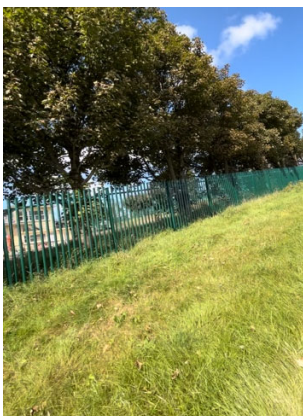
Fig 7: Hedgerow 7

Hedge No.	Coordinates	Species	Height	Crown Spread	Age	Condition	Comments	Recommendations	Category Grading
7	51.9267000°N -8.1757764°W 51.9267715°N -8.1744772°W	Sycamore (<i>Acer pseudoplatanus</i>)	9 m - 17 m	N 3 m S 3 m E 3 m W 3 m	EM	Fair - Good	A double line of sycamore trees, with the inner row somewhat younger and likely planted to serve as additional screening, sycamore is a fast growing species with large canopies; 3 no. trees now measure 17m or more in height; the trees seem healthy with no obvious signs of pathogen attack or poor health; the trees serve as an important screen to the Water Treatment facility; the sycamore canopies provide shade and shelter to Hedgerow no. 3, limiting large canopy growth in that hedge	No work required presently	B2

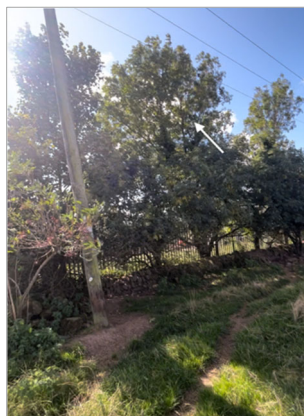
Fig 8: Hedgerow 8

Hedge No.	Coordinates	Species	Height	Crown Spread	Age	Condition	Comments	Recommendations	Category Grading
8	51.9267742°N -8.1744061°W 51.9269675°N -8.1743186°W	Ash (<i>Fraxinus excelsior</i>)	14 m	N 3 m S 3 m E 3 m W 3 m	EM	Fair	A line of 6 no. ash trees on level ground, growing inside the fence line of the Water Treatment facility along its eastern boundary; they are early mature and of fair health; however, they all show early signs of ash dieback infection, recognisable by the curling of outer leaves at the newest growth tips and minor thinning of the crowns; these ash were likely purposely planted at the time of the sycamores and not indigenous to the site, thus the different rate of infection of ash dieback disease	Retain for the short term, monitor and re-inspect in 2024 and 2025 to assess any progression of disease infection; if disease has not significantly progressed by 2025, retain, manage and monitor; if it has measurably progressed, remove and replant with other larger canopy native trees (Oak, Alder, Scots Pine)	C2

The ash trees planted along the fence line at the eastern boundary of the water treatment facility were presumably installed at the same time as the sycamore. At a distance they appear healthy, but at close range are showing signs of the initial stages of ash dieback. These trees should be retained and monitored in the short term, but will likely require removal within the coming decade.

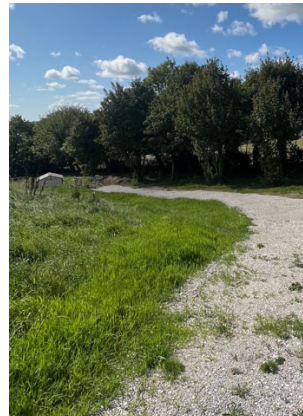
Fig 9: Hedgerow 9

Hedge No.	Coordinates	Species	Height	Crown Spread	Age	Condition	Comments	Recommendations	Category Grading
9	51.9270934°N -8.1743052°W 51.9276388°N -8.1741369°W	Sycamore (<i>Acer pseudoplatanus</i>)	12 m	N 3 m S 3 m E 3 m W 3 m	EM	Fair-Good	A single line of 9 no. early-mature sycamore trees whose canopies now touch, forming a contiguous tree row; the upper crowns illustrate some congestion with restricted branch development and some stems are not straight, all trees have been crown lifted with the lower branches cut back from the fence line, the health of the trees seems to be good with no visible signs of decay or infection	Retain, no further work required presently	B2

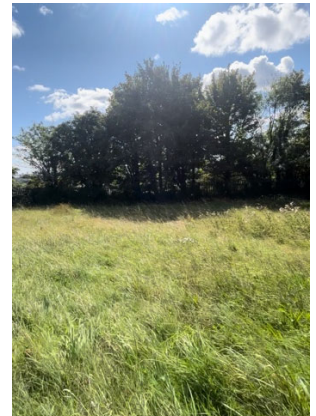
Fig 10: Hedgerow 10

Hedge No.	Coordinates	Species	Height	Crown Spread	Age	Condition	Comments	Recommendations	Category Grading
10	51.9276727°N -8.1741966°W 51.9276587°N -8.1744688°W	Ash (<i>Fraxinus excelsior</i>)	9 m	N 3 m S 3 m E 3 m W 3 m	EM	Fair	A line of 4 no. ash trees on level ground, growing inside the fence line of the Water Treatment facility along its northern boundary; they are early mature and of fair health; however, they all show early signs of ash dieback infection, recognisable by the curling of outer leaves at the newest growth tips and minor thinning of the crowns; these ash were likely purposely planted at the time of the sycamores and not indigenous to the site, thus the different rate of infection of ash dieback disease; the ash canopies cast some shade onto Hedgerow no. 4	Retain for the short term, monitor and re-inspect in 2024 and 2025 to assess any progression of disease infection; if disease has not significantly progressed by 2025, retain, manage and monitor; if it has measurably progressed, remove; replanting to occur within the adjacent Hedgerow no.4	C2
