PLANNING SUBMISSION

Engineering Infrastructure Report for 272 dwellings for Castle Rock Homes (Midleton) Ltd

Broomfield West, Midleton, Co Cork.

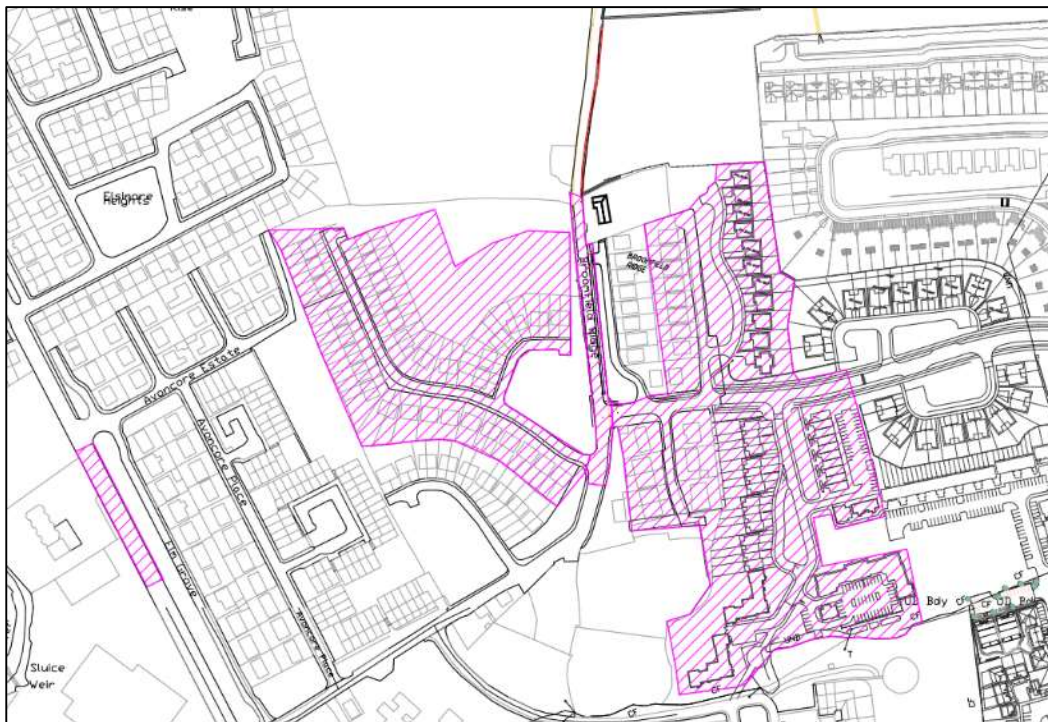
Figure 2.1 SW Receiving Network Catchment Area

An assessment of the capacity of the receiving network has been made. Catchment areas for the network have been calculated and sizes and invert levels of the pipes have been assessed. These capacity calculations are attached in Appendix 'C'. Contributing volumes from existing properties, public roads, the under-construction Park Hill View Estate Ltd Development and the Midleton Water Treatment Plant discharge volumes have been taken into account in these calculations. The catchment areas for this receiving network is shown in Figure 2.1

The receiving network takes runoff from the Hollyridge, Broomfield Ridge, Holly Grove, Holly Court, Broomfield Court and Ivy Court areas east of the L-7360 roadway along with the Brookdale and Abbeylands developments west of the L-7360

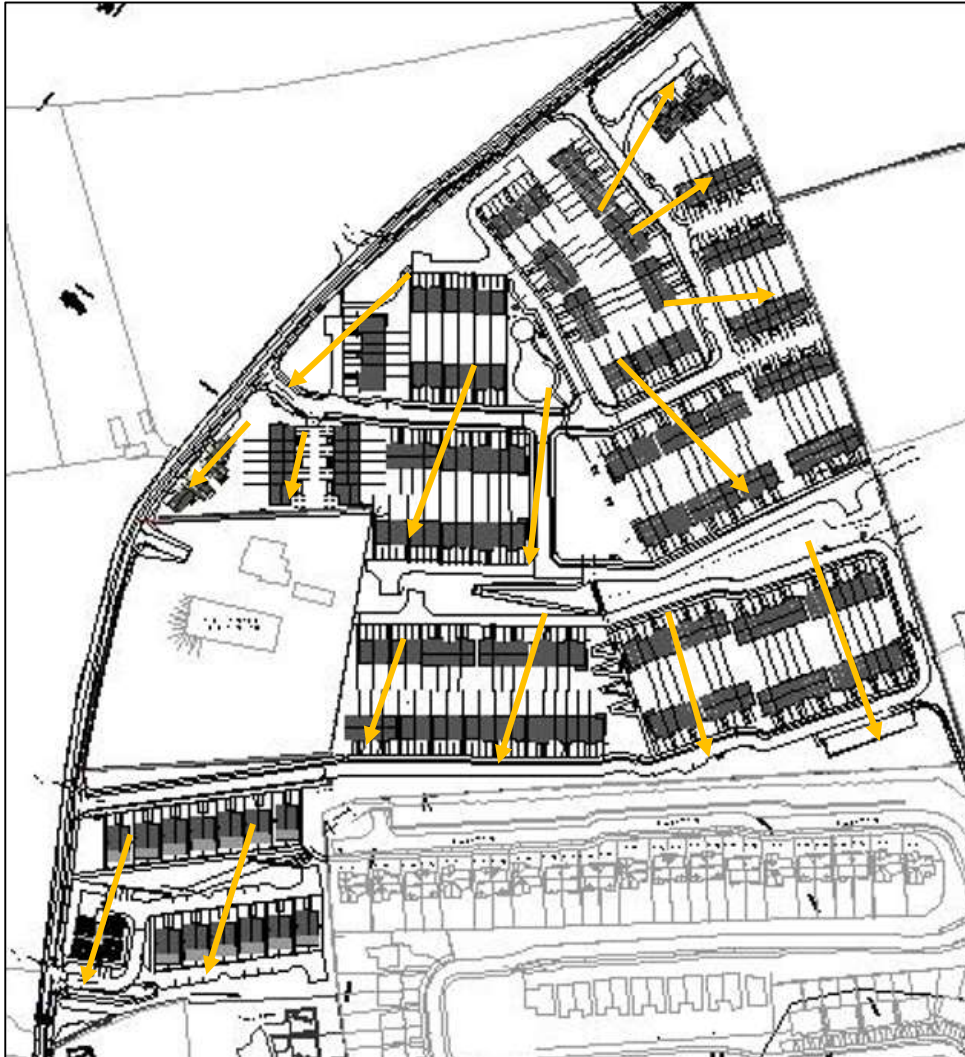
Figure 5.1 Overland Flow Paths

Overland flow paths which run perpendicular to the contours are shown in Figure 5.1. – overlain on the proposed development. In most cases these flow paths are intercepted by estate roads. Where estate roads run in the same direction as the flow paths, raised kerbing at the ends of these will prevent flooding of properties in an extreme rainfall event scenario. Where rainfall is at risk of entering a cul-de-sac area, a raised pedestrian crossing will be constructed at the entrance to this area to prevent flooding of the area. All potential collection areas of exceedance rainfall will be fitted with pairs of road gullies or filter drains to provide extra run-off capacity.

At the centre east-west roadway – where potential rainfall exceedance flow meets the east-west retaining wall there are no road routes downhill from here for exceedance flow to follow. The retaining wall will project 500mm above the ground level to prevent overflow above the wall and to act as a water retention area. The wall construction incorporates a 300mm wide filtration layer directly behind the wall face which extends the full heights of the wall and which has a perforated filter drain at its base, connected to the SW drainage system.

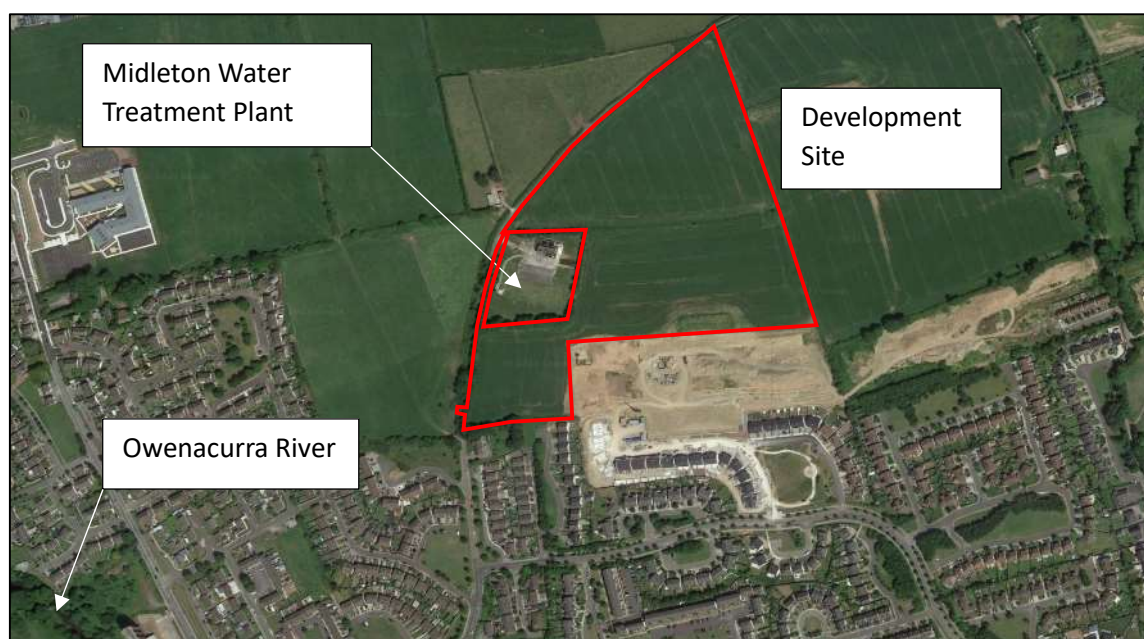
Figure 6.1 Location of proposed development

The development site is shown in Figure 6.1. It comprises 7.95Ha on lands that are sloping from 1:20 at the upper areas to lands that are sloping at 1:8 at the lower areas. The height of the site above ordnance datum ranges from 29.6m AOD at its lowest point to 67.7m AOD at the highest point.

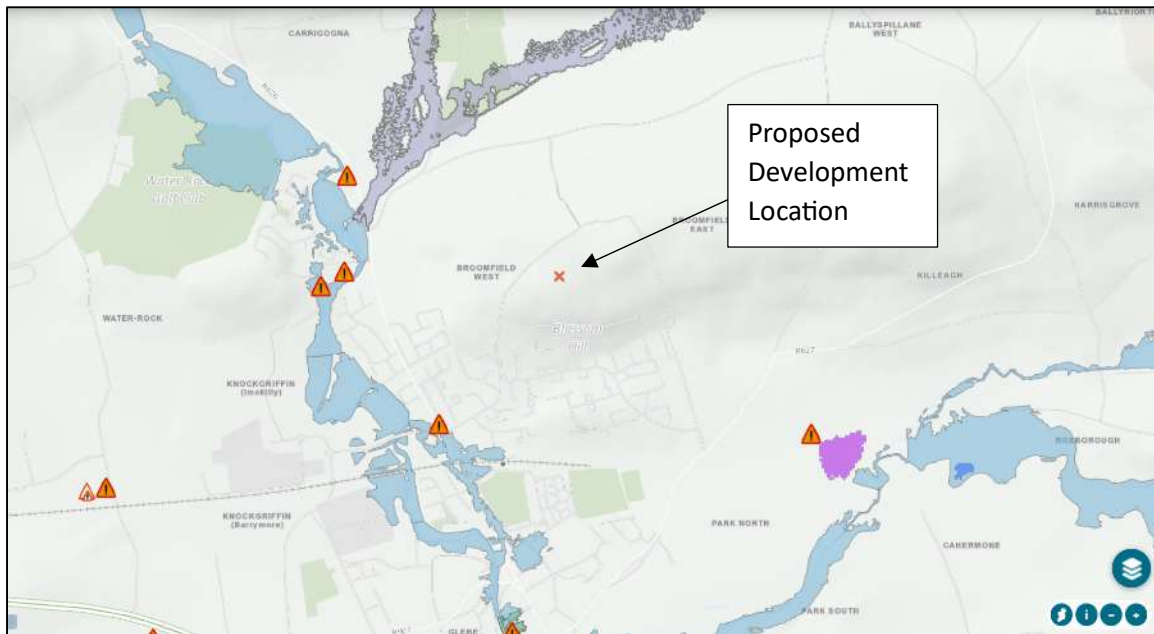
Figure 6.5 OPW National Flood Hazard Mapping

The Flood hazard mapping in Figure 6.5 shows one flood incident, associated with river flooding away from the site and well below the site level. This map also shown Geological Survey of Ireland Maximum Historic Groundwater Flooding. There is no record of ground water flooding at the subject site.

The OPW flood mapping does not predict any flooding at the proposed development site.

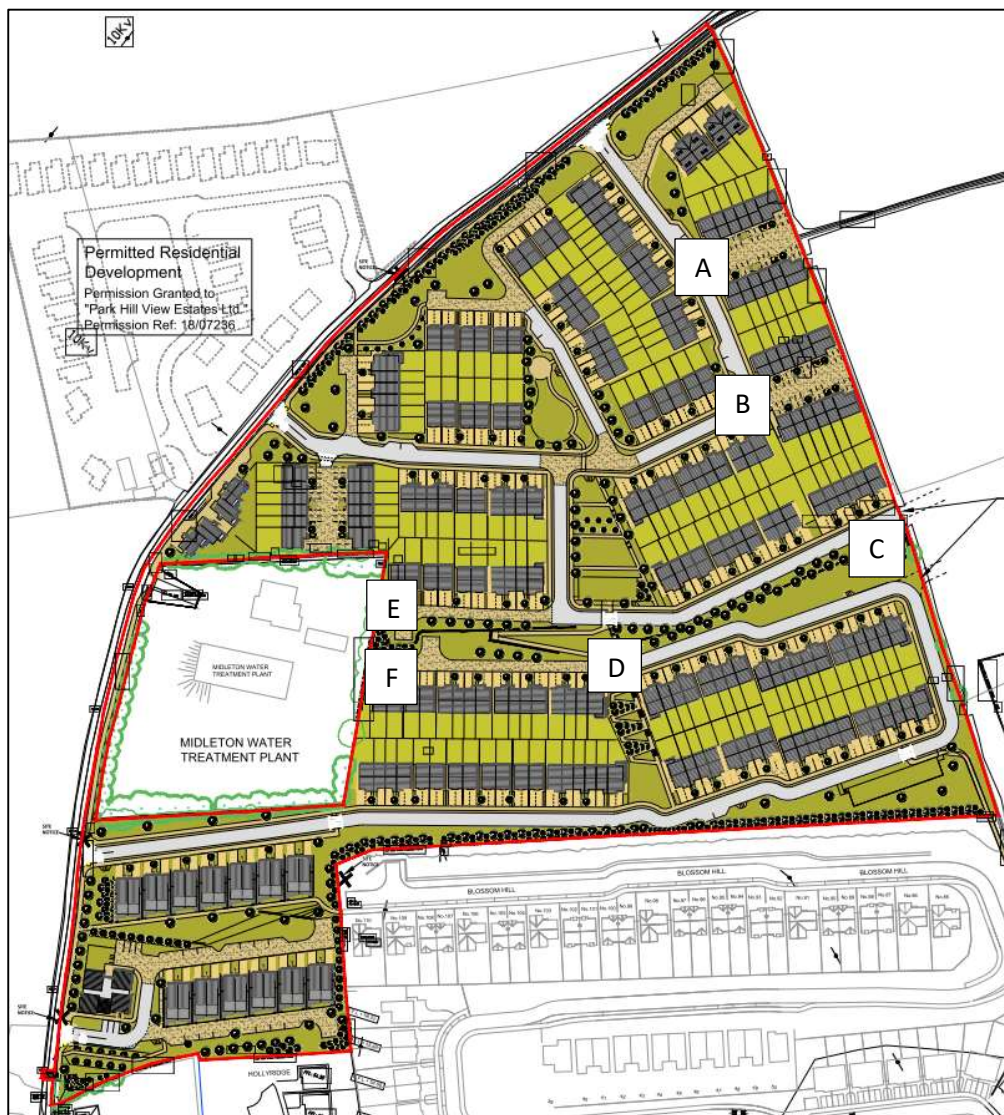
Figure 6.10 Plan of site showing potential vulnerable locations during a pluvial exceedance event

Roads throughout have 150mm high kerbing which will direct overflow waters downhill and away from properties. There are a number of locations where ponding of excess runoff is possible with a potential risk to properties. These vulnerable locations within the development are shown below are assessed individually hereunder.

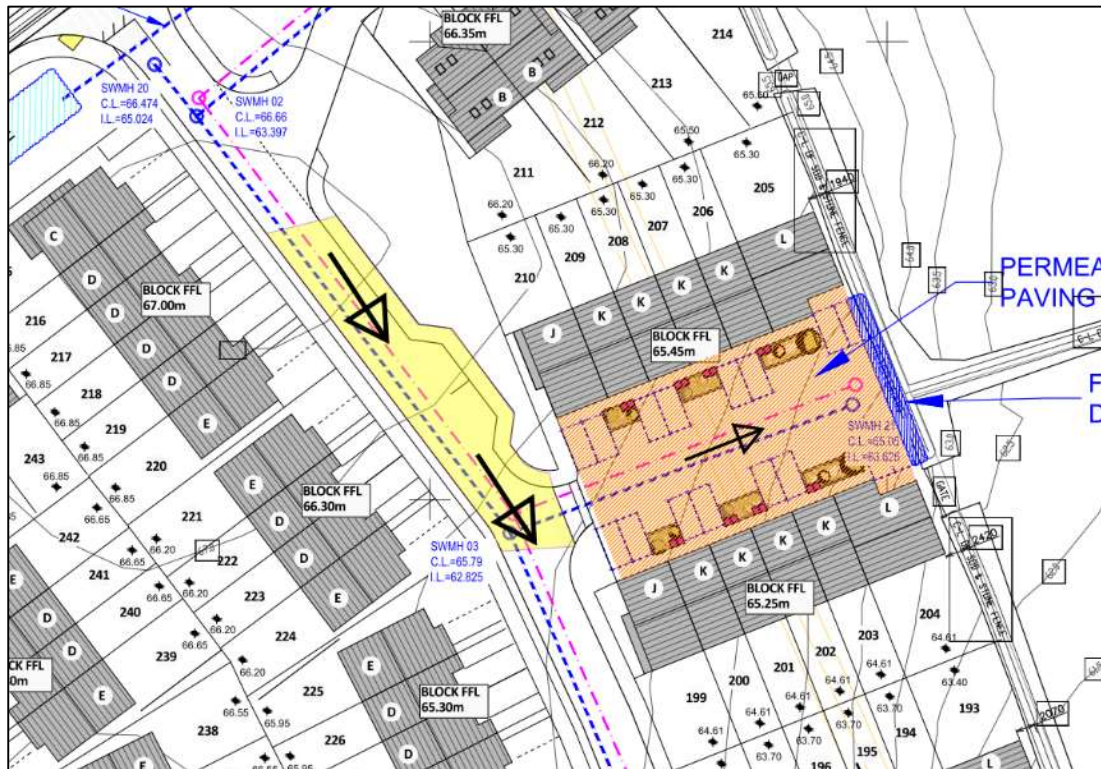
Figure 6.11 Location A - detail

The north-western courtyard housing has a fall from the high point of the development to the eastern boundary of the courtyard. The area of estate roadway passing the courtyard entrance where exceedance may occur is shown highlighted. A raised table entry is incorporated at the entrance to ensure surface water from the estate road does not enter the courtyard area. Within the courtyard itself any surface water exceedance that is not drained by the permeable paving will pass to the filter drain at the lower end.

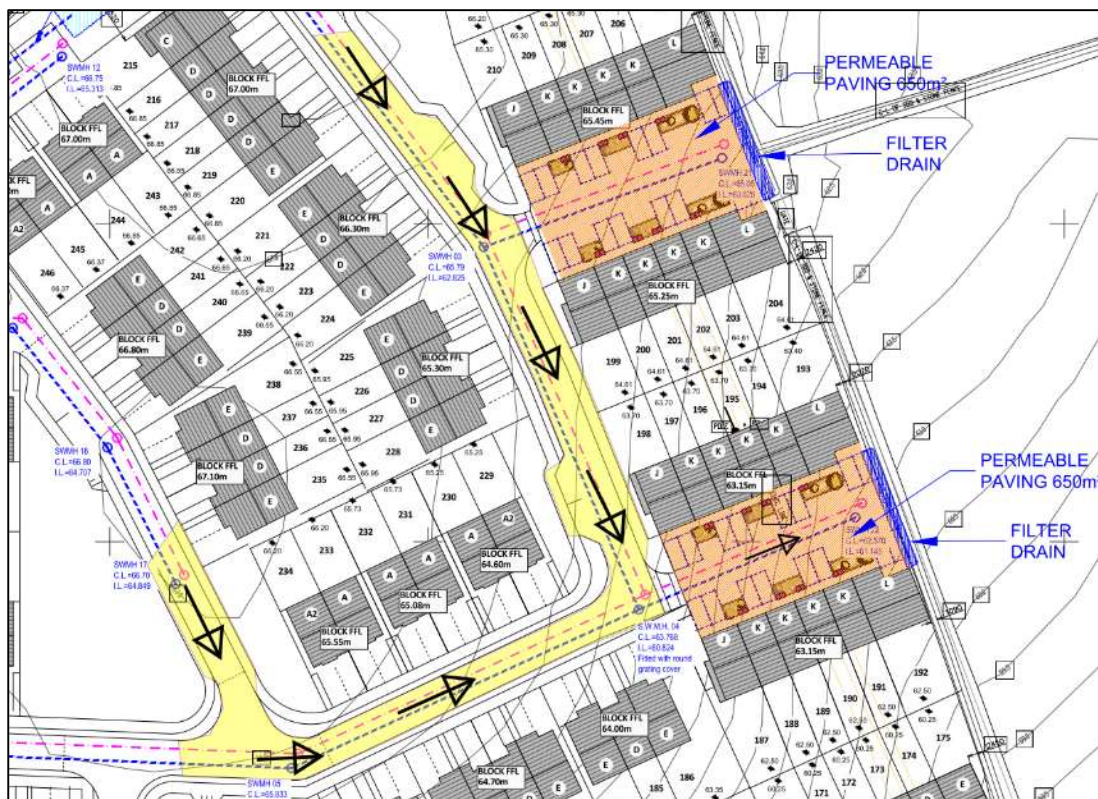
Figure 6.12 Location B - detail

The courtyard housing at this location has a fall from the high point of the development to the eastern boundary of the courtyard. The estate roadway falls from two directions towards the entry point of the courtyard. A raised table entry is incorporated at the entrance of the courtyard to ensure surface water from the estate road does not enter the courtyard area. The SWMH04 manhole at this location will be fitted with D400 round grating cover and two gullies will be situated at the lower corner. The kerb at the lower road edge will be kept full height as far as the driveway point of House No 186. The top of the raised table is 290mm below the FFL of this house. Within the courtyard any surface water exceedance that is not drained by the permeable paving will pass to the filter drain at the lower end. The filter drain capacity is outlined in section 5.11.2 above.

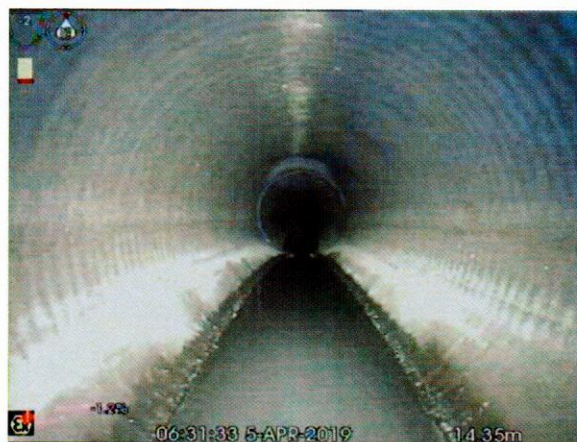
S2X_3c24dd86-e9c2-4854-a02e-26cc4f794fcc_20190405_073041_501.jpg, 00:01:20, 14.35 m
Water level, 5% of the vertical dimension

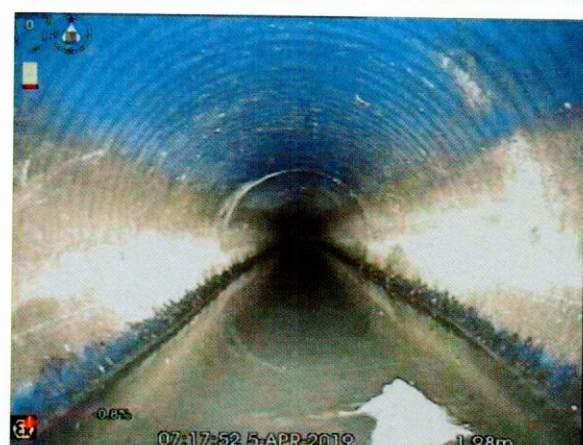
S3X_51ac9785-3074-40fa-9406-ab5ca25e2d2c_20190405_0
81701_604.jpg, 00:00:51, 1.98 m
Water level, 20% of the vertical dimension

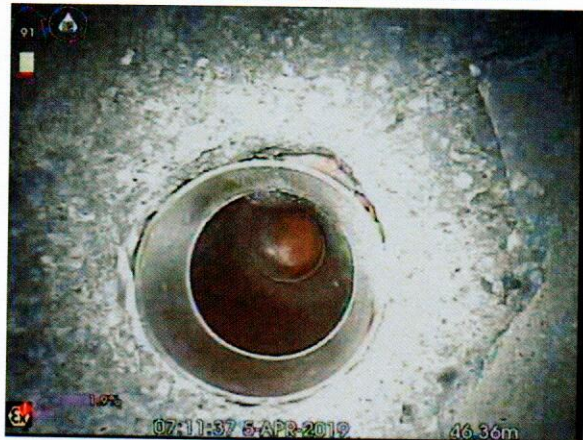
S4X_1c539c1b-af17-430a-a122-eb39745caf70_20190405_081045_894.jpg, 00:05:59, 46.36 m
Connection other than junction at 12 o'clock, diameter:

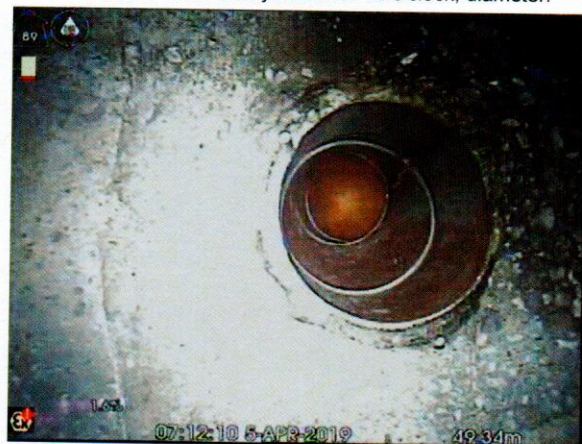
S4X_70a28ef5-6797-4dd6-b806-d4c54aea946f_20190405_081119_111.jpg, 00:06:25, 49.34 m
Connection other than junction at 12 o'clock, diameter:

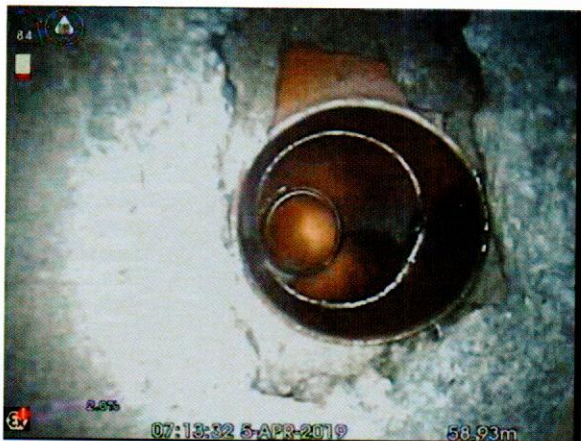
S4X_0e1e6e37-3caa-43e9-b2cf-042f1139d628_20190405_081240_534.jpg, 00:07:39, 58.93 m
Connection other than junction at 12 o'clock, diameter:

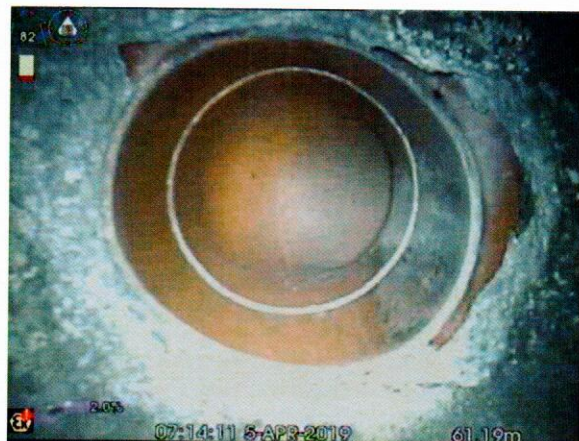
S4X_0a9403e3-fb40-4f72-b1bf-ef6ebd8fc1bf_20190405_081320_079.jpg, 00:08:11, 61.19 m
Connection other than junction at 12 o'clock, diameter:

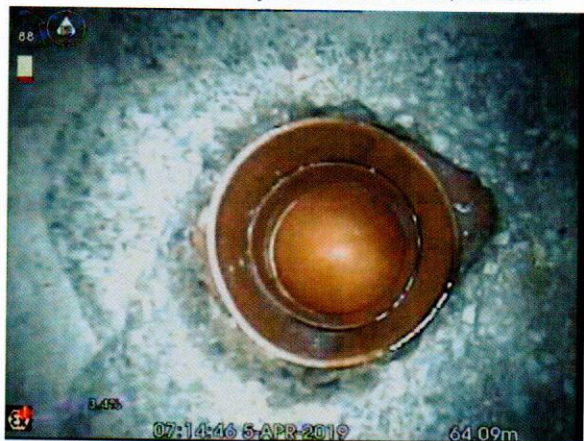
S4X_a38e43f0-4d8b-475b-90dc-9483a57644e7_20190405_081355_262.jpg, 00:08:39, 64.09 m
Connection other than junction at 12 o'clock, diameter:

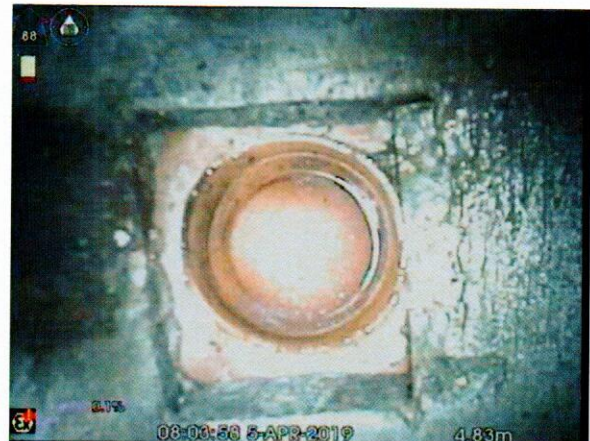
S5X_693240fd-ed56-427d-b066-fe6b68a06725_20190405_090306_660.jpg, 00:00:30, 4.83 m
Connection other than junction at 12 o'clock, diameter:

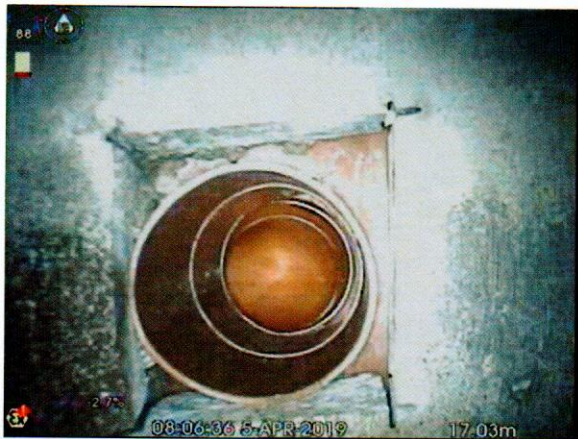
S5X_bd0ee04a-35e7-4a44-b67f-3794dc58536d_20190405_090545_028.jpg, 00:03:01, 17.03 m
Connection other than junction at 12 o'clock, diameter:

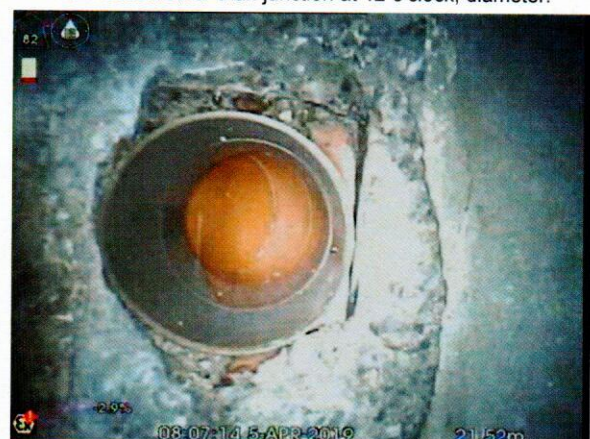
S5X_4b0726a5-1b8e-4719-8026-5574e0baccf4_20190405_090622_341.jpg, 00:03:30, 21.52 m
Connection other than junction at 12 o'clock, diameter:

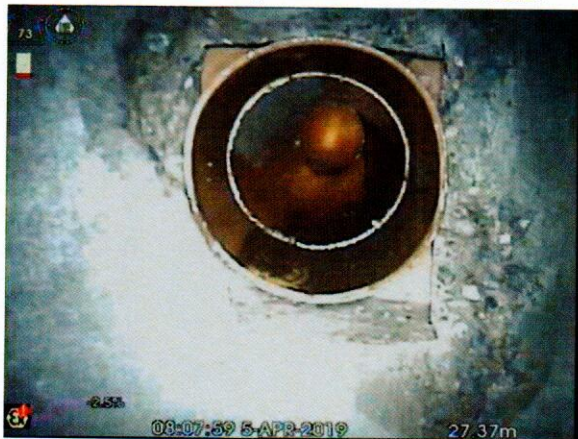
S5X_e997d85e-513a-4c9e-a330-d3a995be0e1e_20190405_090707_939.jpg, 00:04:08, 27.37 m
Connection other than junction at 12 o'clock, diameter:

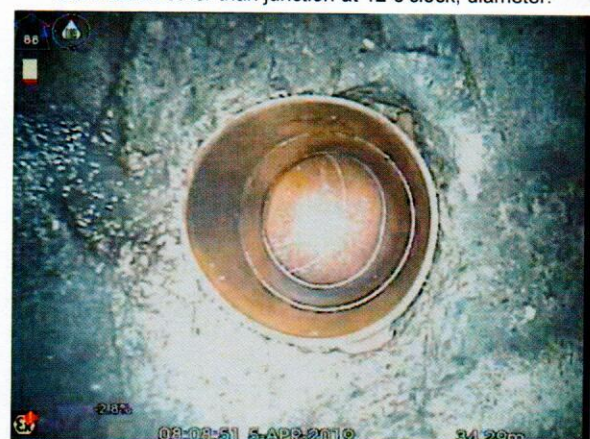
S5X_dc88f43e-10f2-439f-90a0-45b58179b8de_20190405_090759_213.jpg, 00:04:51, 34.29 m
Connection other than junction at 12 o'clock, diameter:

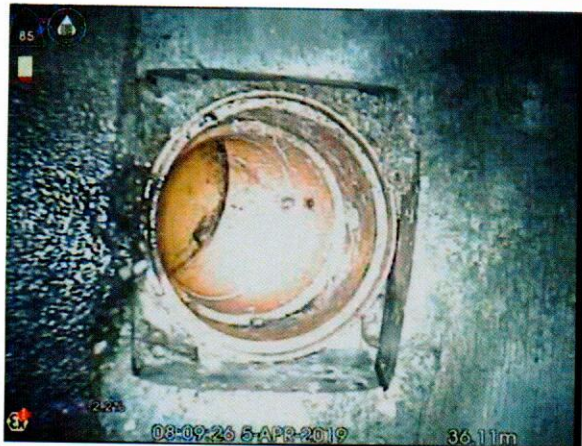
S5X_b30b547f-62c6-437a-8a7e-d78a072d496e_20190405_090834_506.jpg, 00:05:12, 36.11 m
Connection other than junction at 12 o'clock, diameter:

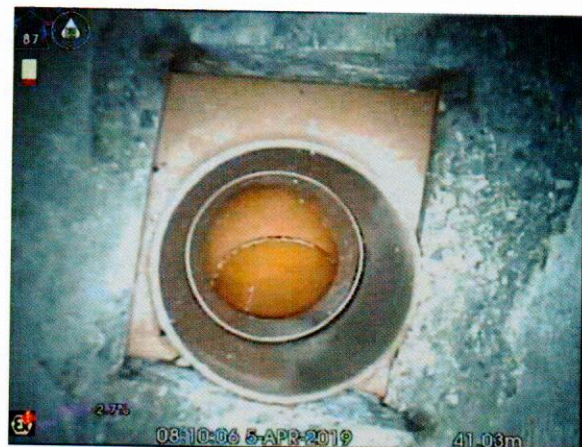
S5X_a2af812d-00a0-49d5-82f5-9c2578d3b00a_20190405_090914_929.jpg, 00:05:45, 41.03 m
Connection other than junction at 12 o'clock, diameter:

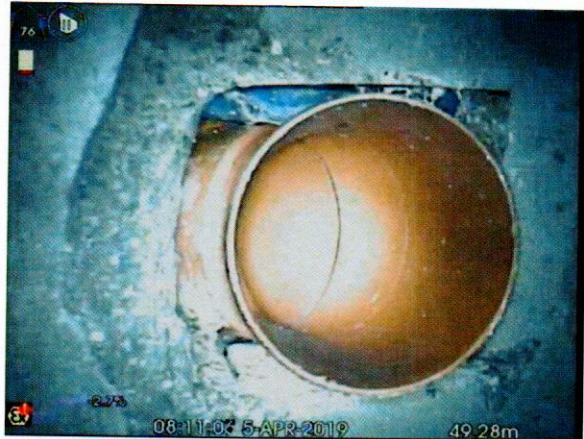
S5X_5188388e-7b81-4df1-9aaa-194757a45e84_20190405_091014_963.jpg, 00:06:34, 49.28 m
Connection other than junction at 11 o'clock, diameter:

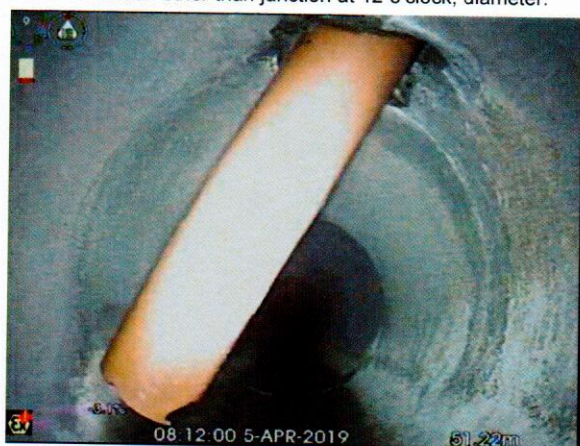
S5X_d9c04386-cfdb-4432-a2e0-6620da3a2084_20190405_091108_192.jpg, 00:06:56, 51.22 m
Connection intruding at 1 o'clock, diameter: 100mm, intrusion:

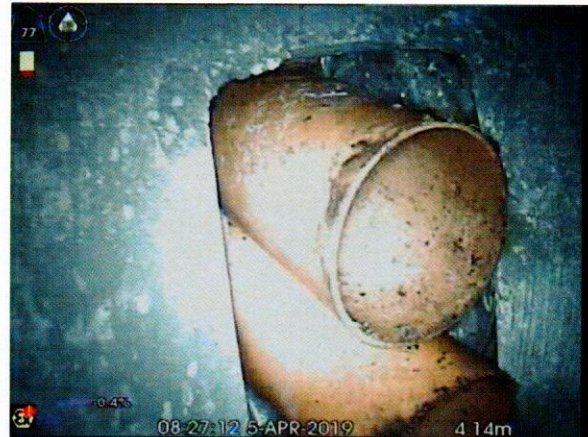
S6X_91b31115-cf97-4745-8a43-0827462e78b0_20190405_092621_053.jpg, 00:00:39, 4.14 m
Connection other than junction at 12 o'clock, diameter:

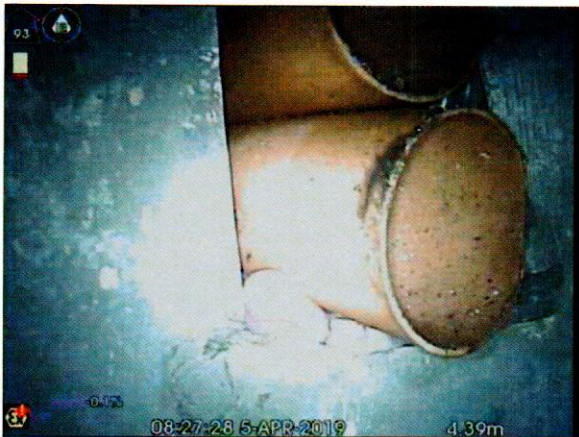
S6X_a4098aa4-0653-4636-a51a-36339279b92e_20190405_092636_205.jpg, 00:00:46, 4.39 m
Connection other than junction at 12 o'clock, diameter:

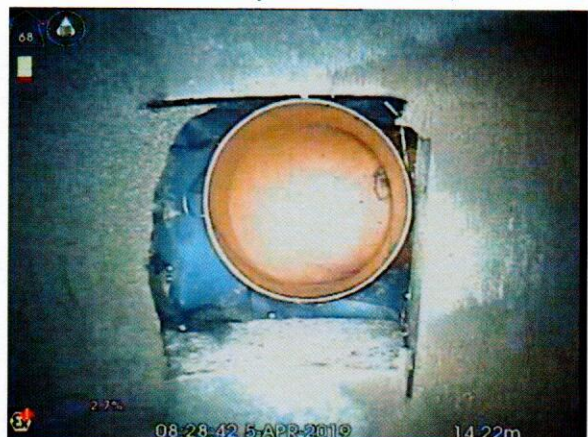
S6X_c9ec7afd-1a4f-4ea7-9098-e3660764c0f2_20190405_092750_886.jpg, 00:01:54, 14.22 m
Connection other than junction at 12 o'clock, diameter:

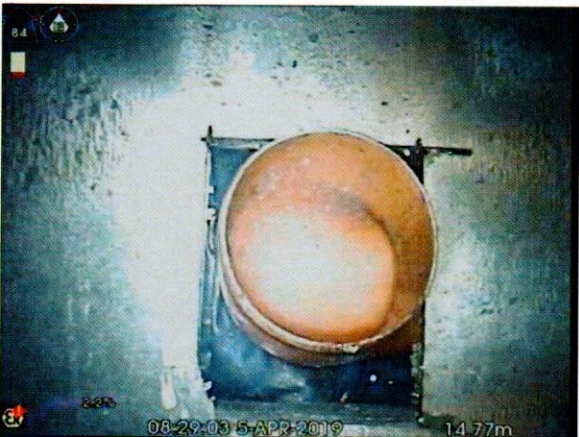
S6X_81383c55-9e7a-4746-8099-ef1c849ac6b8_20190405_092812_269.jpg, 00:02:07, 14.77 m
Connection other than junction at 12 o'clock, diameter:

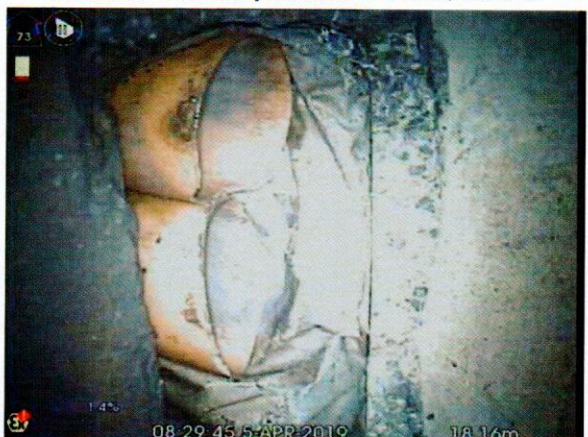
S6X_a74c1424-4840-47fc-b6ea-f90ae8ef89d6_20190405_092853_457.jpg, 00:02:37, 18.16 m
Connection other than junction at 11 o'clock, diameter:

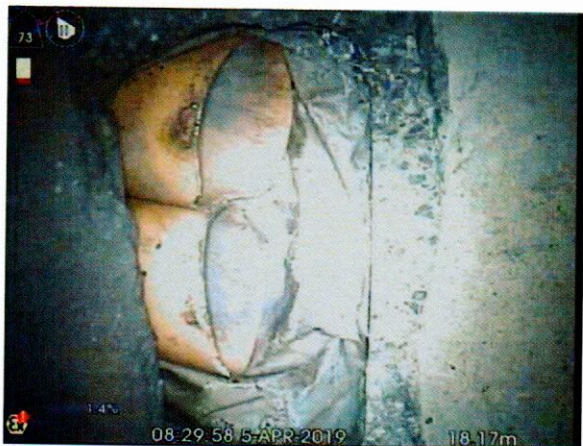
S6X_bdf240ab-03ce-4839-a13b-4a7ff26210f2_20190405_092
906_364.jpg, 00:02:43, 18.17 m
Connection other than junction at 12 o'clock, diameter:

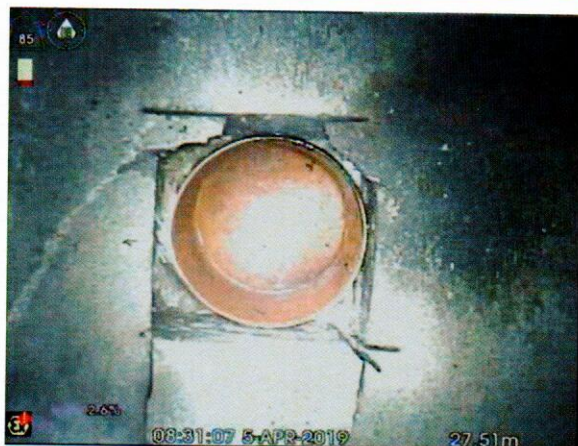
S6X_906c9892-9f70-4388-9326-8bfcfe449905_20190405_09
3015_084.jpg, 00:03:41, 27.51 m
Connection other than junction at 12 o'clock, diameter:

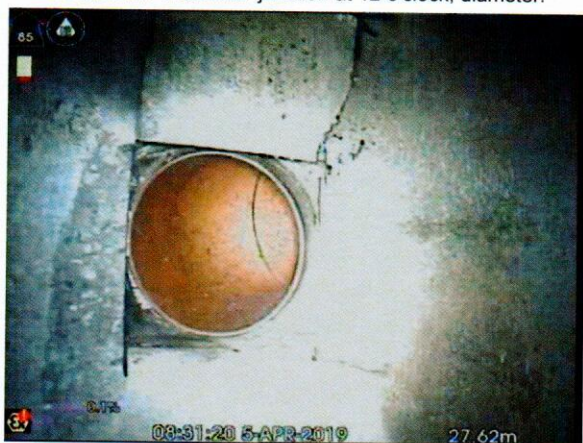
S6X_d6038f54-fdae-433f-a67f-0de6ba9aa6ba_20190405_093
028_351.jpg, 00:03:47, 27.62 m
Connection other than junction at 12 o'clock, diameter:

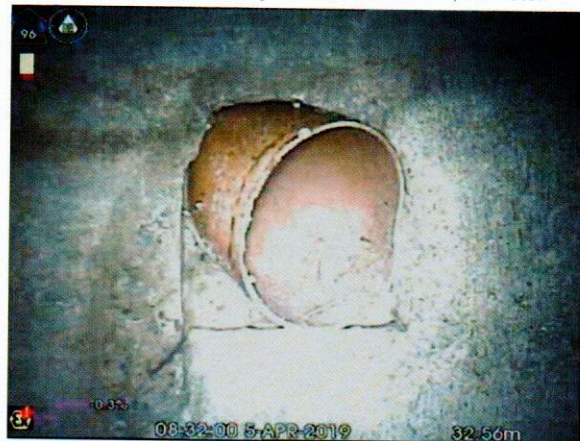
S6X_3f5f0a68-e51d-4e08-a22b-9b6fb0ced204_20190405_09
3108_985.jpg, 00:04:20, 32.56 m
Connection other than junction at 12 o'clock, diameter:

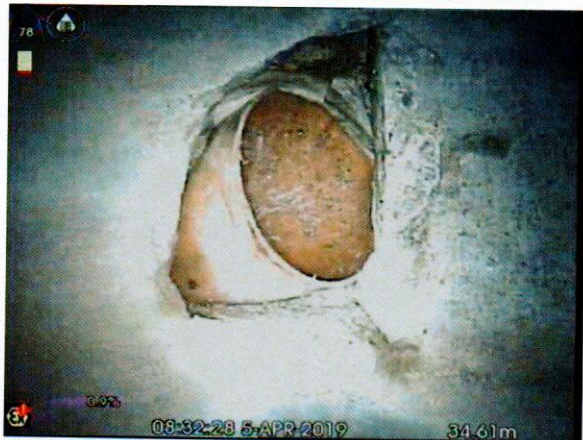
S6X_ddbe4989-b184-447f-9b4f-07cca075102e_20190405_09
3136_478.jpg, 00:04:39, 34.61 m
Connection other than junction at 12 o'clock, diameter:

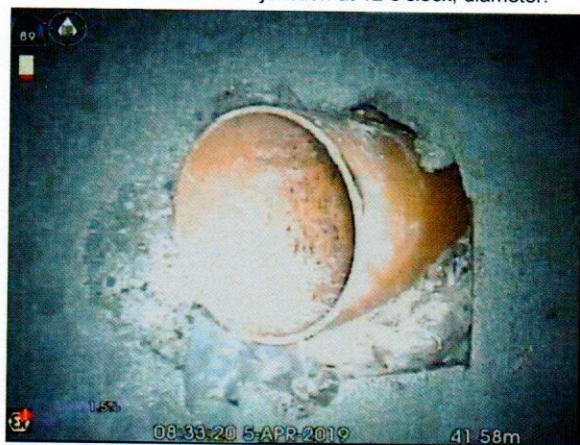
S6X_1735cf16-efdb-4b0a-88ca-38dbbd134ab1_20190405_09
3229_036.jpg, 00:05:23, 41.57 m
Connection other than junction at 12 o'clock, diameter:

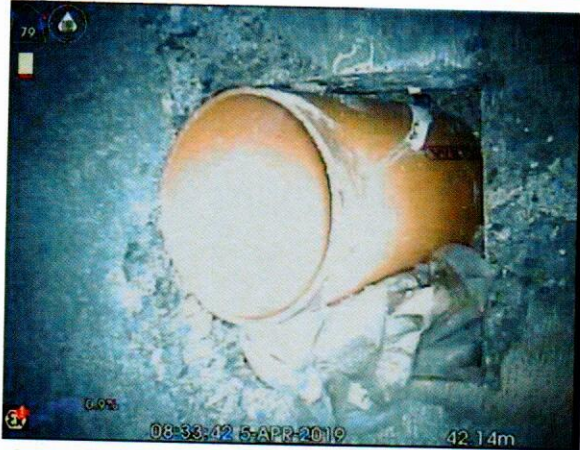
S6X_28decd9d-07d9-44c7-92b2-5de24c9dc43b_20190405_093250_338.jpg, 00:05:35, 42.14 m
Connection other than junction at 12 o'clock, diameter:

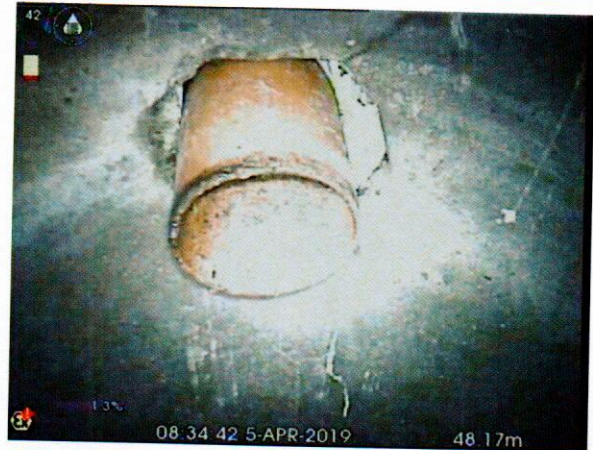
S6X_0d19f72f-ee95-4bcb-a8f3-93b19fae9762_20190405_093350_333.jpg, 00:06:23, 48.17 m
Connection intruding at 12 o'clock, diameter: 100mm,

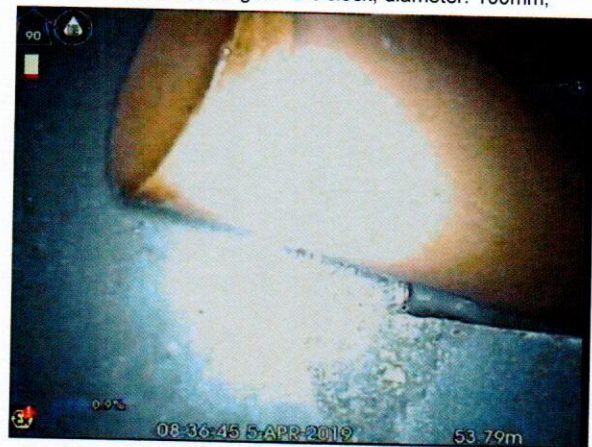
S6X_db2ccba5-02ab-4808-a2f3-f6fb28bc5a34_20190405_093553_252.jpg, 00:07:32, 53.79 m
Connection intruding at 12 o'clock, diameter: 100mm,

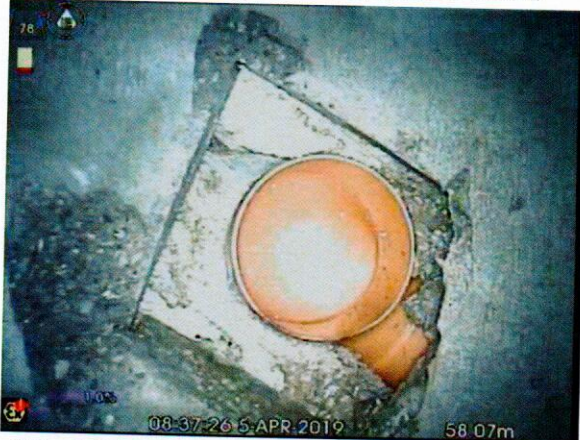
S6X_c5a221d9-8216-4a70-82c9-317fa8dbc8cf_20190405_093635_123.jpg, 00:08:05, 58.07 m
Connection other than junction at 12 o'clock, diameter:

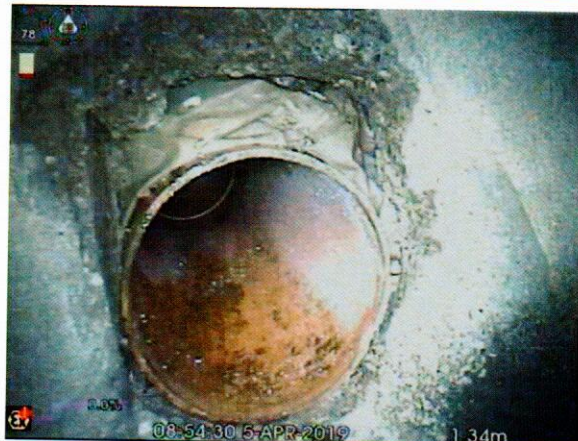
S7X_5389aa5f-4fe3-4cf8-b377-cfb7861908ba_20190405_095
338_868.jpg, 00:01:38, 1.34 m
Connection other than junction at 12 o'clock, diameter:

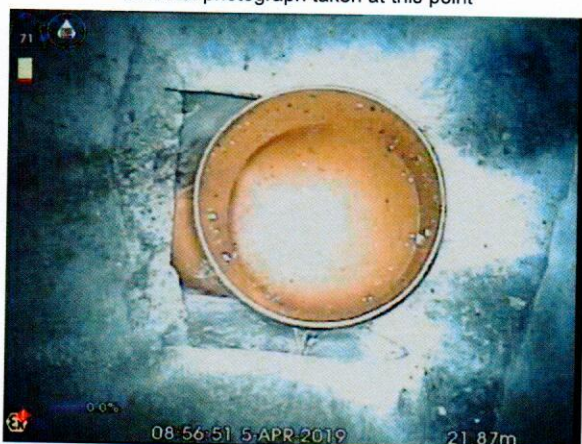
S7X_31436574-988a-4e7e-9a63-8803c35111fa_20190405_095
95559_947.jpg, 00:03:30, 21.87 m
Connection other than junction at 12 o'clock, diameter:

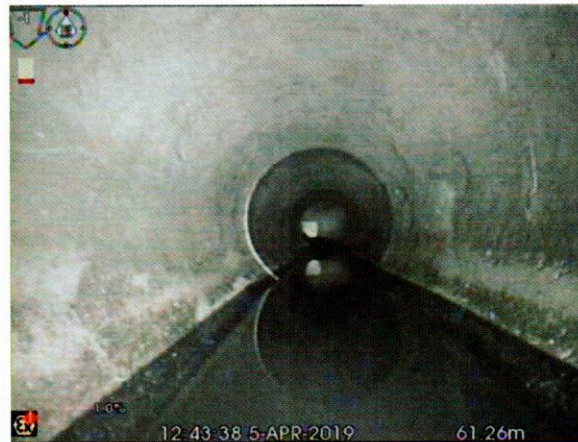
S10X_f3b594ef-ef55-4d79-baf5-181129d52886_20190405_13
4246_959.jpg, 00:05:21, 61.26 m

Water level, 10% of the vertical dimension

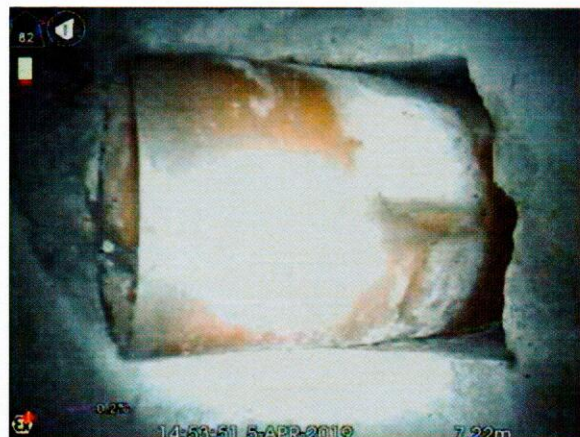
S11X_8c26414c-5570-4c5c-9c45-72a3d62b1144_20190405_155300_478.jpg, 00:00:53, 7.22 m
Connection other than junction at 1 o'clock, diameter: 150mm

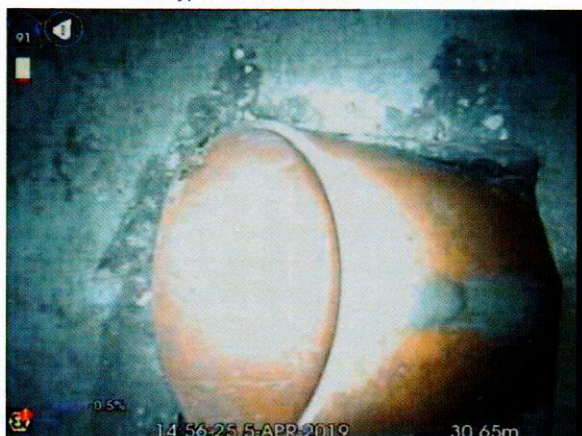
S11X_97e89ff1-cece-4ded-a60d-67b0788aebb6_20190405_155533_720.jpg, 00:03:15, 30.65 m
Connection other than junction at 1 o'clock, diameter: 150mm

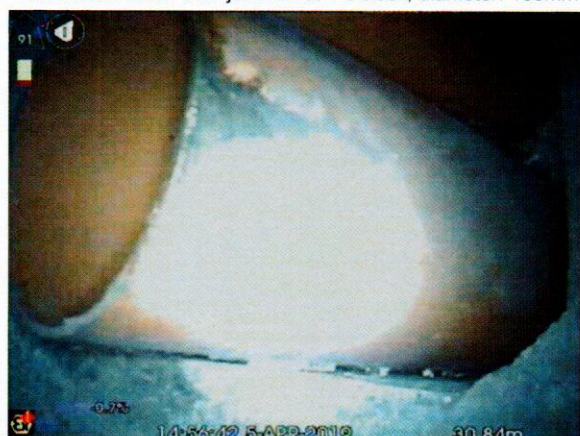
S11X_b51732fa-f87c-498b-98f5-c59dd0c10ad3_20190405_155550_998.jpg, 00:03:25, 30.84 m
Connection other than junction at 1 o'clock, diameter: 150mm

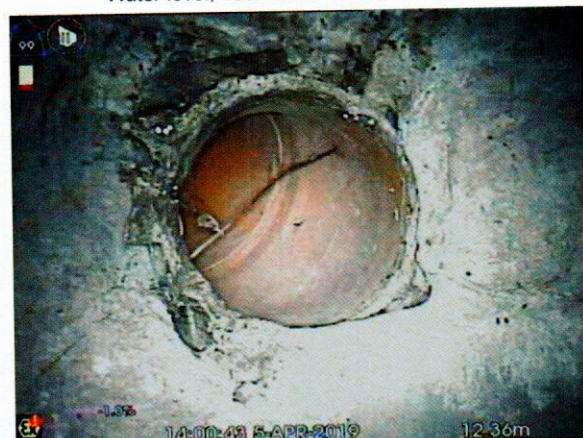
S12X_1bd62a68-ad66-4de4-b315-8e019f14ab10_20190405_145952_710.jpg, 00:04:18, 12.36 m
Connection other than junction at 12 o'clock, diameter:

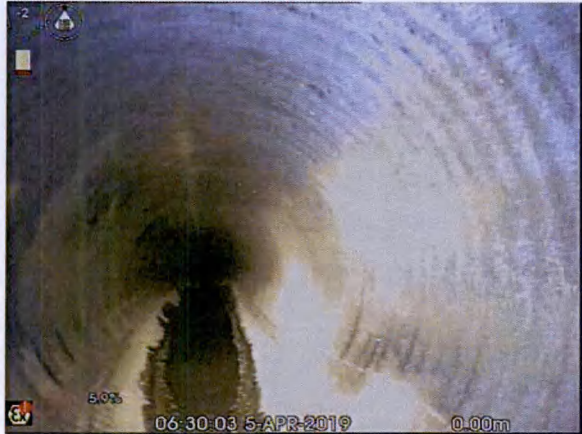
S2X_2608f175-6544-4e1c-a755-5bcd4680625b_20190405_072911_710.jpg, 00:00:00, 0.00 m
Start node type, manhole, reference number: S2

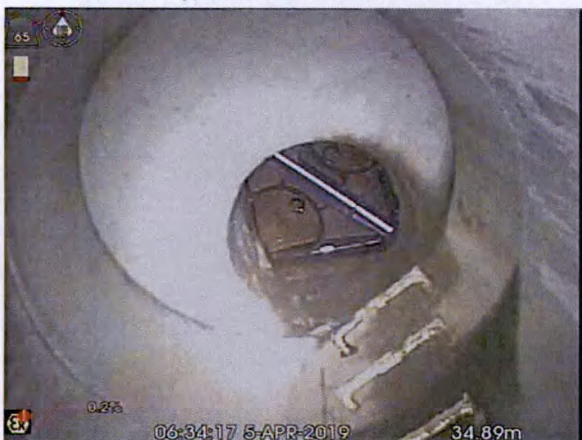
S2X_145dd4f1-9c8c-4397-98e5-7cbd74295ccd_20190405_073325_858.jpg, 00:03:29, 34.89 m
Finish node type, manhole, reference number: S3

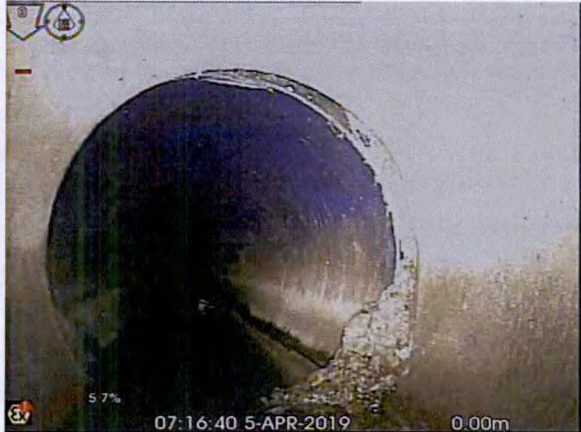
S3X_9e923133-f59a-4261-918a-f2247a8f9391_20190405_08
1548_768.jpg, 00:00:00, 0.00 m
Start node type, manhole, reference number: S4

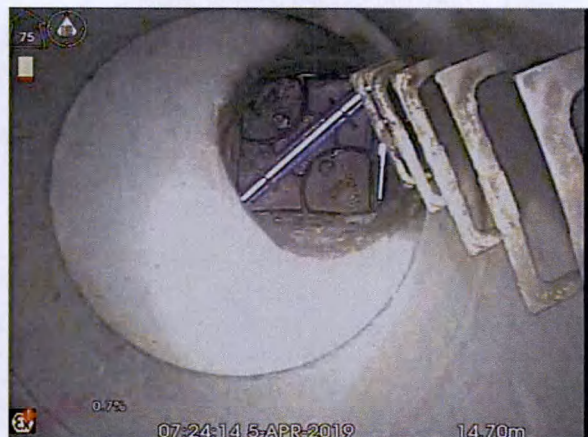
S3X_3154a530-4788-4cb9-9b2f-c8e0ef97cbe9_20190405_08
2323_160.jpg, 00:06:46, 14.68 m
Finish node type, manhole, reference number: S3

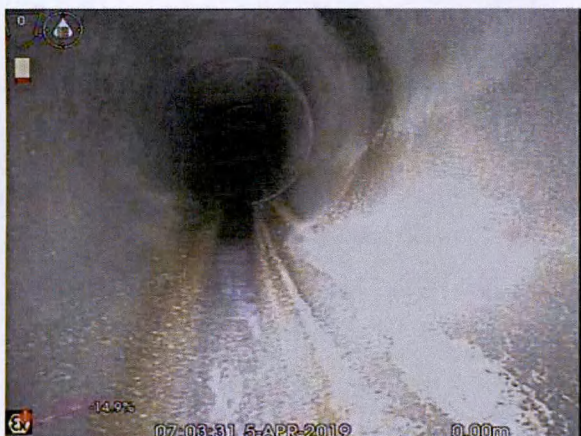
S4X_6b0fc3f3-69d8-4222-817c-d3ec9f1d921d_20190405_08
0239_607.jpg, 00:00:00, 0.00 m
Start node type, manhole, reference number: S5

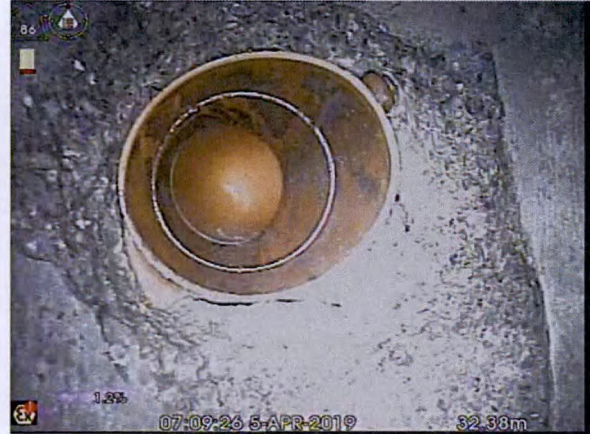
S4X_4dd6337d-9aba-4882-aa9d-5cf20b35e773_20190405_080834_359.jpg, 00:04:12, 32.38 m
Connection other than junction at 12 o'clock, diameter:

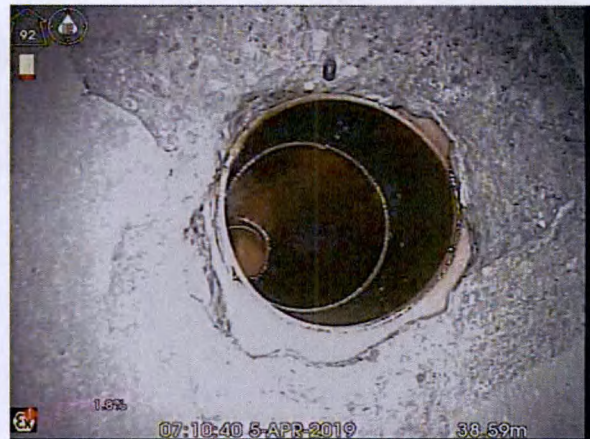
S4X_b34d13cd-a11f-4f5a-83bd-292a71613fec_20190405_080949_148.jpg, 00:05:11, 38.59 m
Connection other than junction at 12 o'clock, diameter:

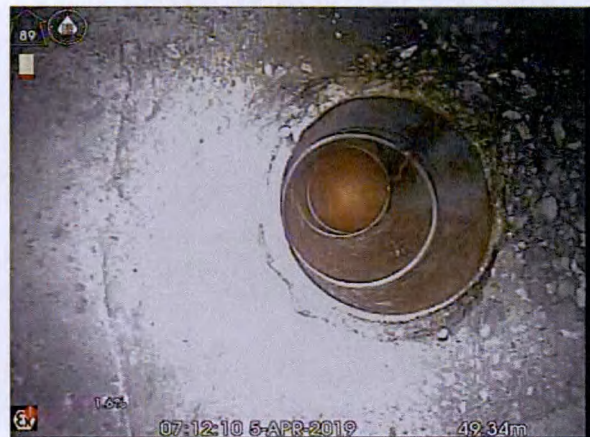
S4X_70a28ef5-6797-4dd6-b806-d4c54aea946f_20190405_081119_111.jpg, 00:06:25, 49.34 m
Connection other than junction at 12 o'clock, diameter:

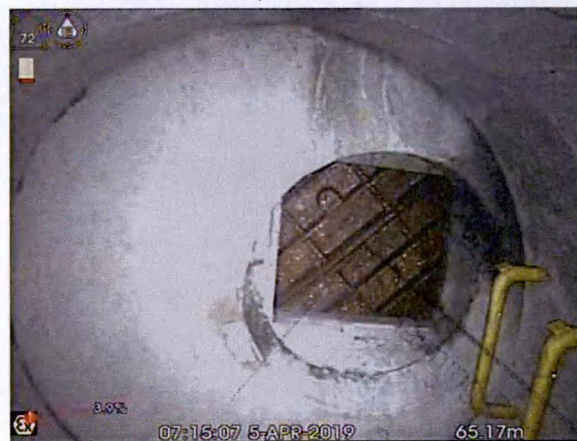
S4X_bb89ef55-97ee-4461-8fa9-05e0bdeb471d_20190405_081415_982.jpg, 00:08:55, 65.17 m
Finish node type, manhole, reference number: S4

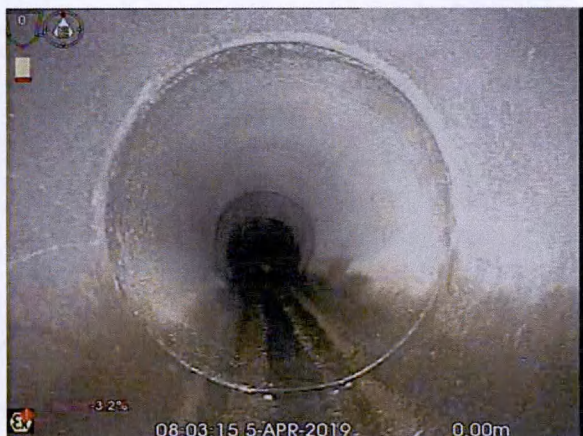
S5X_3a8da4cf-5542-444f-a34e-e58f58df49c0_20190405_090223_838.jpg, 00:00:00, 0.00 m
Start node type, manhole, reference number: S5

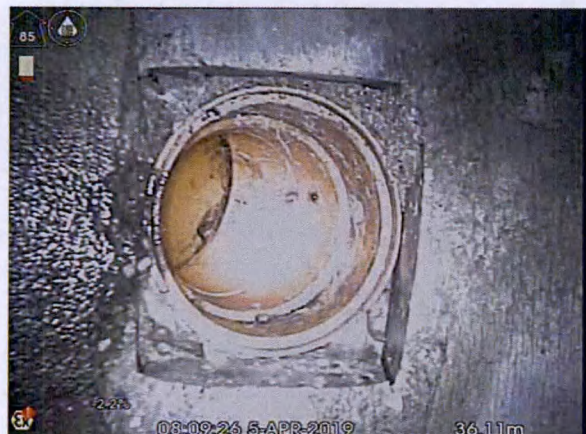
S5X_b30b547f-62c6-437a-8a7e-d78a072d496e_20190405_090834_506.jpg, 00:05:12, 36.11 m

Connection other than junction at 12 o'clock, diameter:

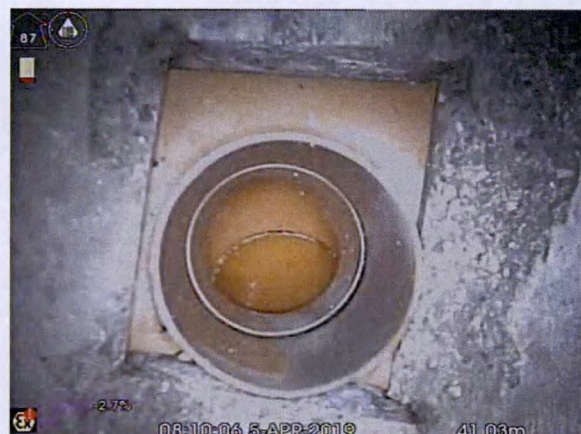
S5X_a2af812d-00a0-49d5-82f5-9c2578d3b00a_20190405_090914_929.jpg, 00:05:45, 41.03 m

Connection other than junction at 12 o'clock, diameter:

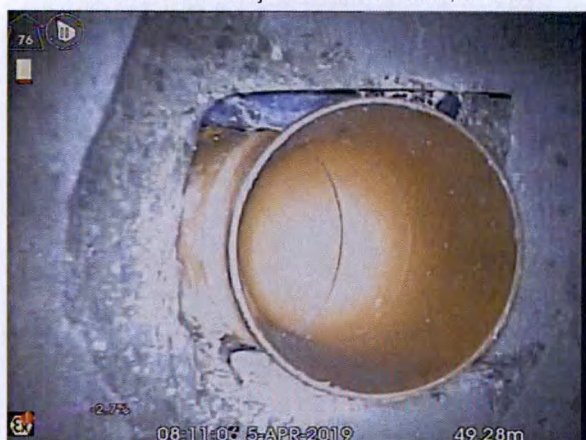
S5X_5188388e-7b81-4df1-9aaa-194757a45e84_20190405_091014_963.jpg, 00:06:34, 49.28 m

Connection other than junction at 11 o'clock, diameter:

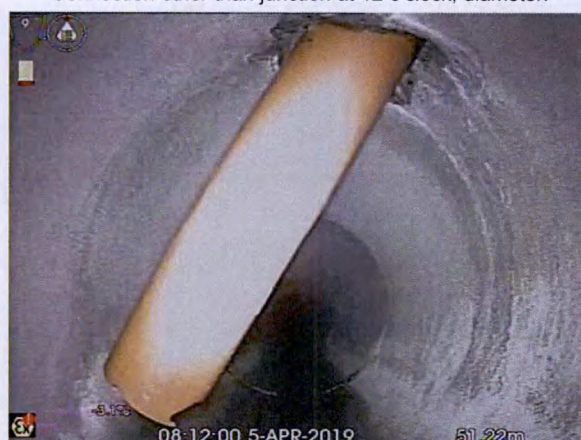
S5X_d9c04386-cfdb-4432-a2e0-6620da3a2084_20190405_091108_192.jpg, 00:06:56, 51.22 m

Connection intruding at 1 o'clock, diameter: 100mm, intrusion:
