PLANNING SUBMISSION

Engineering Infrastructure Report for 272 dwellings for Castle Rock Homes (Midleton) Ltd

Broomfield West, Midleton, Co Cork.

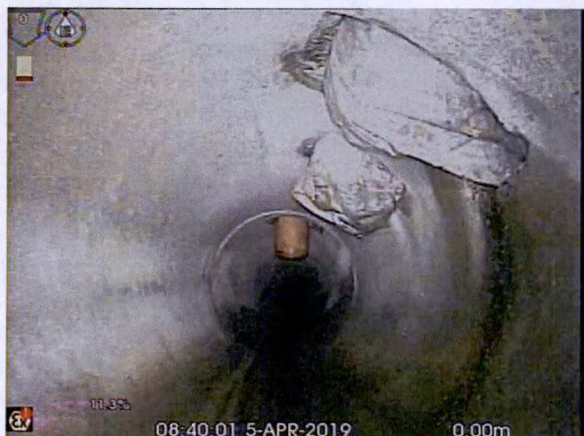
S5X_104bc7a0-720a-47f0-9d37-14bde05d9d88_20190405_093909_790.jpg, 00:00:00, 0.00 m
Start node type, manhole, reference number: S6

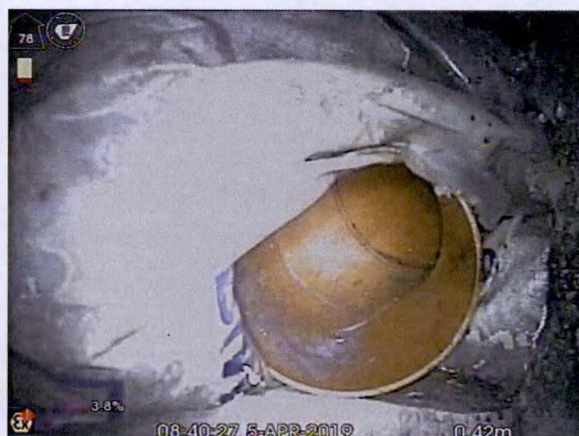
S5X_03b0457f-bb8e-468f-9713-1786b92e3fda_20190405_093935_556.jpg, 00:00:14, 0.42 m
Connection other than junction at 2 o'clock, diameter: 100mm

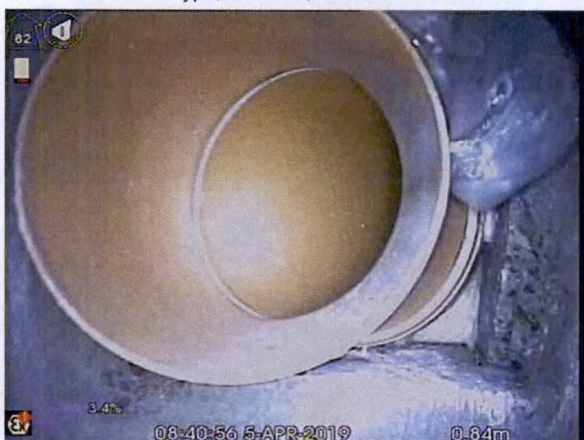
S5X_b7966323-76b6-459a-b1e1-98e9956461e4_20190405_094005_065.jpg, 00:00:28, 0.84 m
Connection intruding at 2 o'clock, diameter: 100mm, intrusion:

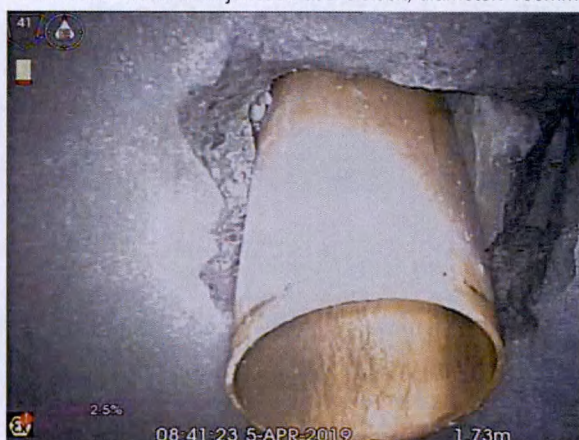
S5X_62aa0cc2-107c-47cd-adfc-3f77a6d3f8cb_20190405_094031_971.jpg, 00:00:43, 1.73 m
Connection intruding at 12 o'clock, diameter: 100mm,

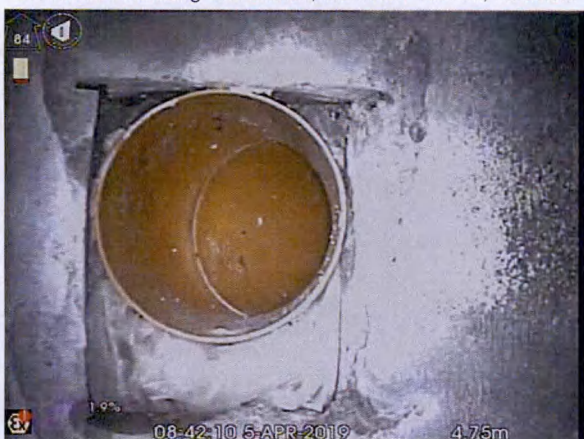
S5X_370e06e4-84f4-4c8a-a3a3-c44a2989c107_20190405_094118_654.jpg, 00:01:18, 4.75 m
Connection other than junction at 1 o'clock, diameter: 100mm

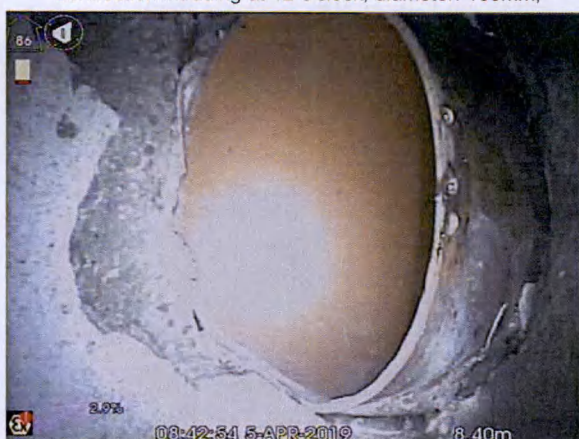
S5X_acceb949-f9b9-48f2-85ef-1e599e766fc5_20190405_094202_125.jpg, 00:01:52, 8.40 m
Connection other than junction at 2 o'clock, diameter: 100mm

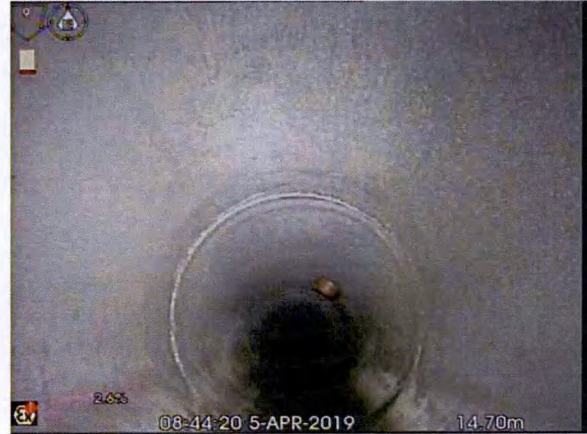
S5X_1d400da9-4a1b-4c68-8818-be19158c9803_20190405_094328_528.jpg, 00:02:45, 14.70 m
Survey abandoned

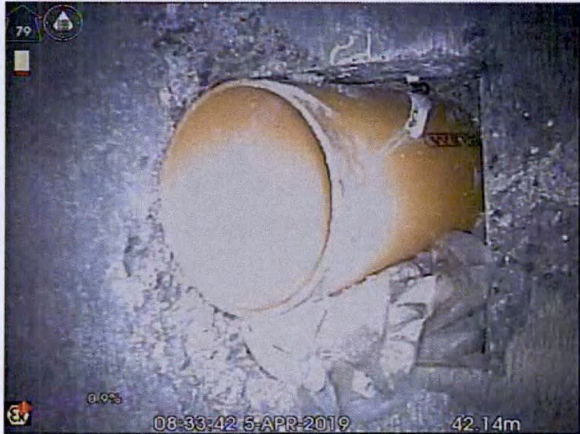
S6X_28dec9d-07d9-44c7-92b2-5de24c9dc43b_20190405_093250_338.jpg, 00:05:35, 42.14 m

Connection other than junction at 12 o'clock, diameter:

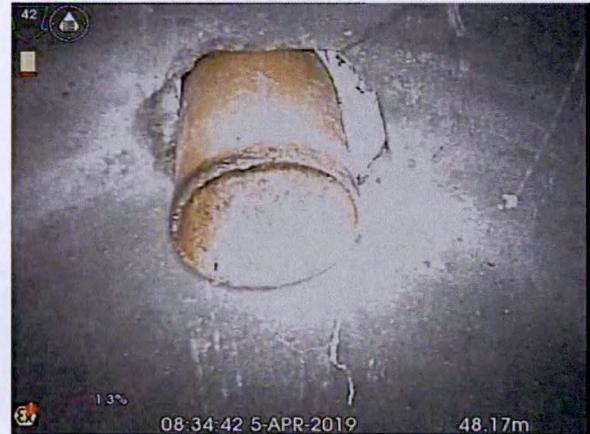
S6X_0d19f72f-ee95-4bcb-a8f3-93b19fae9762_20190405_09350_333.jpg, 00:06:23, 48.17 m

Connection intruding at 12 o'clock, diameter: 100mm,

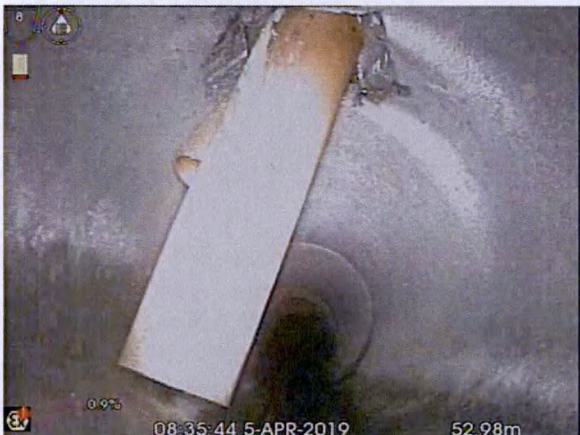
S6X_884f3d3d-f874-4854-8418-3b70886c52c6_20190405_093453_196.jpg, 00:07:02, 52.98 m

Connection intruding at 12 o'clock, diameter: 100mm,

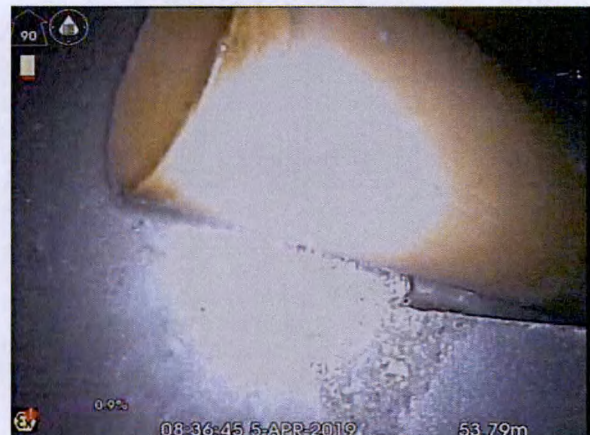
S6X_db2ccba5-02ab-4808-a2f3-f6fb28bc5a34_20190405_093553_252.jpg, 00:07:32, 53.79 m

Connection intruding at 12 o'clock, diameter: 100mm,

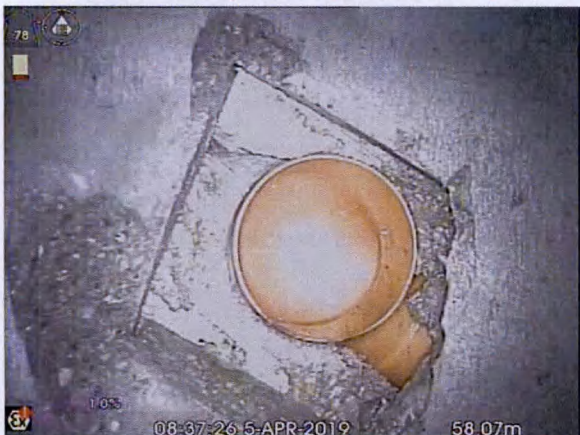
S6X_c5a221d9-8216-4a70-82c9-317fa8dbc8cf_20190405_093635_123.jpg, 00:08:05, 58.07 m

Connection other than junction at 12 o'clock, diameter:

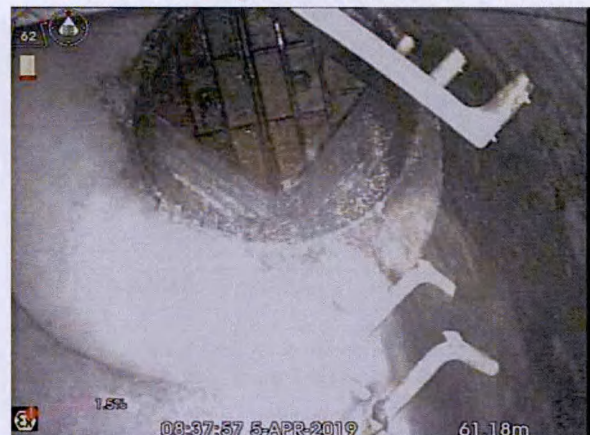
S6X_2600c881-53cf-4c40-b02b-ee08dc7ae9b1_20190405_093705_399.jpg, 00:08:30, 61.18 m

Finish node type, manhole, reference number: S7

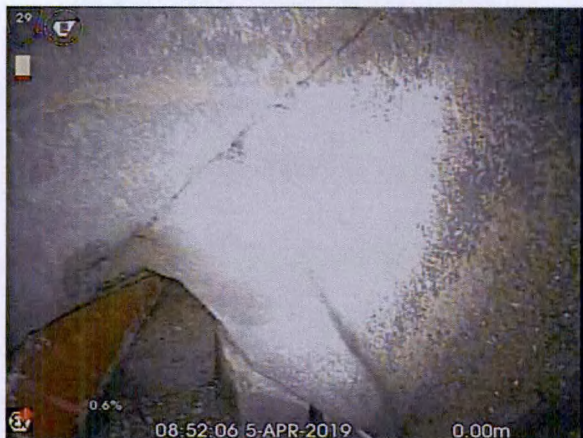
S7X_e95e40db-f421-4224-9e8c-5d1c64228623_20190405_095114_099.jpg, 00:00:24, 0.00 m
Cracks, multiple from 4 o'clock to 6 o'clock

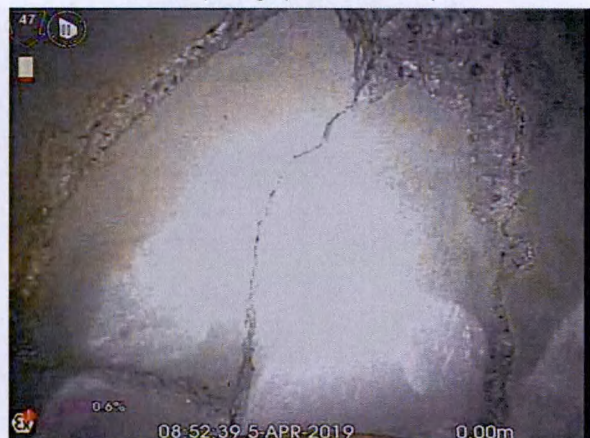
S7X_ca062aaf-6af5-4bed-ad91-987a9282a6d7_20190405_095147_073.jpg, 00:00:40, 0.00 m
Fracture spiral from 9 o'clock to 3 o'clock

Section	PLR	Grade	Description
9	S7X	4	Fracture spiral from 9 o'clock to 3 o'clock

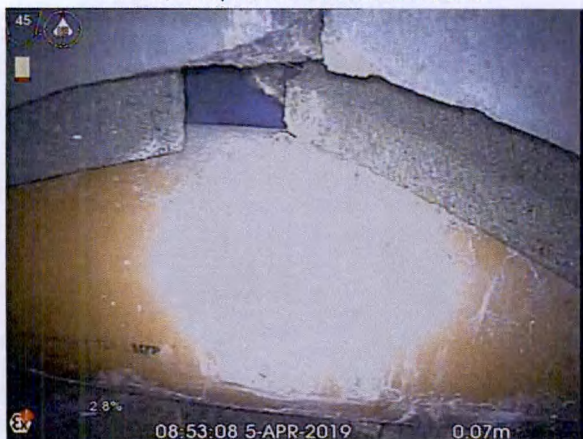
S7X_d006f887-6511-4b65-b4da-cfa26ba72726_20190405_095217_150.jpg, 00:00:54, 0.07 m
General photograph taken at this point

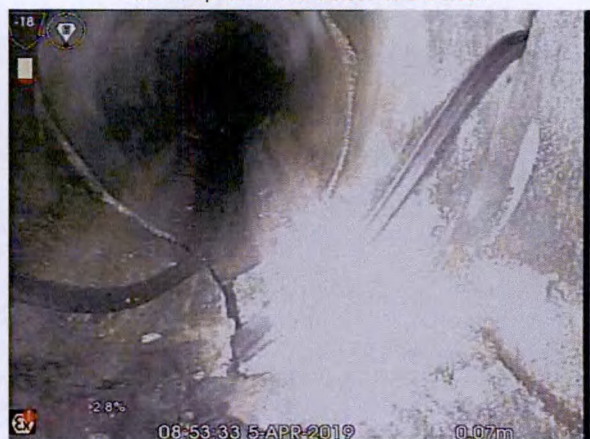
S7X_507b6eab-e483-4ccb-9798-b9840ae9fe90_20190405_095241_489.jpg, 00:01:01, 0.07 m
Sealing ring broken from 3 o'clock to 9 o'clock

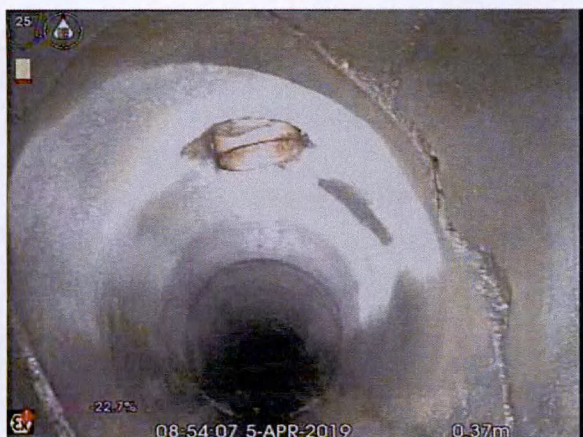
S7X_7668e268-54dd-4054-bff4-0173f5f9763b_20190405_095314_961.jpg, 00:01:21, 0.37 m
Cracks, spiral from 12 o'clock to 12 o'clock

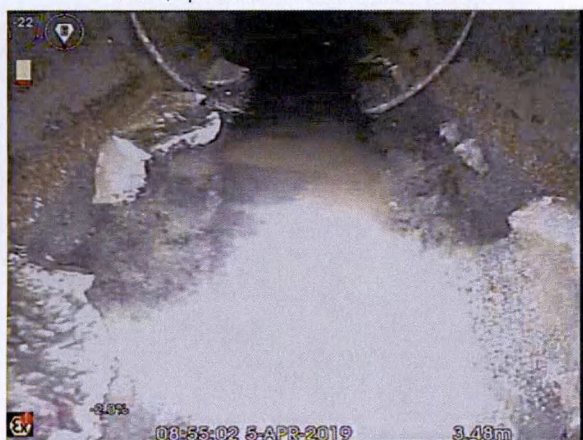
S7X_45db0c5d-8ed2-4482-a9ef-89be9f78f5ff_20190405_095410_824.jpg, 00:01:58, 3.48 m
General photograph taken at this point

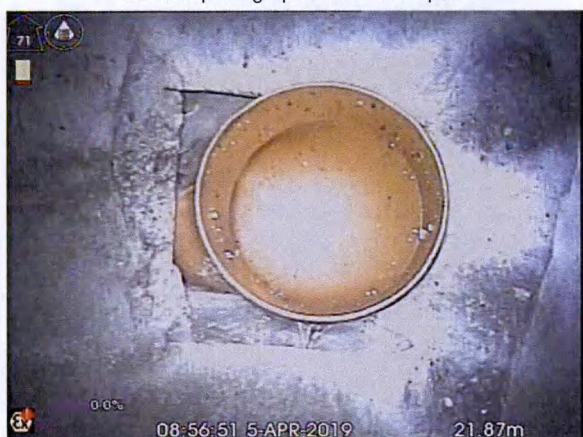
S7X_31436574-988a-4e7e-9a63-8803c35111fa_20190405_095559_947.jpg, 00:03:30, 21.87 m
Connection other than junction at 12 o'clock, diameter:

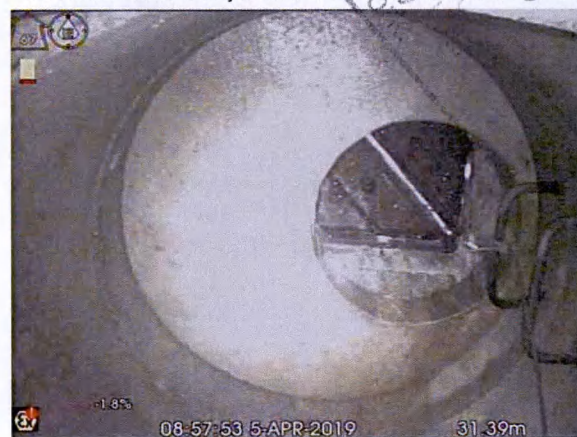
S7X_a6d2ef8d-17e9-4708-9152-e0ca7997194e_20190405_095701_470.jpg, 00:04:26, 31.38 m
Finish node type, manhole, reference number: S8

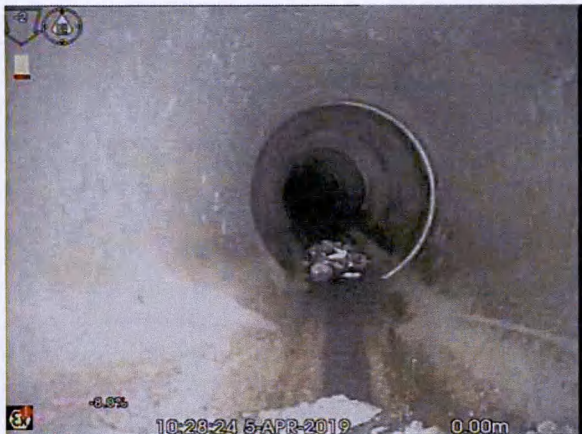
S8X_416171ae-cd8c-4dee-a7c8-081971adace7_20190405_1
12732_811.jpg, 00:00:00, 0.00 m
Start node type, manhole, reference number: S8

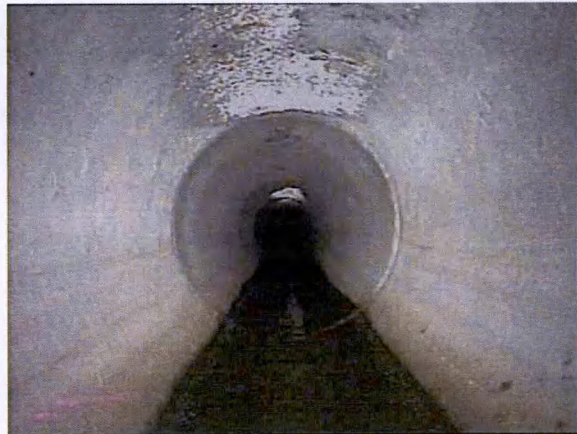
S8X_f3ae3c52-c9e2-435d-85d9-ce996e3978a7_20190405_1
14838_269.jpg, 00:14:34, 78.81 m
Survey abandoned

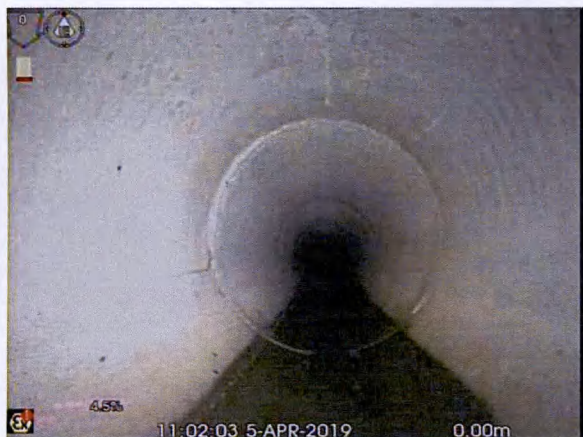
S8X_7e3b0df1-74e1-44e9-b001-48fa4edb2e65_20190405_12
0112_208.jpg, 00:00:00, 0.00 m
Start node type, manhole, reference number: S9

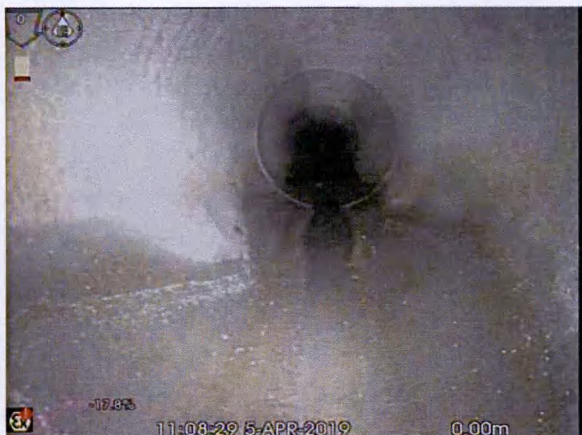
S9X_144cd6f6-0f76-4b04-90bd-f1f8add8c847_20190405_120
737_601.jpg, 00:00:00, 0.00 m
Start node type, manhole, reference number: S9

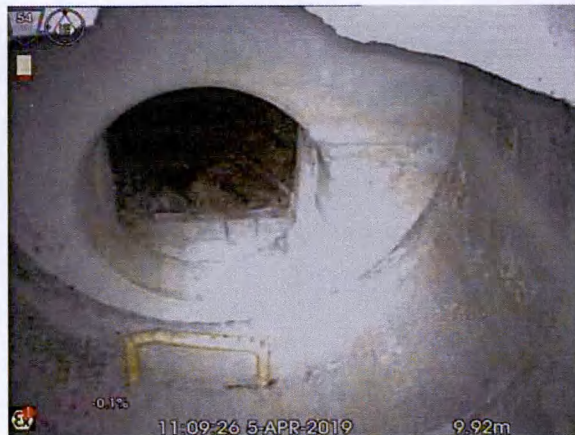
S9X_ea66e2f4-6960-4c58-b4e6-be7f4ad17f91_20190405_12
0835_240.jpg, 00:00:49, 9.92 m
Finish node type, manhole, reference number: S10

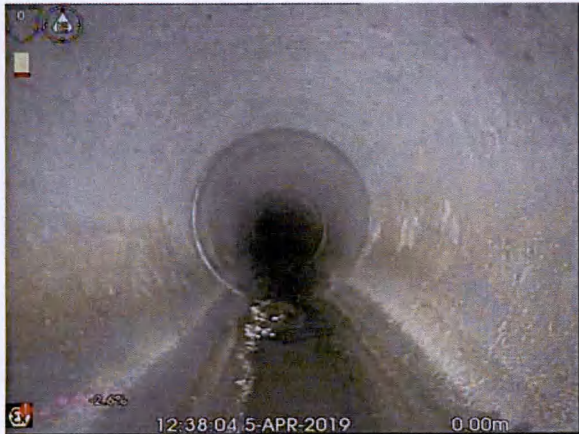
S10X_fc02f629-fa01-4181-91fa-71543718d68d_20190405_13
3713_174.jpg, 00:00:00, 0.00 m
Start node type, manhole, reference number: S10

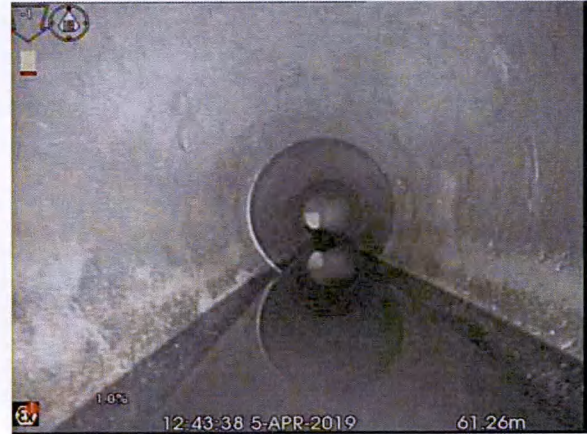
S10X_f3b594ef-ef55-4d79-baf5-181129d52886_20190405_13
4246_959.jpg, 00:05:21, 61.26 m
Water level, 10% of the vertical dimension

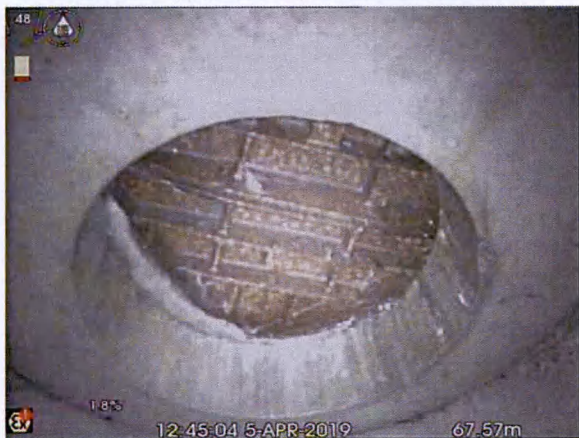
S10X_a69e2a28-feaf-4cff-85c4-7a83b30f4b02_20190405_13
4412_733.jpg, 00:06:41, 67.57 m
Finish node type, manhole, reference number: S11

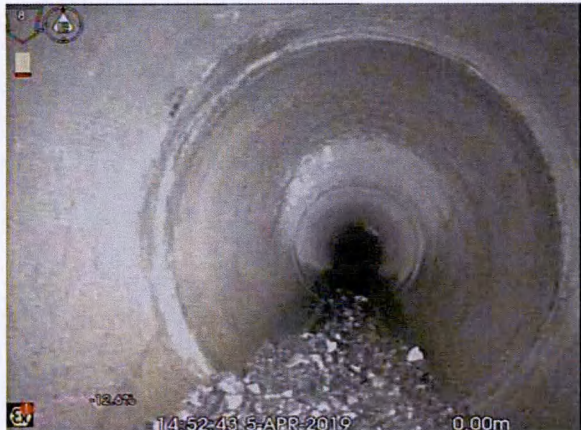
S11X_0f7f2399-5c83-4708-94ca-2adb86d599b4_20190405_155152_771.jpg, 00:00:00, 0.00 m
Start node type, manhole, reference number: S11

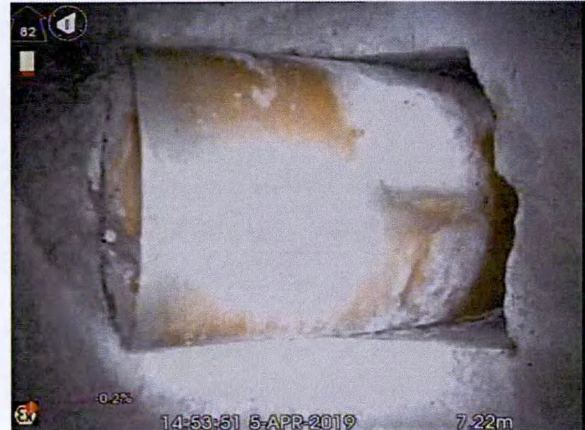
S11X_8c26414c-5570-4c5c-9c45-72a3d62b1144_20190405_155300_478.jpg, 00:00:53, 7.22 m
Connection other than junction at 1 o'clock, diameter: 150mm

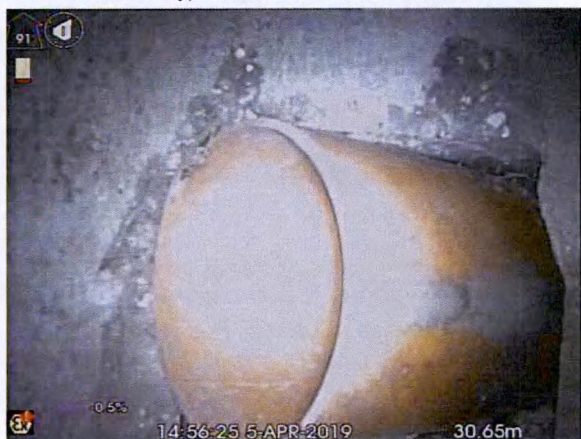
S11X_97e89ff1-cece-4ded-a60d-67b0788aebb6_20190405_155533_720.jpg, 00:03:15, 30.65 m
Connection other than junction at 1 o'clock, diameter: 150mm

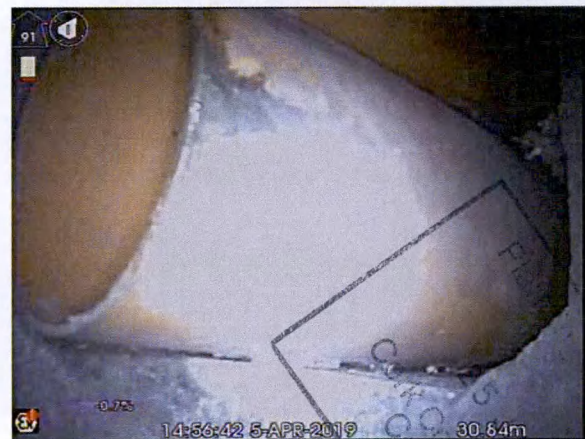
S11X_b51732fa-f87c-498b-98f5-c59dd0c10ad3_20190405_155550_998.jpg, 00:03:25, 30.64 m
Connection other than junction at 1 o'clock, diameter: 150mm

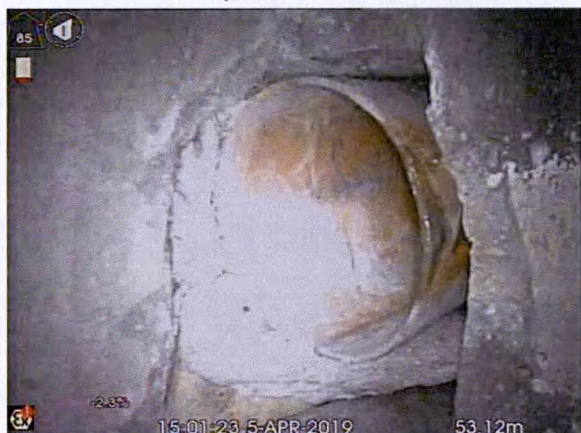
S11X_bced69d4-79c0-4d55-a302-6040b96b55cc_20190405_160032_561.jpg, 00:07:57, 53.11 m
Connection other than junction at 1 o'clock, diameter: 150mm

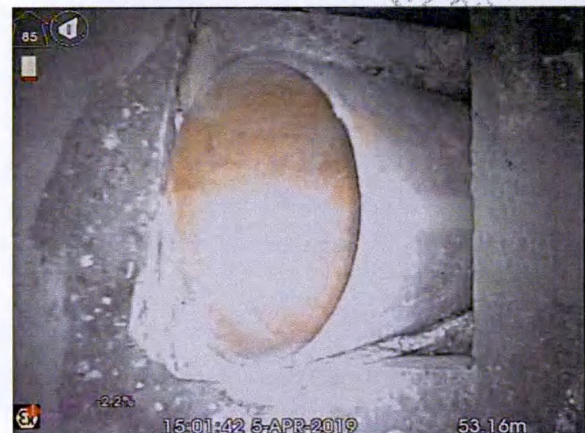
S11X_4159b65c-b355-45a4-92e8-229edce50242_20190405_160051_701.jpg, 00:08:06, 53.16 m
Connection other than junction at 1 o'clock, diameter: 150mm

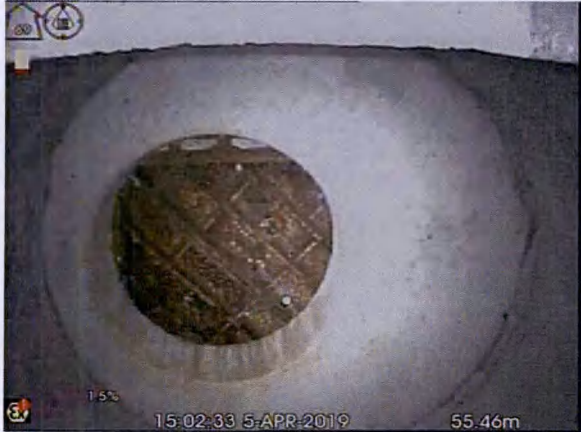
S11X_0c83f958-bcf9-481f-9fee-3e27b1badafb_20190405_16
0142_182.jpg, 00:08:50, 55.46 m

Finish node type, manhole, reference number: S12

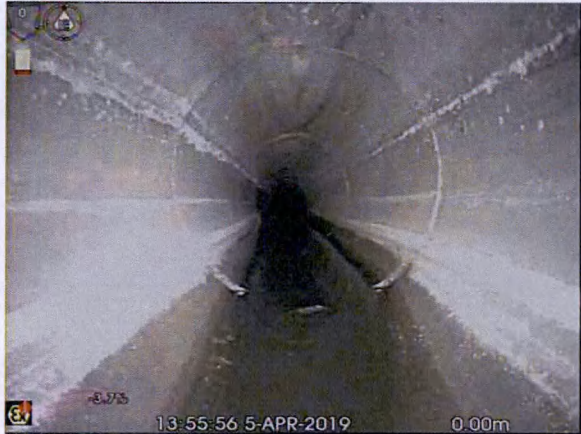
S12X_530986e0-6df5-4e9a-9f86-33bcd7ea806_20190405_1
45505_405.jpg, 00:00:00, 0.00 m
Start node type, manhole, reference number: S12

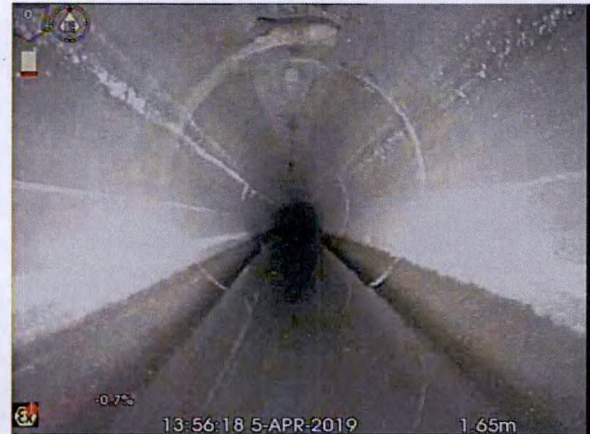
S12X_a4c78e13-8fa1-48da-99c7-0acaecf3be4c_20190405_1
45527_027.jpg, 00:00:12, 1.65 m
Water level, 10% of the vertical dimension

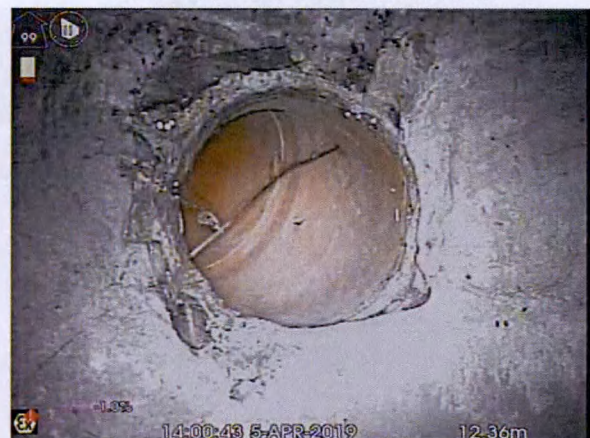
S12X_1bd62a68-ad66-4de4-b315-8e019f14ab10_20190405_1
145952_710.jpg, 00:04:18, 12.36 m
Connection other than junction at 12 o'clock, diameter:

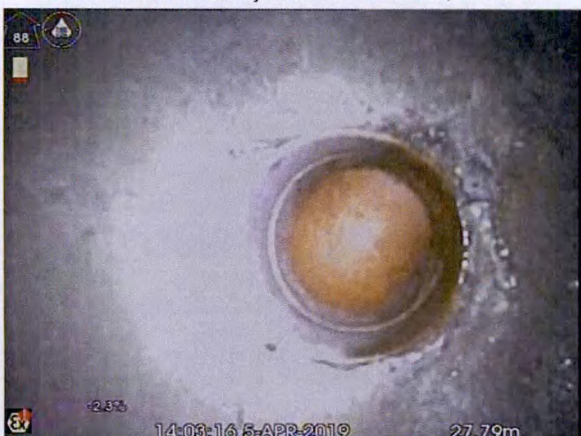
S12X_7c569883-7420-47af-be2e-602fc3a58e52_20190405_1
50225_562.jpg, 00:06:39, 27.79 m
Connection other than junction at 12 o'clock, diameter:

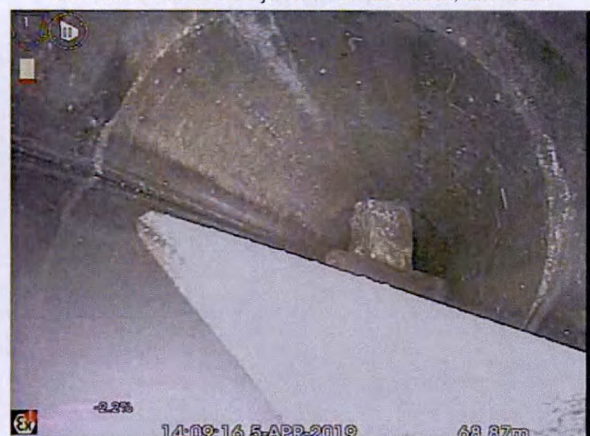
S12X_14a235e1-3da0-4edc-ba07-3a80a5ae47d2_20190405_1
150825_482.jpg, 00:11:35, 68.87 m
Finish node type, manhole, reference number: S13

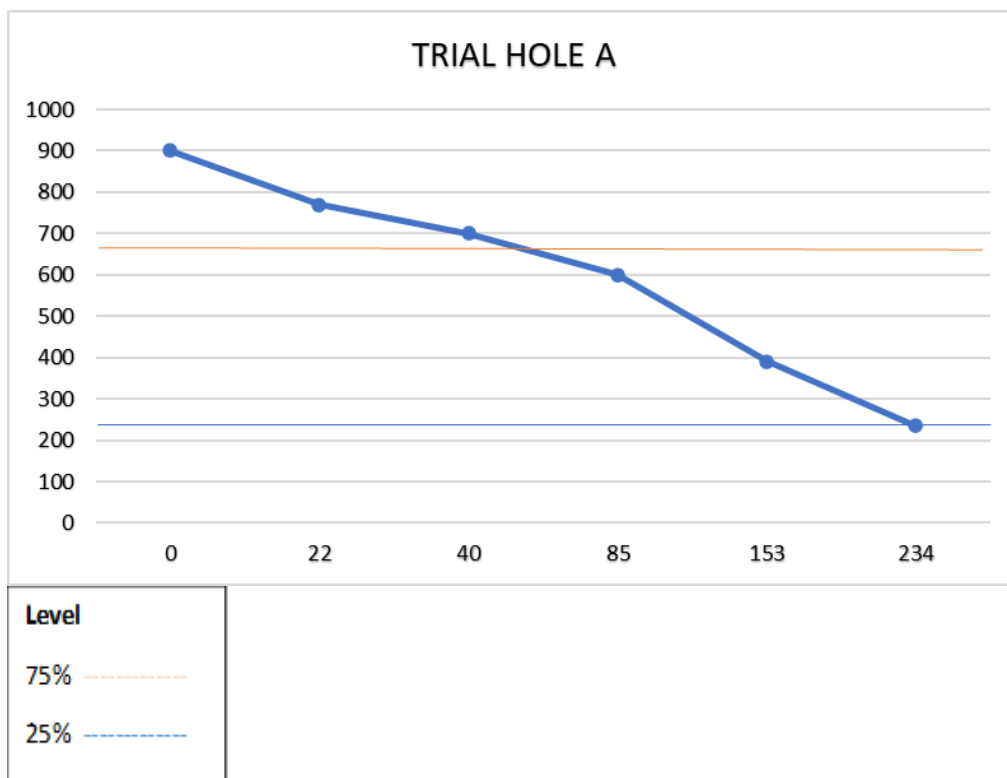
$$T_{p75-25} = 156 \text{ minutes}$$

$$\text{Soil Infiltration Rate } F: \frac{V_{p75-25}}{A_{p50} \times t_{p75-25}} = \frac{0.792}{3.036 \times 156 \times 60} = 2.8 \times 10^{-5} \text{m/s}$$

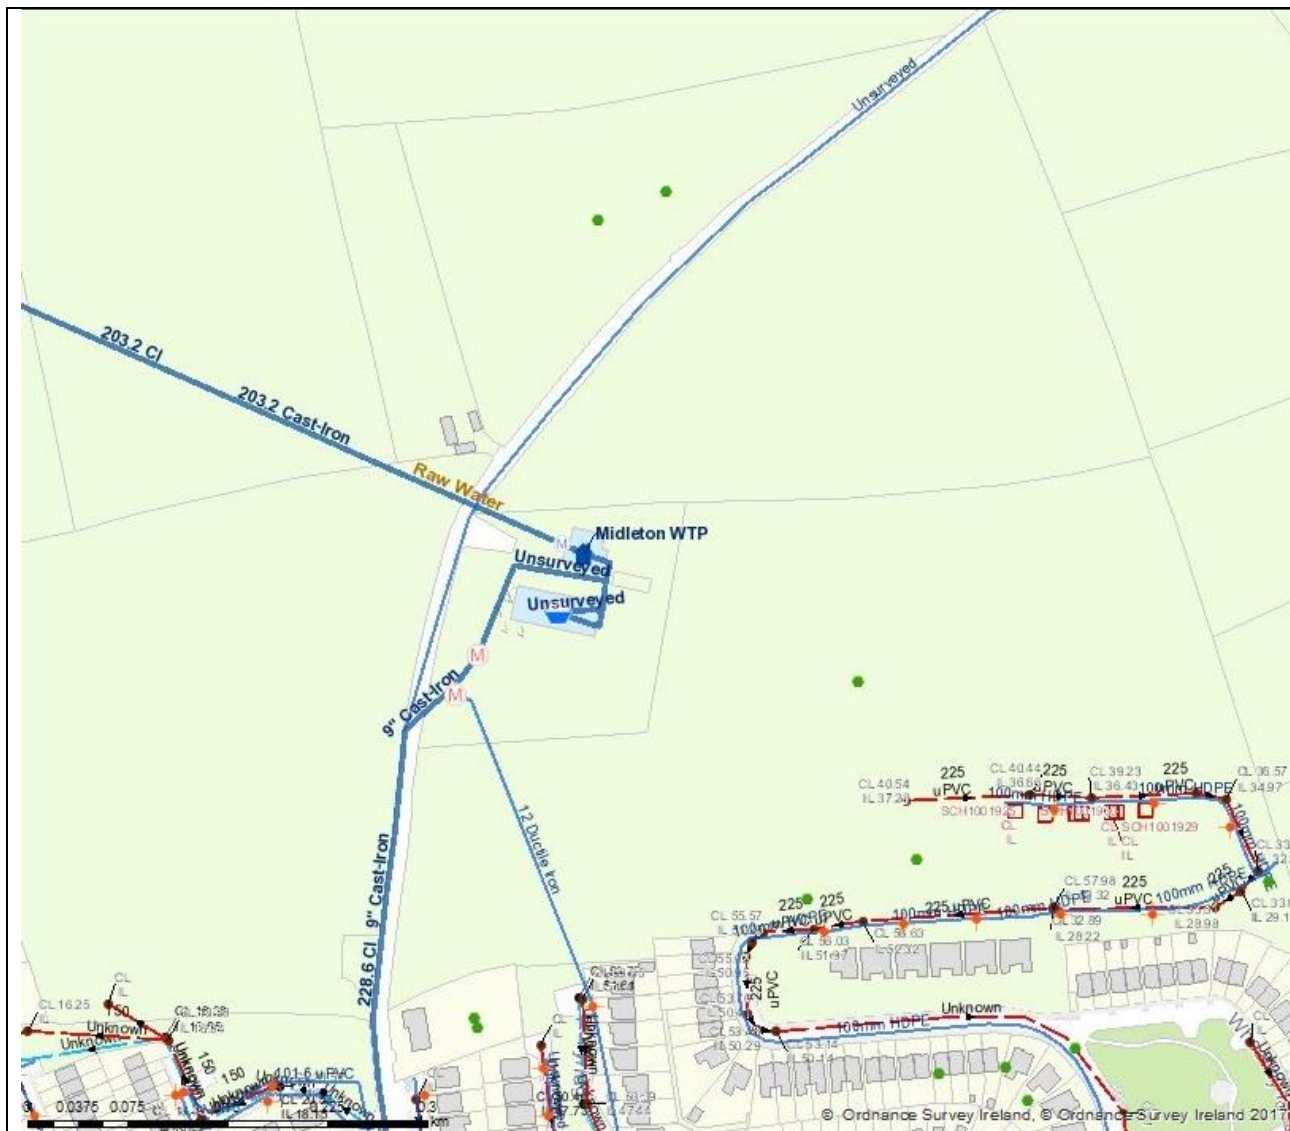
The map included below outlines the current Irish Water infrastructure adjacent to your site:

Whilst every care has been taken in its compilation Irish Water gives this information as to the position of its underground network as a general guide only on the strict understanding that it is based on the best available information provided by each Local Authority in Ireland to Irish Water. Irish Water can assume no responsibility for and give no guarantees, undertakings or warranties concerning the accuracy, completeness or up to date nature of the information provided and does not accept any liability whatsoever arising from any errors or omissions. This information should not be relied upon in the event of excavations or any other works being carried out in the vicinity of the Irish Water underground network. The onus is on the parties carrying out excavations or any other works to ensure the exact location of the Irish Water underground network is identified prior to excavations or any other works being carried out. Service connection pipes are not generally shown but their presence should be anticipated.
