PLANNING SUBMISSION

Engineering Infrastructure Report for 268 dwellings for Castle Rock Homes (Midleton) Ltd

Broomfield West, Midleton, Co Cork.

Date: 03.05.2023

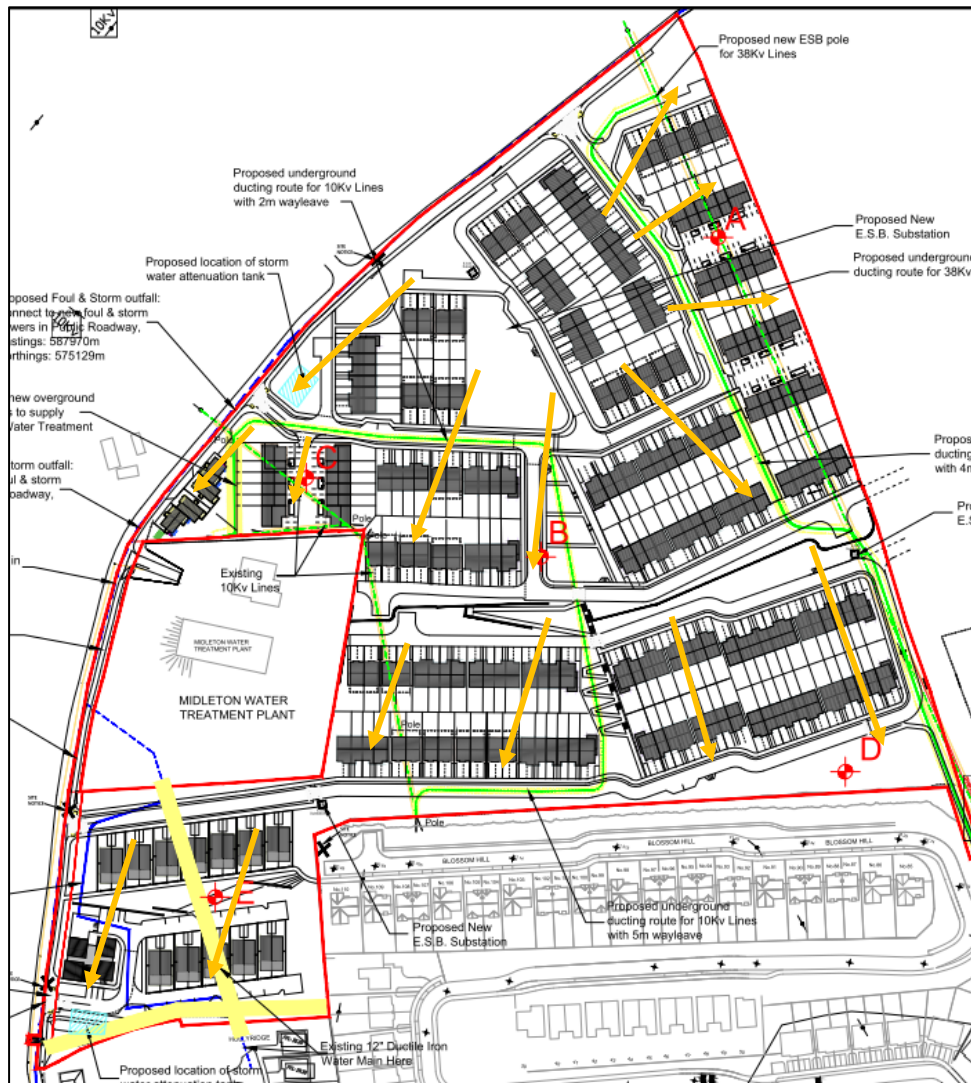
Figure 5.1 Overland Flow Paths

Overland flow paths which run perpendicular to the contours are shown in Figure 5.1. – overlain on the proposed development. In most case these flow paths are intercepted by estate roads. Where estate roads run in the same direction as the flow paths, raised kerbing at the ends of these will prevent flooding of properties in an extreme rainfall event scenario. Where rainfall is at risk of entering a cul-de-sac area, a raised pedestrian crossing will be constructed at the entrance to this area to prevent flooding of the area. All potential collection areas of exceedance rainfall will be fitted with pairs of road gullies or filter drains to provide extra run-off capacity.

At the centre east-west roadway – where potential rainfall exceedance flow meets the east-west retaining wall there are no road routes downhill from here for exceedance flow to follow. The retaining wall will project 500mm above the ground level to prevent overflow above the wall and to act as a water retention area. The wall construction incorporates a 300mm wide filtration layer directly behind the wall face which extends the full heights of the wall and which has a perforated filter drain at its base, connected to the SW drainage system.

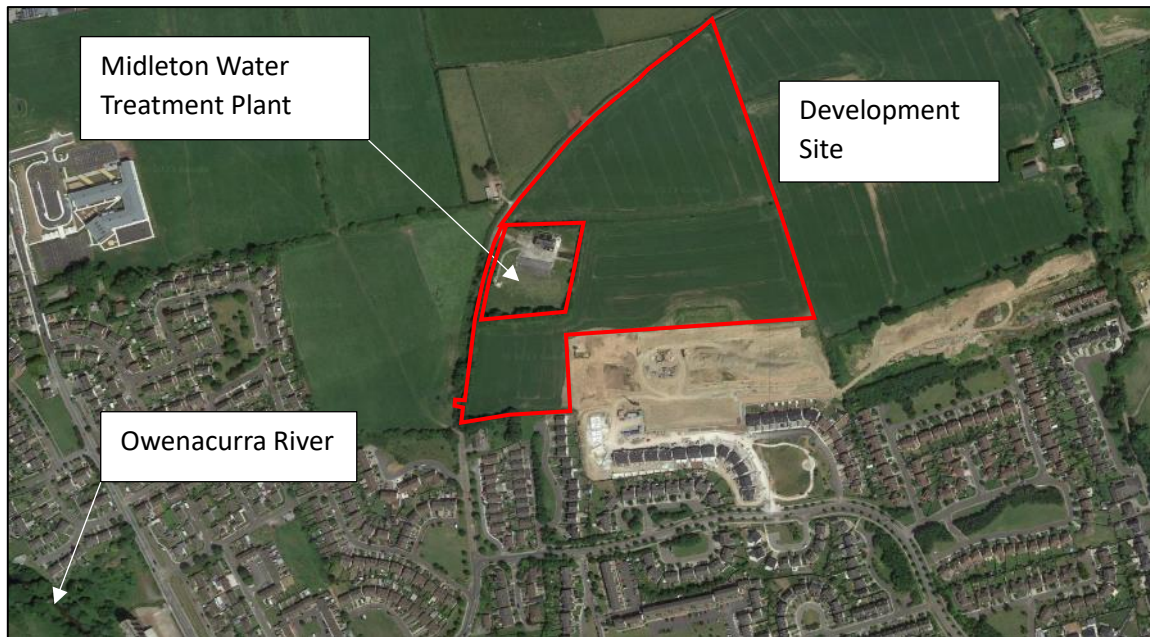
Figure 6.1 Location of proposed development

The development site is shown in Figure 6.1. It comprises 7.95Ha on lands that are sloping from 1:20 at the upper areas to lands that are sloping at 1:8 at the lower areas. The height of the site above ordnance datum ranges from 29.6m AOD at its lowest point to 67.7m AOD at the highest point.

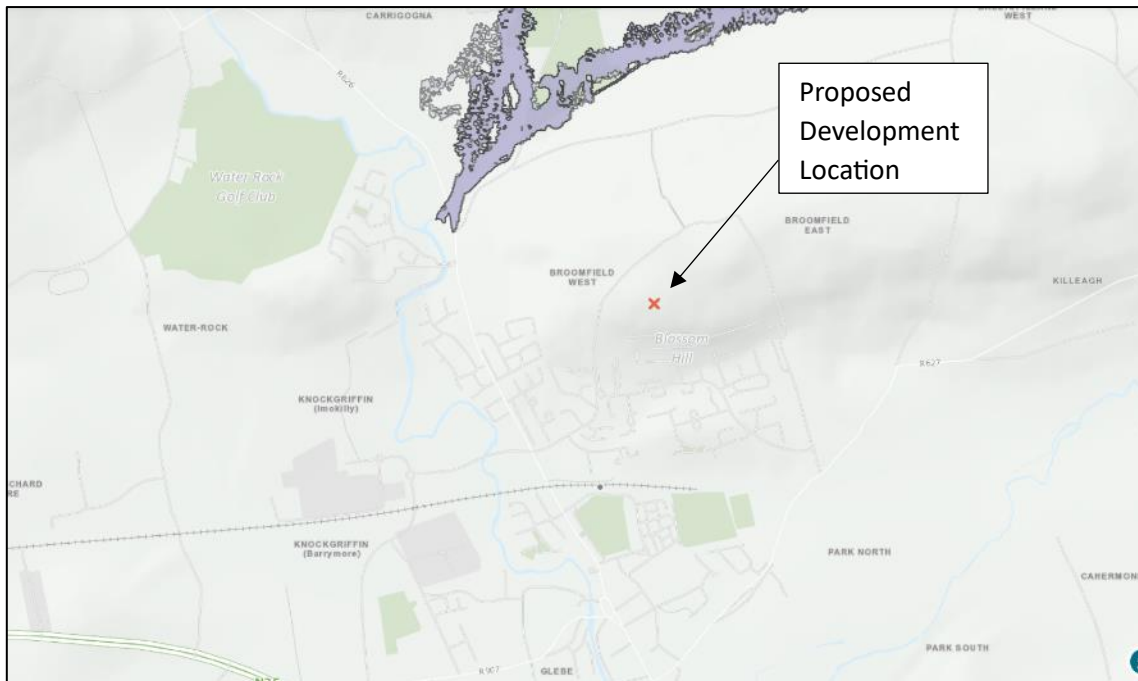
Figure 6.3 Indicative Fluvial Flooding High End Future Scenario Low & Medium Probability

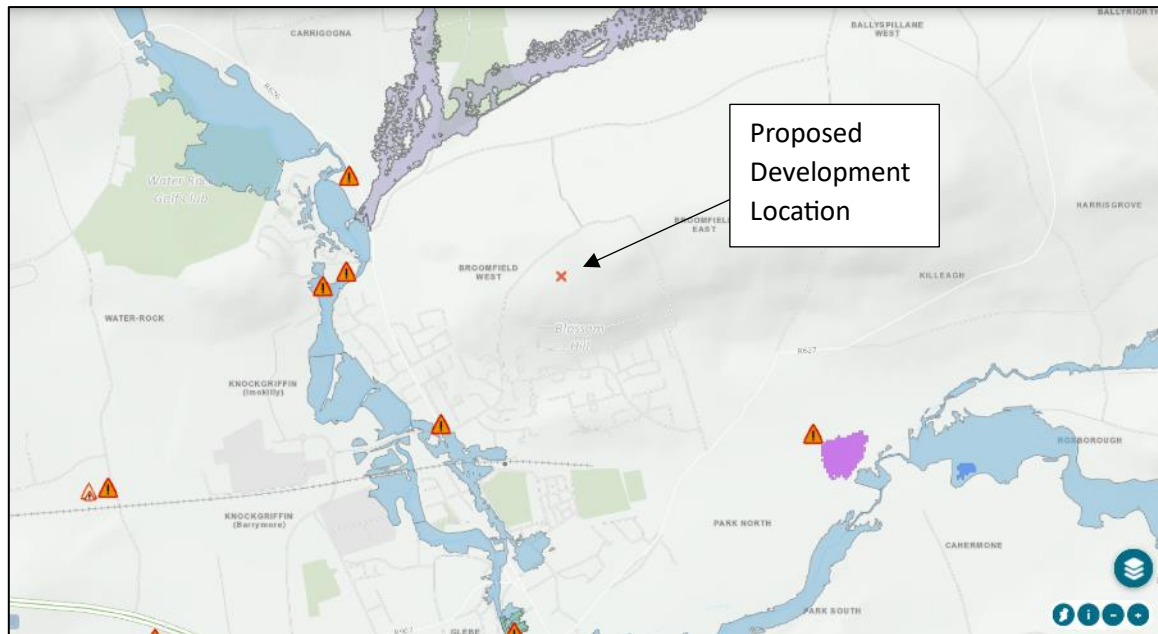
Figure 6.5 OPW National Flood Hazard Mapping

The Flood hazard mapping in Figure 6.5 shows one flood incident, associated with river flooding away from the site and well below the site level. This map also shown Geological Survey of Ireland Maximum Historic Groundwater Flooding. There is no record of ground water flooding at the subject site.

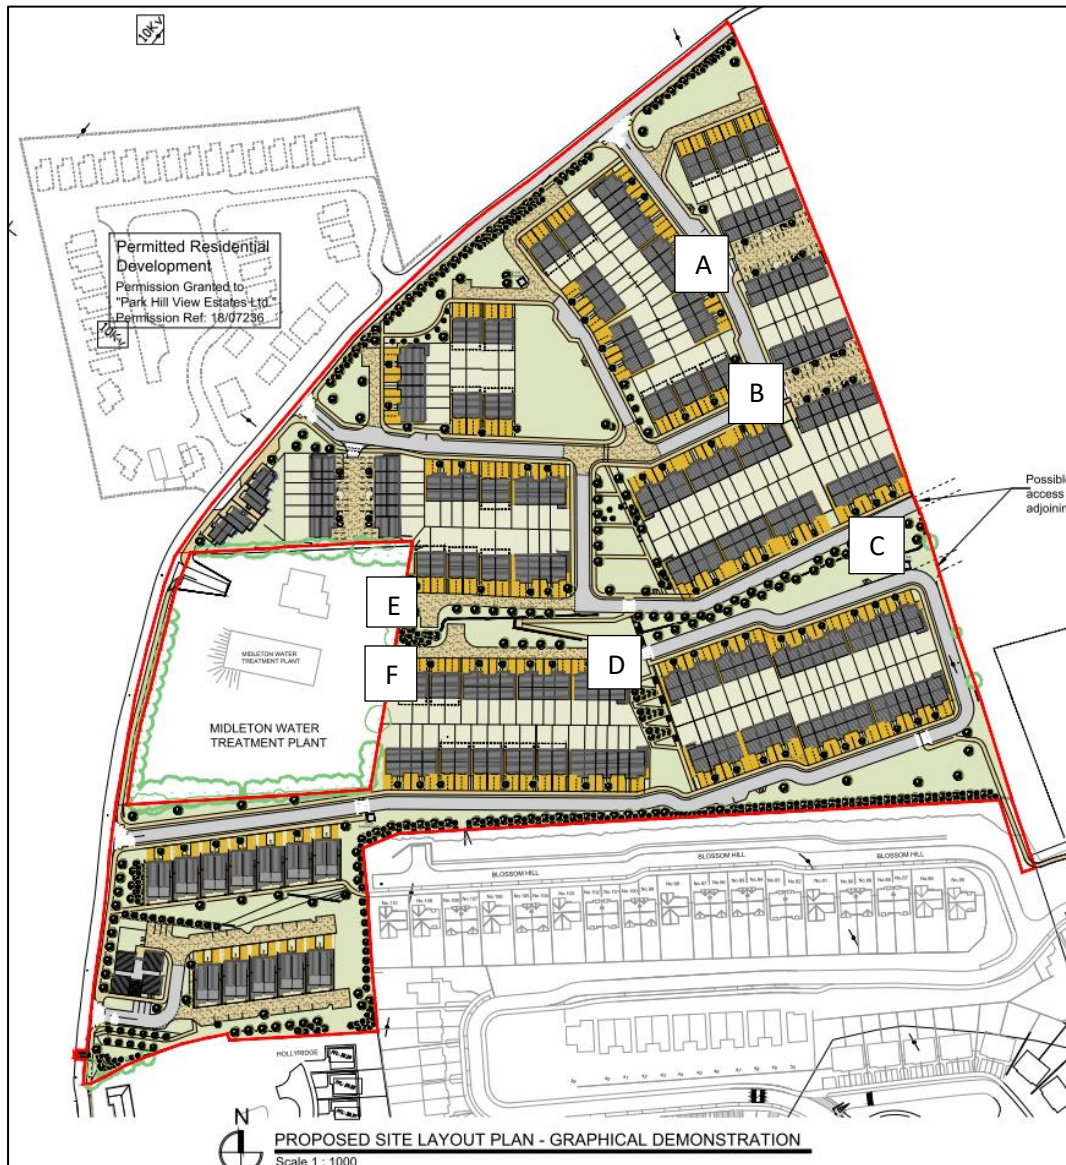
Figure 6.10 Plan of site showing potential vulnerable locations during a pluvial exceedance event

Roads throughout have 150mm high kerbing which will direct overflow waters downhill and away from properties. There are a number of locations where ponding of excess runoff is possible with a potential risk to properties. These vulnerable locations within the development are shown below and are assessed individually hereunder.

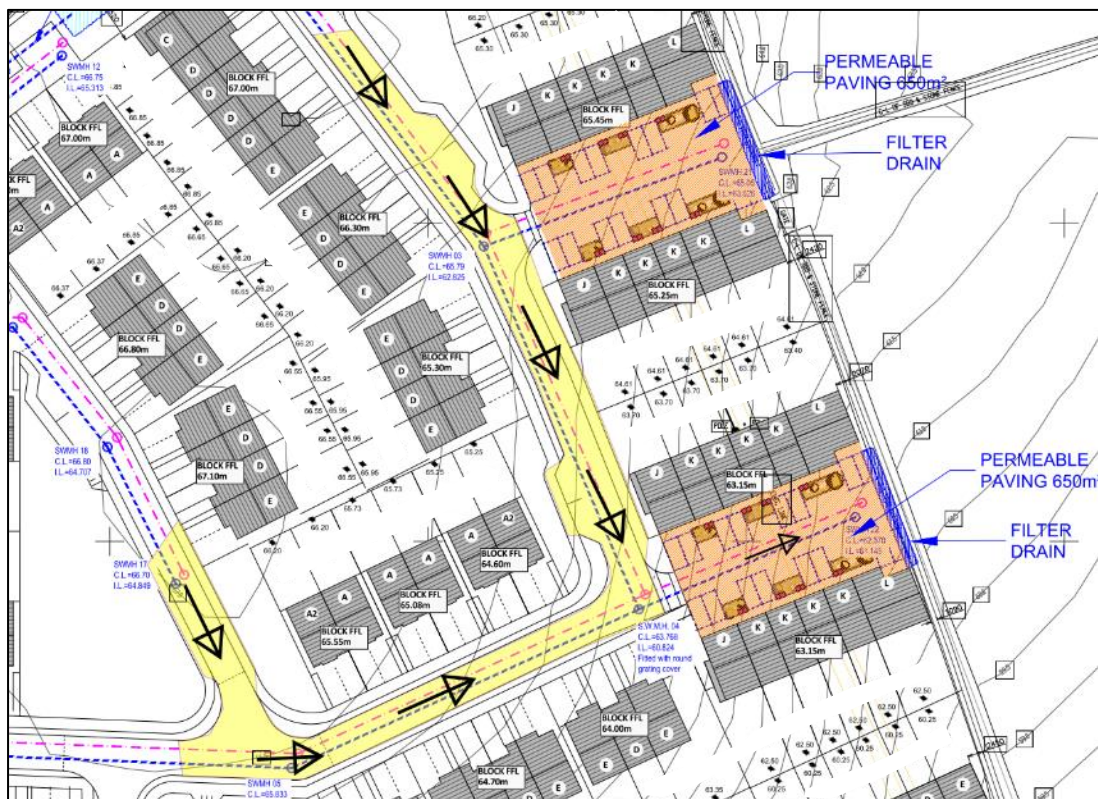
The courtyard housing at this location has a fall from the high point of the development to the eastern boundary of the courtyard. The estate roadway falls from two directions towards the entry point of the courtyard. A raised table entry is incorporated at the entrance of the courtyard to ensure surface water from the estate road does not enter the courtyard area. The SWMH04 manhole at this location will be fitted with D400 round grating cover and two gullies will be situated at the lower corner. The kerb at the lower road edge will be kept full height as far as the driveway point of House No 186. The top of the raised table is 290mm below the FFL of this house. Within the courtyard any surface water exceedance that is not drained by the permeable paving will pass to the filter drain at the lower end. The filter drain capacity is outlined in section 5.11.2 above.

Figure 6.12 Location B - detail

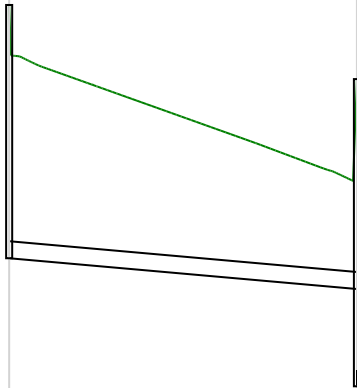
A3 drawing		
Hor Scale 1500		
Ver Scale 100		
Datum (m) 44.000		
Link Name	3.000	
Section Type	225mm	
Slope (1:X)	169.5	
Cover Level (m)	56.557	55.577
Invert Level (m)	53.208	52.801
Length (m)	69.003

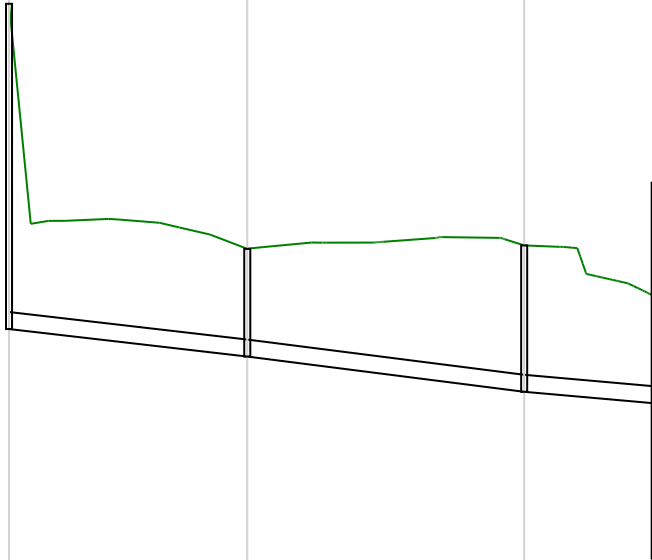
Node Name	63	64	65	39	
<div>A3 drawing</div> <div>Hor Scale 1500 Ver Scale 100</div> <div>Datum (m) 40.000</div>

Link Name	4.000	4.001	4.002	
	Section Type	225mm	225mm	225mm	
	Slope (1:X)	129.9	117.9	169.8	
	Cover Level (m)	53.300	50.060	50.105	50.934
Invert Level (m)	48.999	48.635	48.169	48.016	
Length (m)	47.275	54.946	25.972

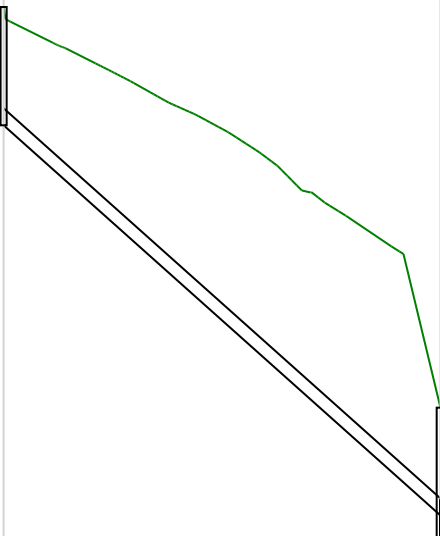
A3 drawing		
Hor Scale 1500		
Ver Scale 100		
Datum (m) 27.000		
Link Name	8.000	
Section Type	225mm	
Slope (1:X)	16.8	
Cover Level (m)	40.720	35.422
Invert Level (m)	39.156	33.997
Length (m)	86.681

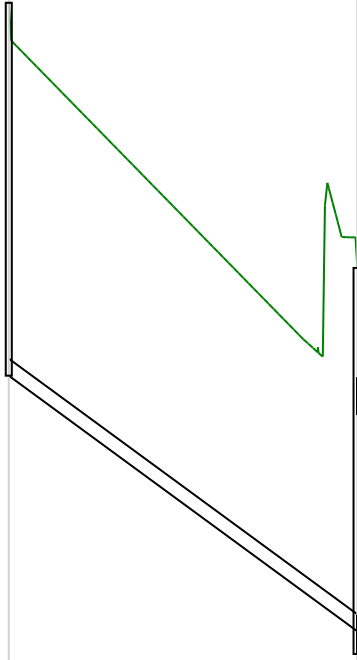
A3 drawing		
Hor Scale 1500		
Ver Scale 100		
Datum (m) 25.000		
Link Name	9.000	
Section Type	225mm	
Slope (1:X)	20.5	
Cover Level (m)	39.120	35.614
Invert Level (m)	34.189	30.809
Length (m)	69.156

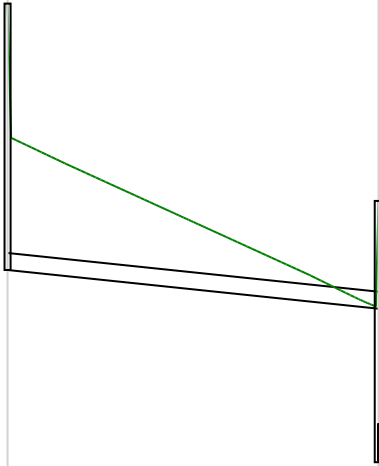
A3 drawing Hor Scale 1500 Ver Scale 100 Datum (m) 23.000			
Link Name		10.000	
Section Type		225mm	
Slope (1:X)		143.8	
Cover Level (m)		36.250	33.640
Invert Level (m)		32.727	32.215
Length (m)		73.608

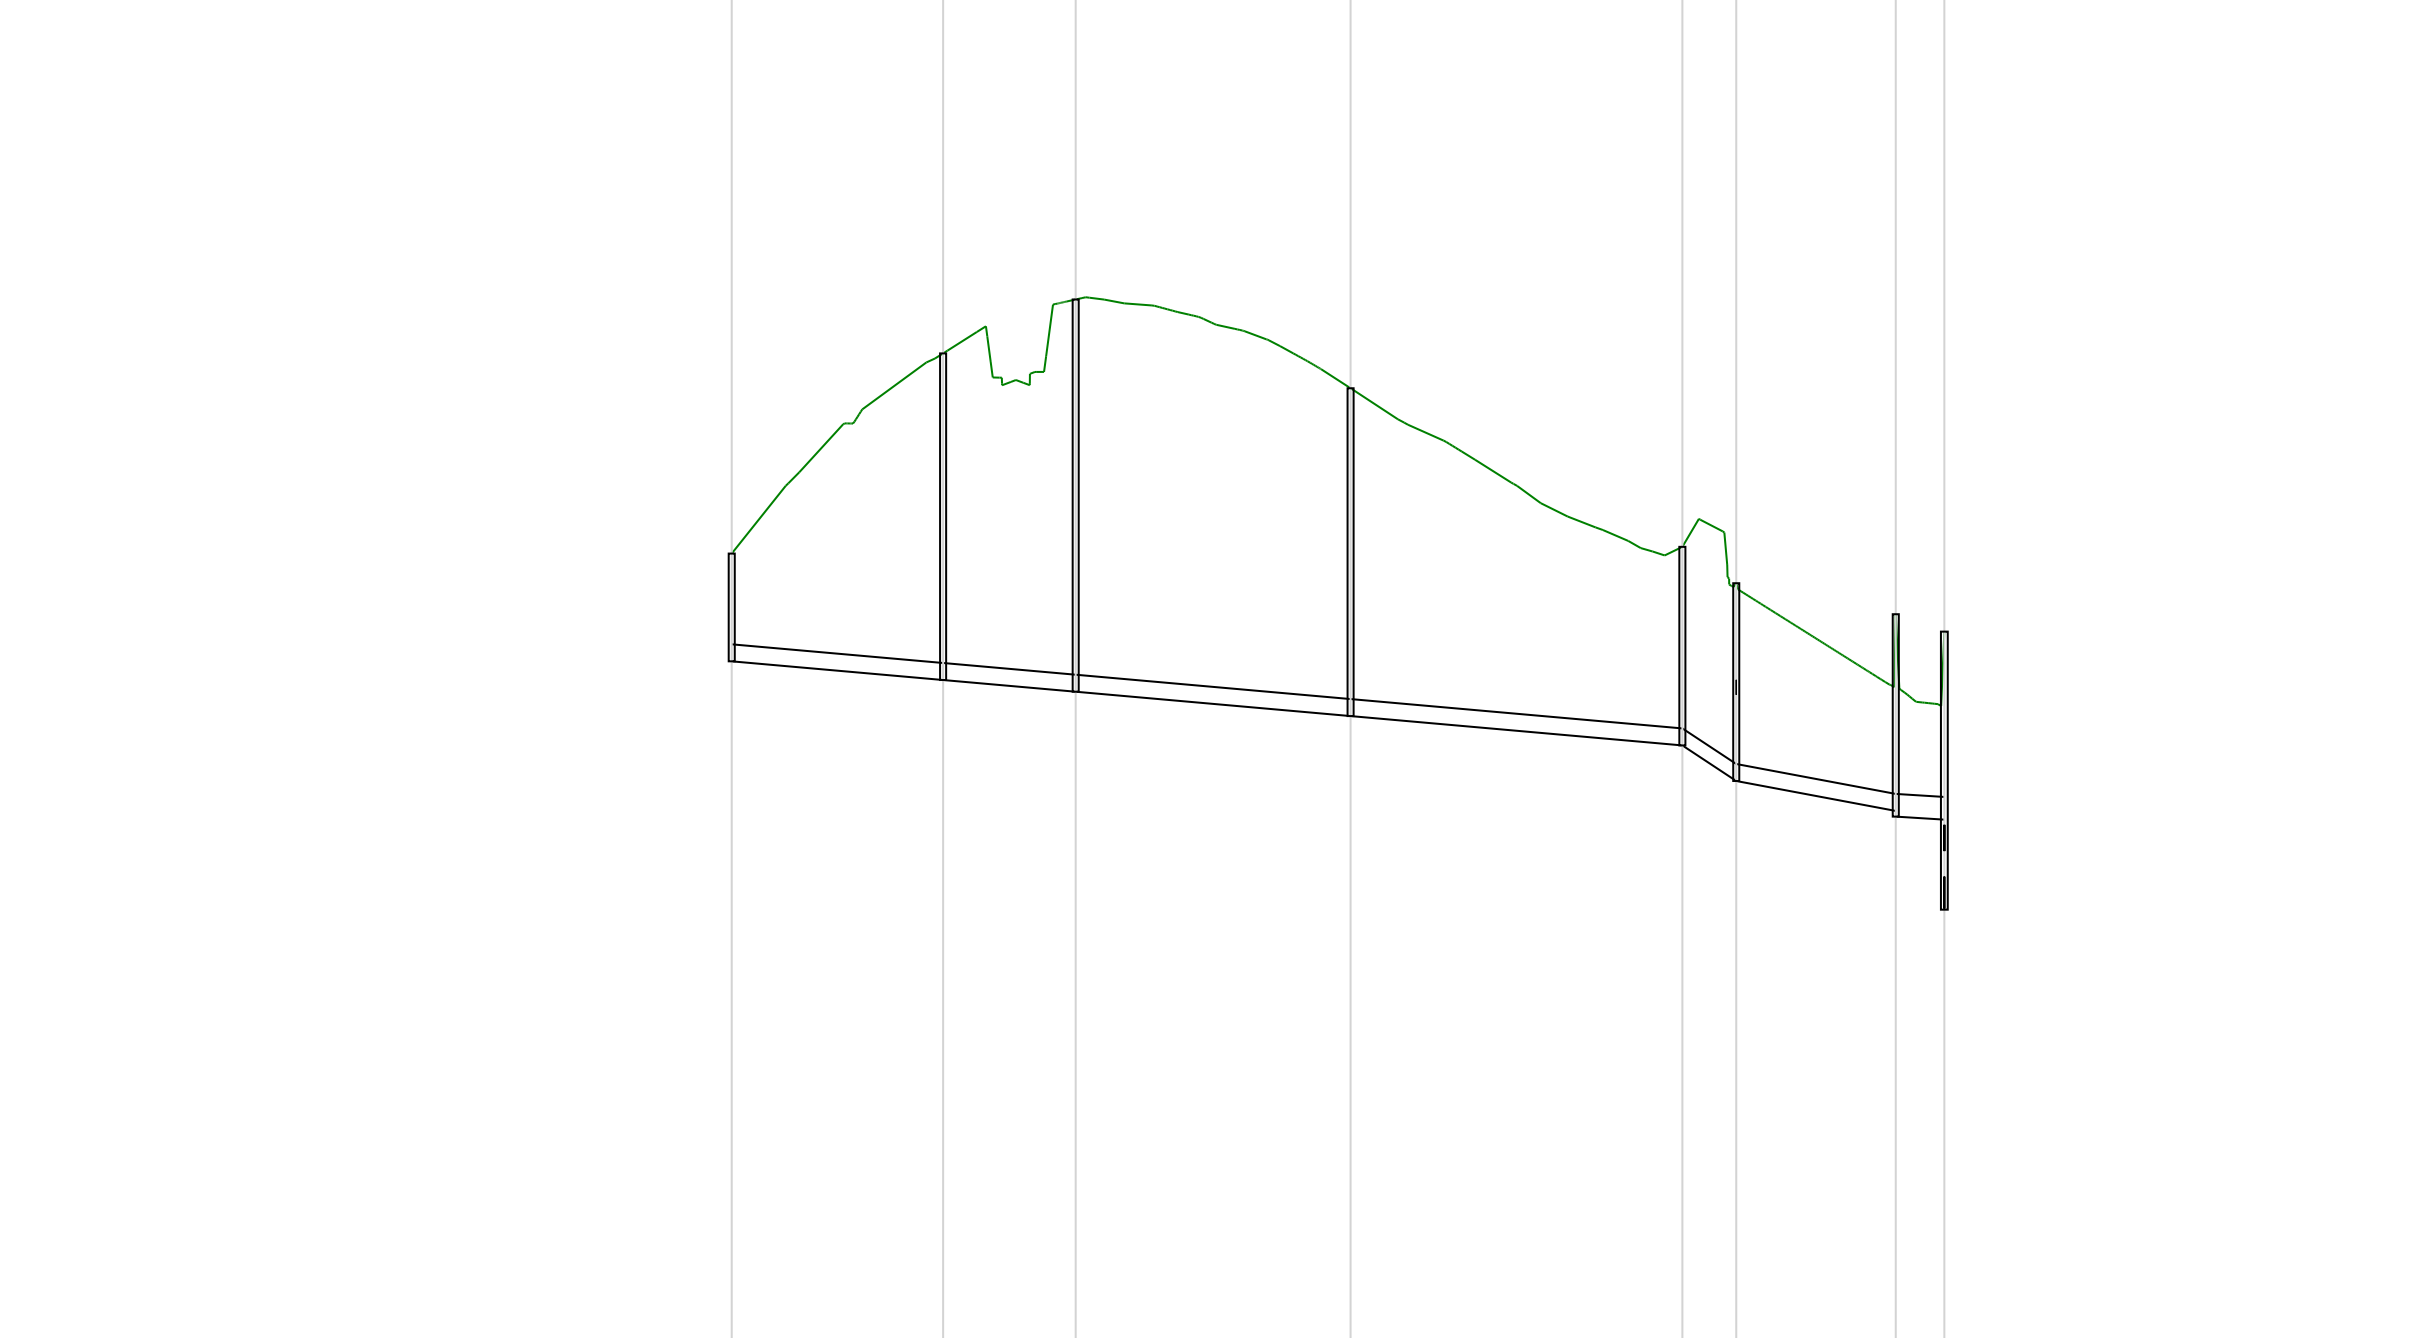
Node Name	30	31	27	28	29	14	15	8
<div><div>A3 drawing</div><div>Hor Scale 1500 Ver Scale 100</div><div>Datum (m) 53.000</div></div>

Link Name	5.000	5.001	5.002	5.003	5.004	5.005	5.006	
Section Type	225mm	225mm	225mm	225mm	225mm	225mm	300mm	
Slope (1:X)	169.8	169.7	169.4	169.7	22.7	80.0	241.0	
Cover Level (m)	64.002	66.649	67.362	66.188	64.091	63.610	63.200	62.970
Invert Level (m)	62.577	62.330	62.175	61.853	61.465	60.994	60.599	60.484
Length (m)	41.943	26.307	54.546	65.835	10.68	31.654	9.64

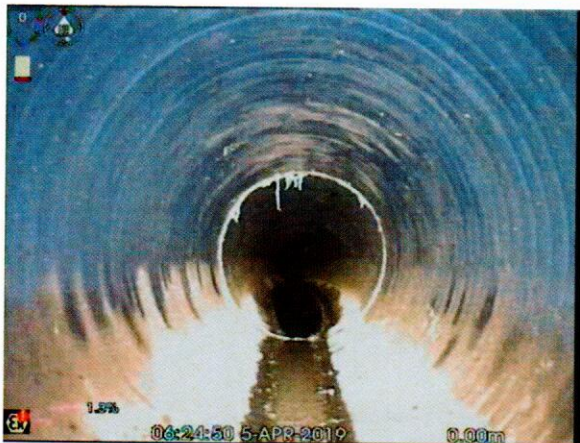
S1X_fb6e0b6d-9bc2-4073-a808-d941a78430c0_20190405_072359_148.jpg, 00:00:00, 0.00 m
Start node type, manhole, reference number: S2

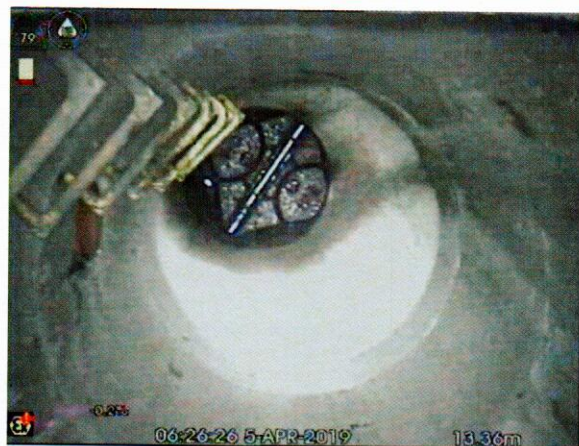
S1X_ca35267c-2005-4aaa-a9e6-63c0758e75ec_20190405_072534_741.jpg, 00:01:26, 13.36 m
Finish node type, manhole, reference number: S1

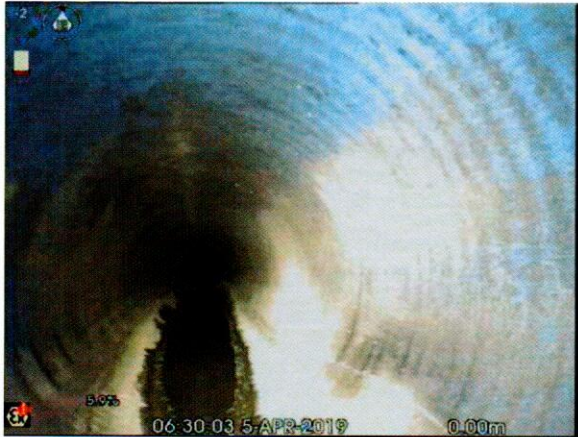
S2X_2608f175-6544-4e1c-a755-5bcd4680625b_20190405_072911_710.jpg, 00:00:00, 0.00 m
Start node type, manhole, reference number: S2

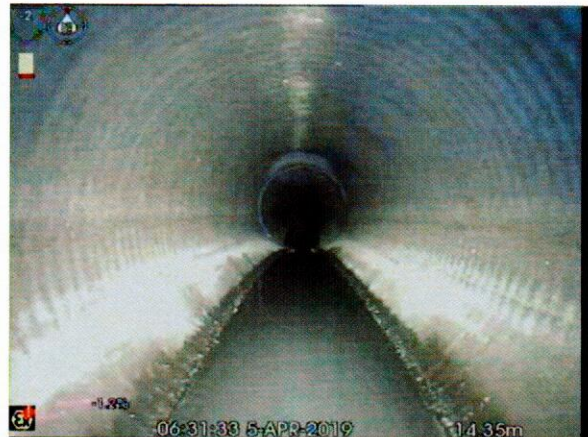
S2X_3c24dd86-e9c2-4854-a02e-26cc4f794fcc_20190405_073041_501.jpg, 00:01:20, 14.35 m
Water level, 5% of the vertical dimension

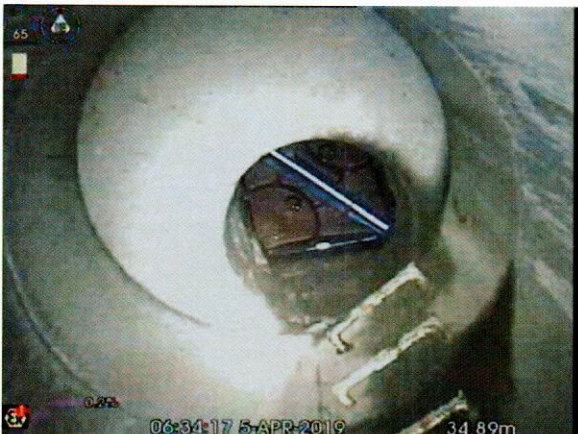
S2X_145dd4f1-9c8c-4397-98e5-7cbd74295ccd_20190405_073325_858.jpg, 00:03:29, 34.89 m
Finish node type, manhole, reference number: S3

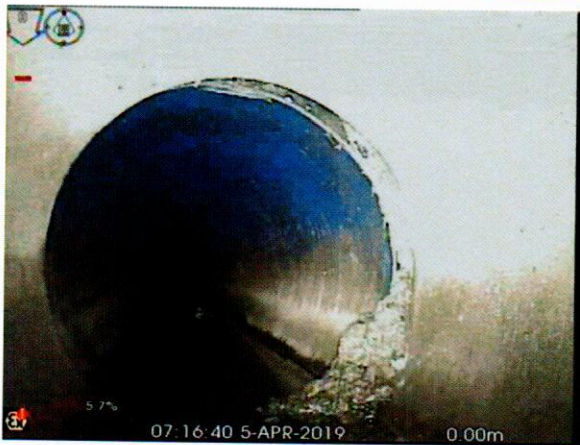
S3X_9e923133-f59a-4261-918a-f2247a8f9391_20190405_08
1548_768.jpg, 00:00:00, 0.00 m
Start node type, manhole, reference number: S4

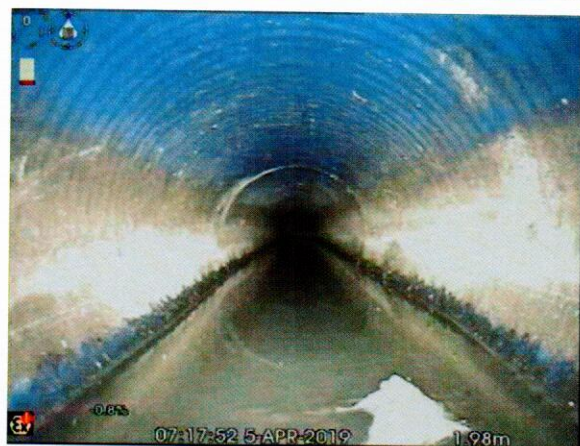
S3X_51ac9785-3074-40fa-9406-ab5ca25e2d2c_20190405_0
81701_604.jpg, 00:00:51, 1.98 m
Water level, 20% of the vertical dimension

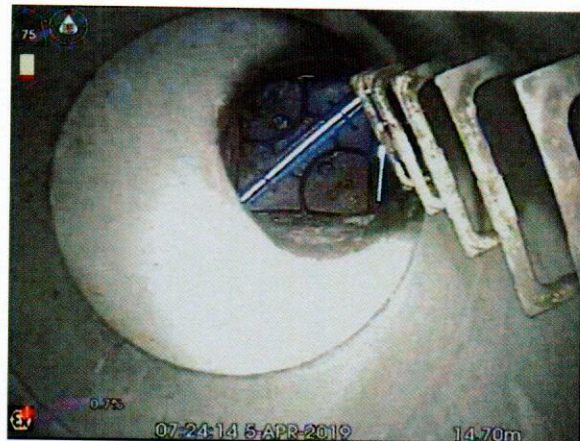
S3X_3154a530-4788-4cb9-9b2f-c8e0ef97cbe9_20190405_08
2323_160.jpg, 00:06:46, 14.68 m
Finish node type, manhole, reference number: S3

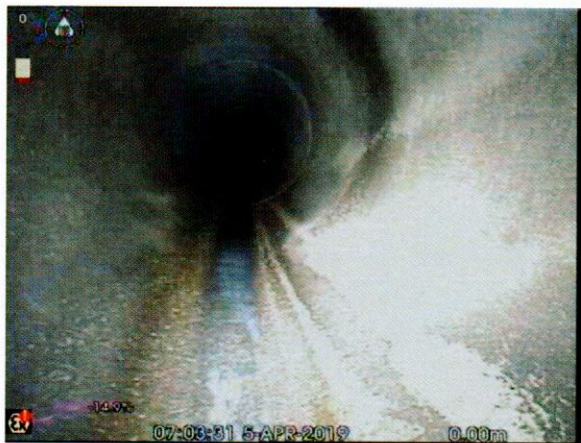
S4X_6b0fc3f3-69d8-4222-817c-d3ec9f1d921d_20190405_080239_607.jpg, 00:00:00, 0.00 m
Start node type, manhole, reference number: S5

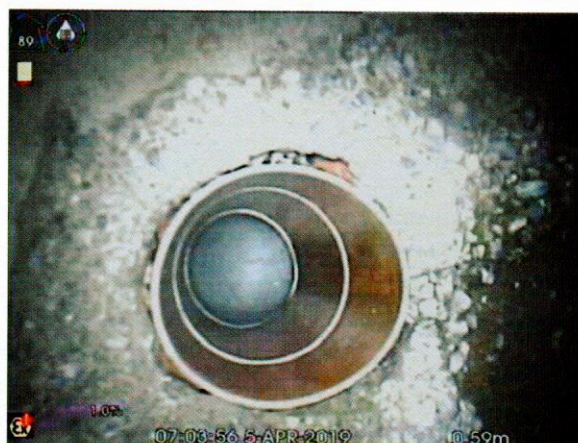
S4X_a5e9ed2b-8f8f-494b-b06d-fe2155b6fd24_20190405_080304_982.jpg, 00:00:11, 0.59 m
Connection other than junction at 12 o'clock, diameter:

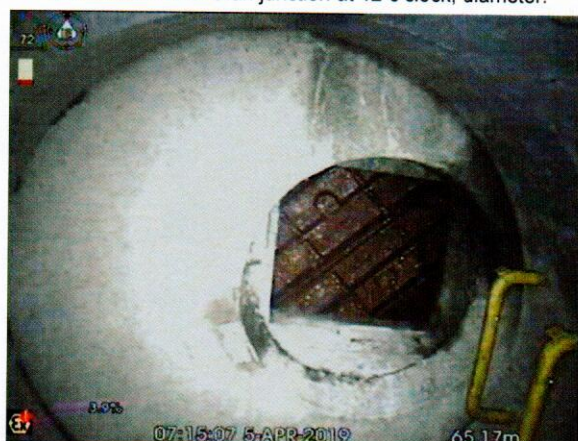
S4X_bb89ef55-97ee-4461-8fa9-05e0bdeb471d_20190405_081415_982.jpg, 00:08:55, 65.17 m
Finish node type, manhole, reference number: S4

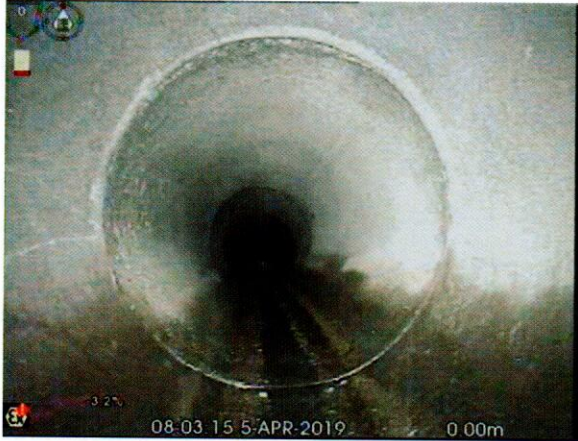
S5X_3a8da4cf-5542-444f-a34e-e58f58df49c0_20190405_090545_028.jpg, 00:00:00, 0.00 m
Start node type, manhole, reference number: S5

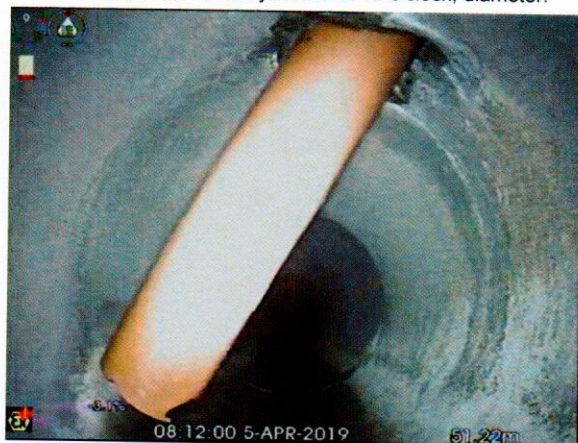
S5X_d9c04386-cfdb-4432-a2e0-6620da3a2084_20190405_091108_192.jpg, 00:06:56, 51.22 m
Connection intruding at 1 o'clock, diameter: 100mm, intrusion:

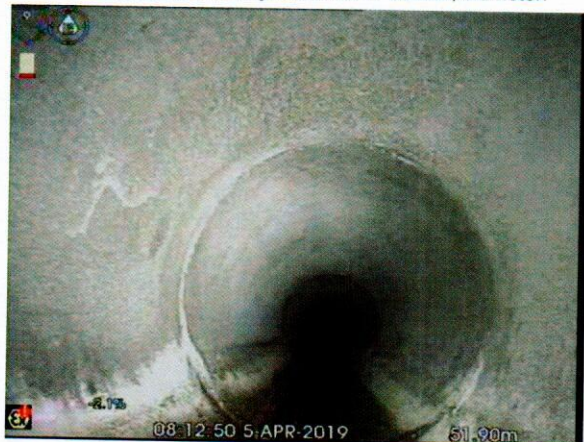
S5X_56b9a2bb-9e90-4269-8e9d-ab53078964d4_20190405_091158_715.jpg, 00:07:24, 51.90 m
Survey abandoned

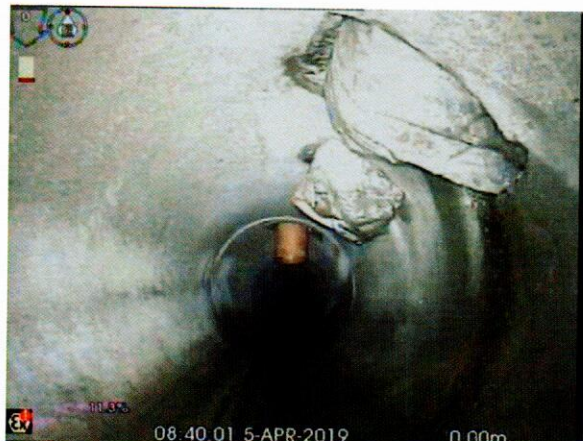
S5X_104bc7a0-720a-47f0-9d37-14bde05d9d88_20190405_093909_790.jpg, 00:00:00, 0.00 m
Start node type, manhole, reference number: S6

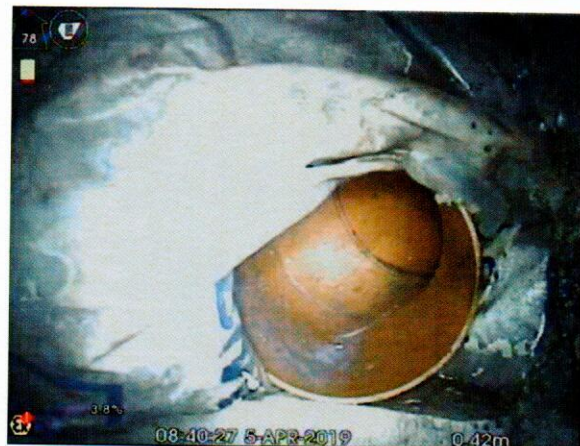
S5X_03b0457f-bb8e-468f-9713-1786b92e3fda_20190405_093935_556.jpg, 00:00:14, 0.42 m
Connection other than junction at 2 o'clock, diameter: 100mm

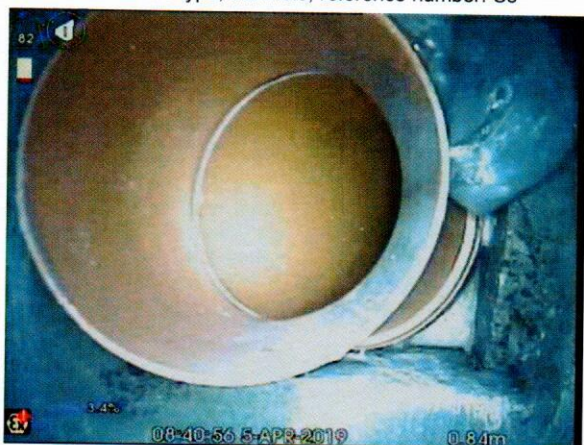
S5X_b7966323-76b6-459a-b1e1-98e9956461e4_20190405_094005_065.jpg, 00:00:28, 0.84 m
Connection intruding at 2 o'clock, diameter: 100mm, intrusion:

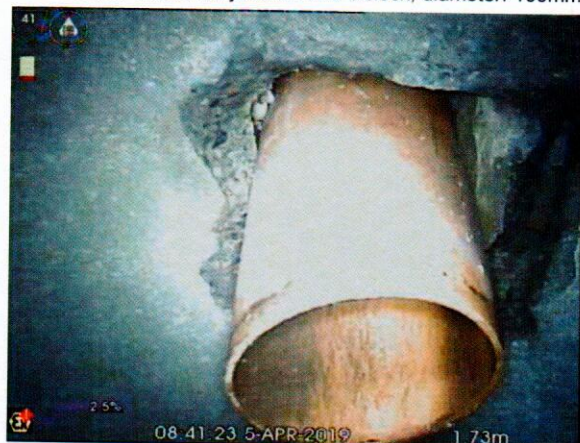
S5X_62aa0cc2-107c-47cd-adfc-3f77a6d3f8cb_20190405_094031_971.jpg, 00:00:43, 1.73 m
Connection intruding at 12 o'clock, diameter: 100mm,

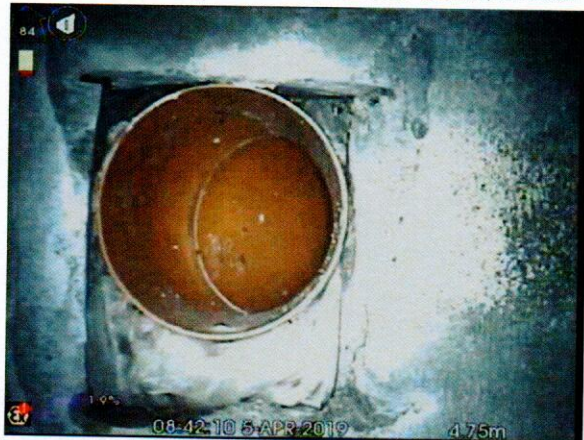
S5X_370e06e4-84f4-4c8a-a3a3-c44a2989c107_20190405_094118_654.jpg, 00:01:18, 4.75 m
Connection other than junction at 1 o'clock, diameter: 100mm

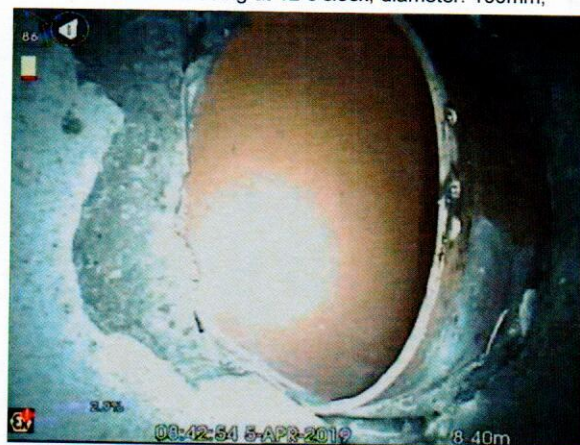
S5X_acceb949-f9b9-48f2-85ef-1e599e766fc5_20190405_094202_125.jpg, 00:01:52, 8.40 m
Connection other than junction at 2 o'clock, diameter: 100mm

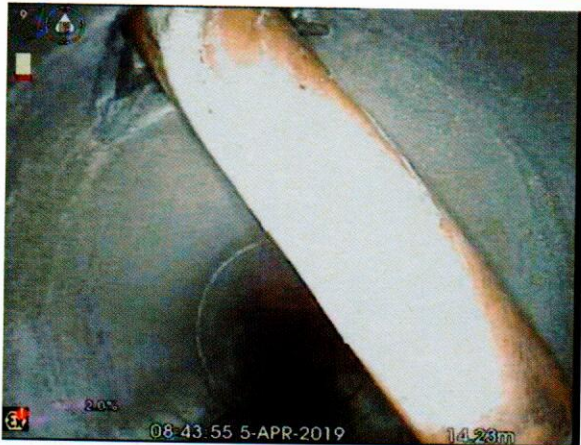
S5X_1b0d48cc-b4e9-416a-a0f1-9fd0bb0d32b9_20190405_094303_328.jpg, 00:02:36, 14.23 m
Connection intruding at 11 o'clock, diameter: 100mm,

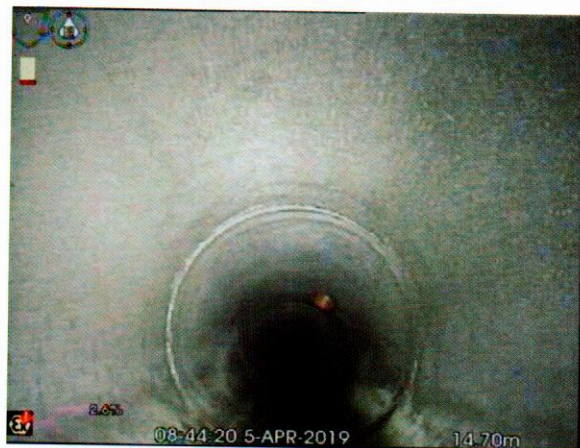
S5X_1d400da9-4a1b-4c68-8818-be19158c9803_20190405_094328_528.jpg, 00:02:45, 14.70 m
Survey abandoned

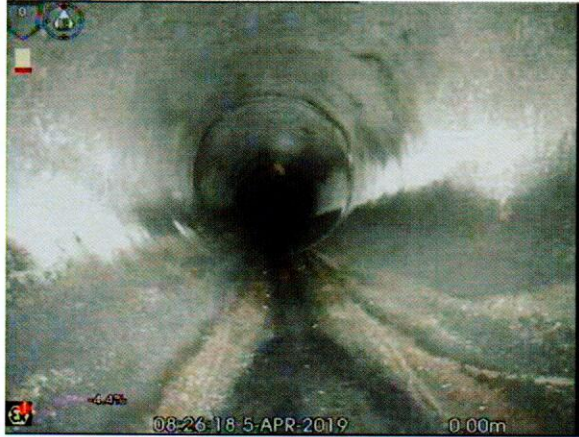
S6X_8127d366-a7dc-4957-9b17-592a26f26520_20190405_092527_372.jpg, 00:00:00, 0.00 m
Start node type, manhole, reference number: S6

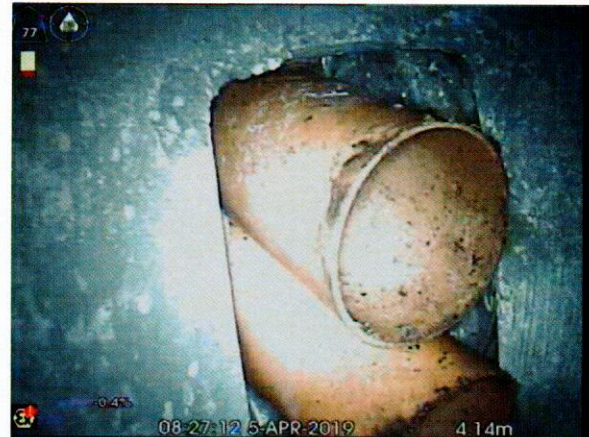
S6X_91b31115-cf97-4745-8a43-0827462e78b0_20190405_092621_053.jpg, 00:00:39, 4.14 m
Connection other than junction at 12 o'clock, diameter:

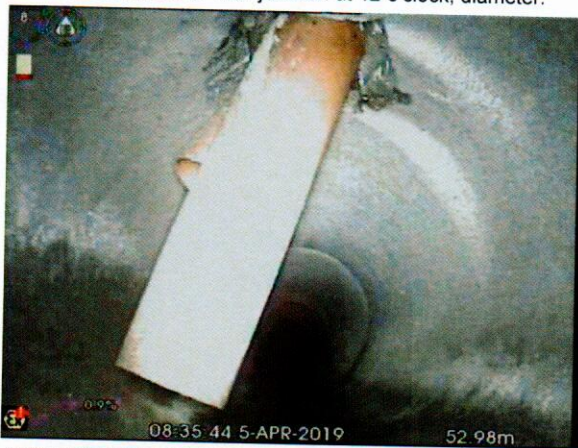
S6X_884f3d3d-f874-4854-8418-3b70886c52c6_20190405_093453_196.jpg, 00:07:02, 52.98 m
Connection intruding at 12 o'clock, diameter: 100mm,

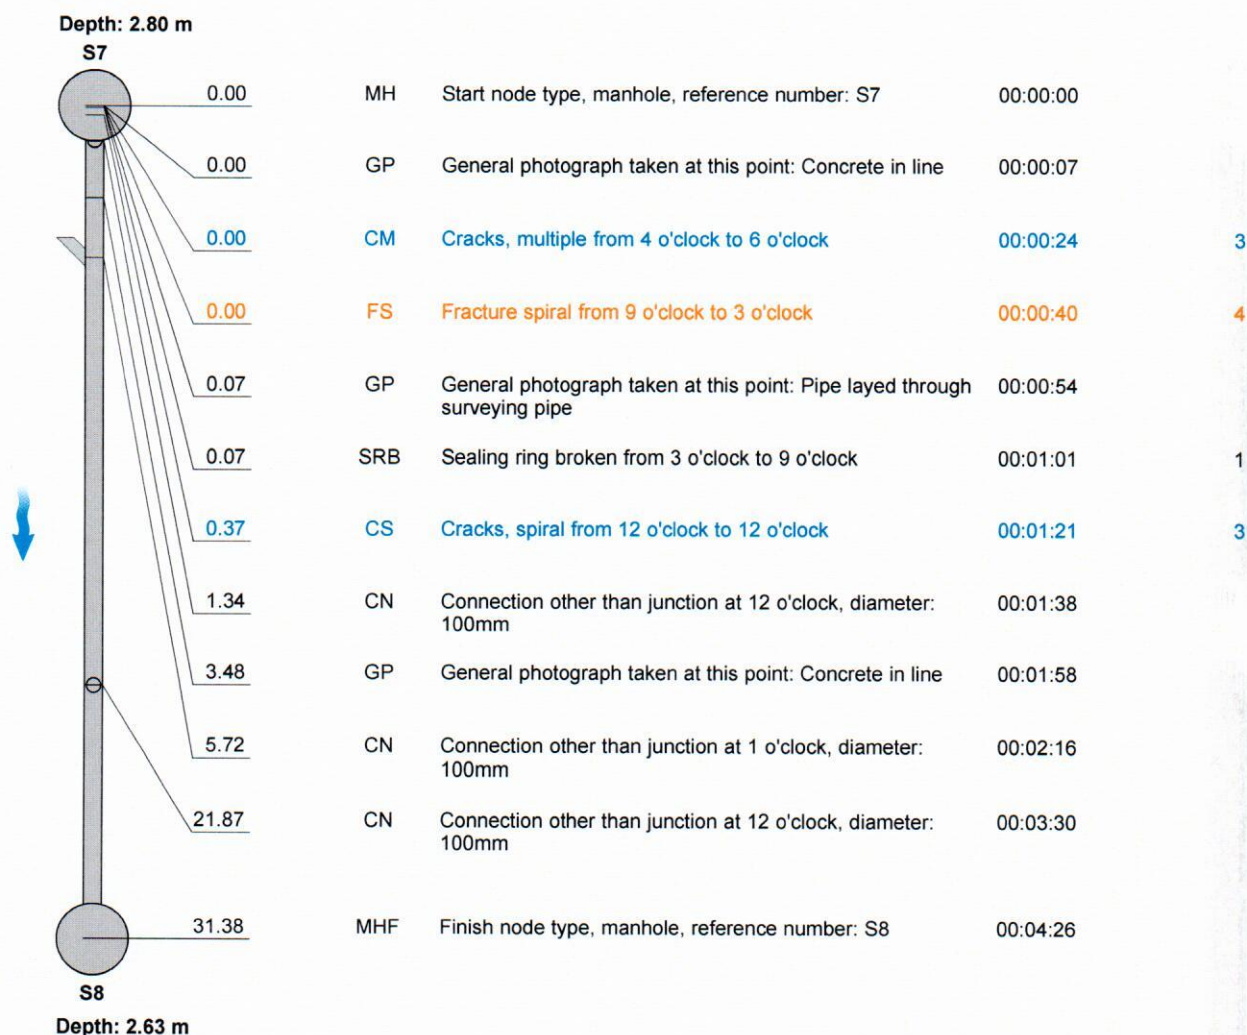
Scale: 1:273 Position [m] Code Observation MPEG Photo Grade

STR No. Def	STR Peak	STR Mean	STR Total	STR Grade	SER No. Def	SER Peak	SER Mean	SER Total	SER Grade
4	165.0	5.3	165.0	4.0	0	0.0	0.0	0.0	1.0

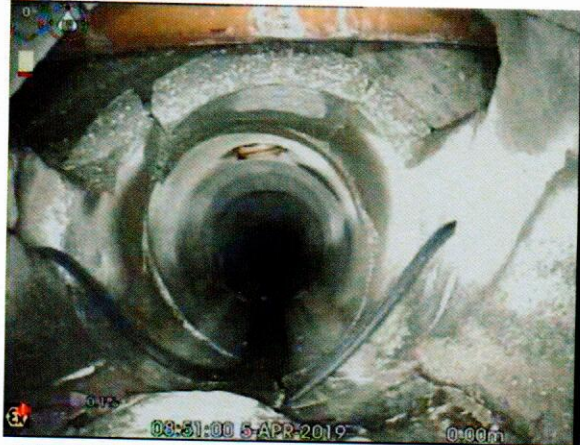
S7X_61b2b2d6-a4dc-436d-b3c1-1745fe7a4a02_20190405_095008_174.jpg, 00:00:00, 0.00 m
Start node type, manhole, reference number: S7

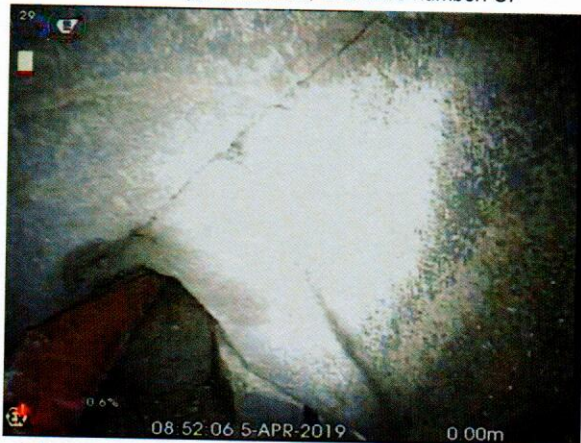
S7X_e95e40db-f421-4224-9e8c-5d1c64228623_20190405_095114_099.jpg, 00:00:24, 0.00 m
Cracks, multiple from 4 o'clock to 6 o'clock

No.	m+	Code	Observation
1	0.00	MH	Start node type, manhole, reference number: S7
2	0.00	GP	General photograph taken at this point
3	0.00	CM	Cracks, multiple from 4 o'clock to 6 o'clock
4	0.00	FS	Fracture spiral from 9 o'clock to 3 o'clock
5	0.07	GP	General photograph taken at this point
6	0.07	SRB	Sealing ring broken from 3 o'clock to 9 o'clock
7	0.37	CS	Cracks, spiral from 12 o'clock to 12 o'clock

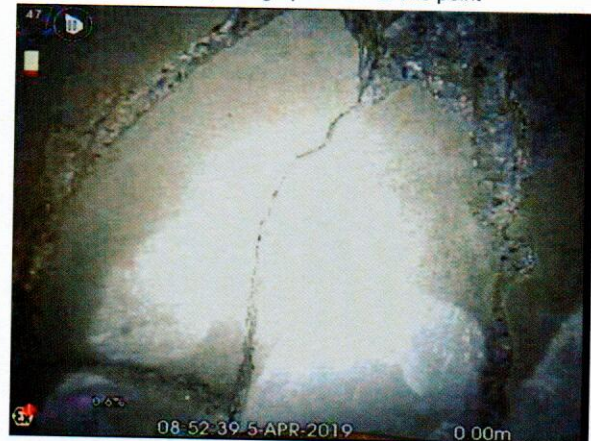
S7X_ca062aaf-6af5-4bed-ad91-987a9282a6d7_20190405_095147_073.jpg, 00:00:40, 0.00 m
Fracture spiral from 9 o'clock to 3 o'clock

Section	PLR	Grade	Description
9	S7X	4	Fracture spiral from 9 o'clock to 3 o'clock

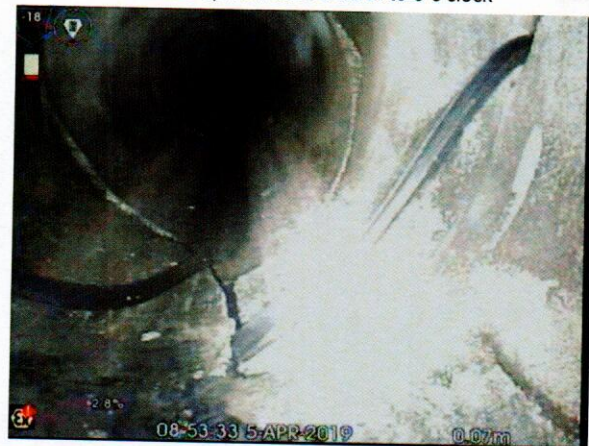
S7X_507b6eab-e483-4ccb-9798-b9840ae9fe90_20190405_095241_489.jpg, 00:01:01, 0.07 m
Sealing ring broken from 3 o'clock to 9 o'clock

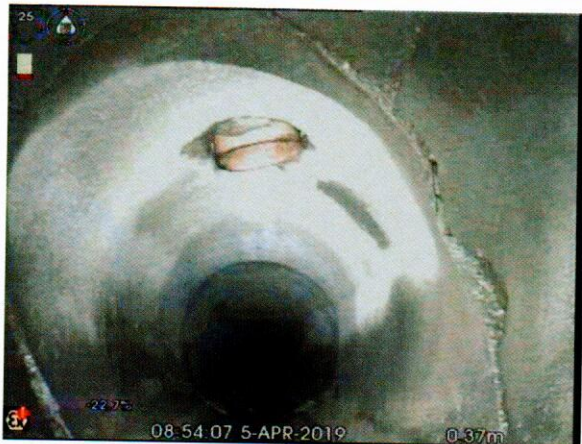
S7X_7668e268-54dd-4054-bff4-0173f5f9763b_20190405_095
314_961.jpg, 00:01:21, 0.37 m
Cracks, spiral from 12 o'clock to 12 o'clock

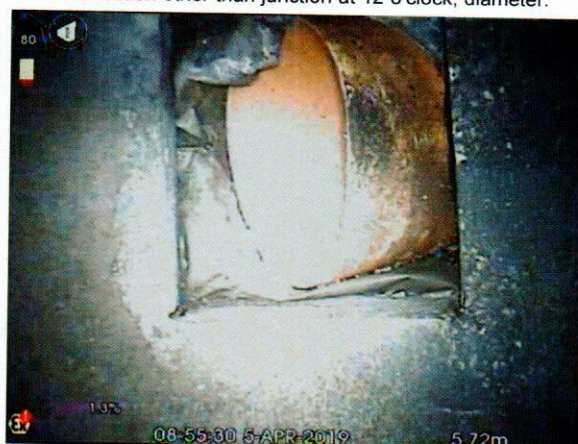
S7X_ff2f0039-0154-4204-b1e9-e659e7926ade_20190405_095
5439_124.jpg, 00:02:16, 5.72 m
Connection other than junction at 1 o'clock, diameter: 100mm

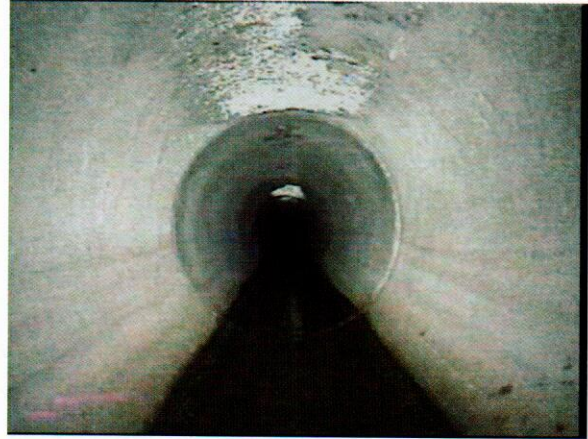
S8X_f3ae3c52-c9e2-435d-85d9-ce996e3978a7_20190405_1
14838_269.jpg, 00:14:34, 78.81 m
Survey abandoned

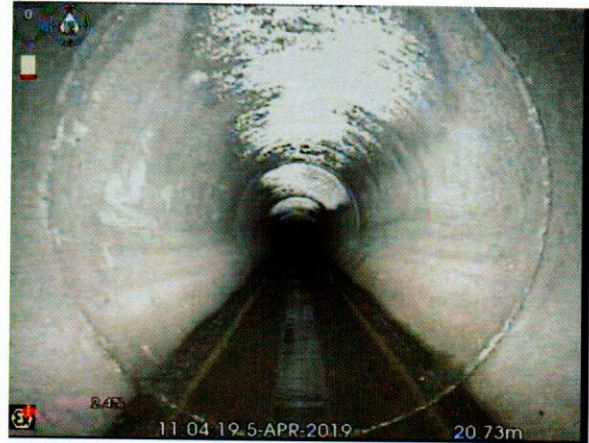
S8X_dd51b15e-55e5-42e3-8028-90a36a45cfef_20190405_12
0328_014.jpg, 00:01:52, 20.73 m
Survey abandoned

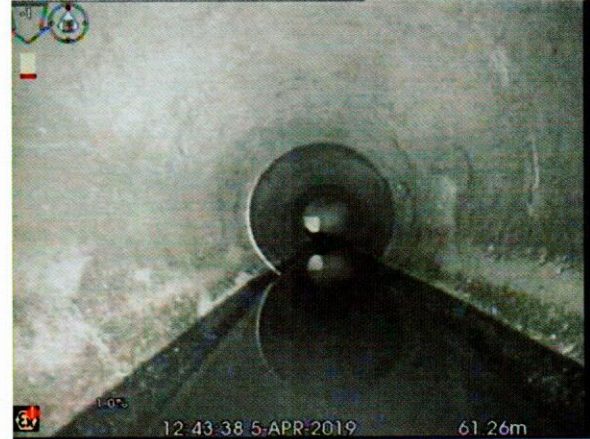
S10X_f3b594ef-ef55-4d79-baf5-181129d52886_20190405_13
4246_959.jpg, 00:05:21, 61.26 m
Water level, 10% of the vertical dimension

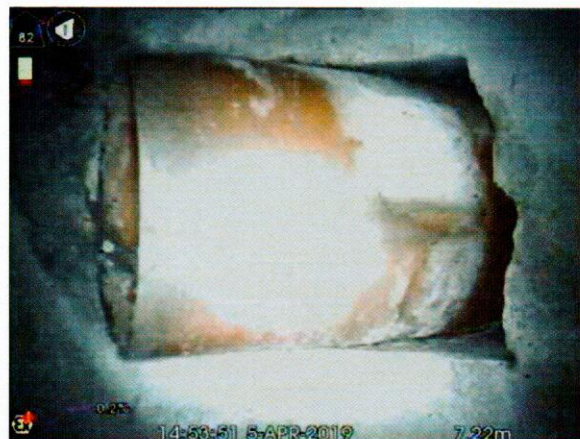
S11X_8c26414c-5570-4c5c-9c45-72a3d62b1144_20190405_155300_478.jpg, 00:00:53, 7.22 m
Connection other than junction at 1 o'clock, diameter: 150mm
