PLANNING SUBMISSION

Engineering Infrastructure Report for 268 dwellings for Castle Rock Homes (Midleton) Ltd

Broomfield West, Midleton, Co Cork.

Date: 03.05.2023

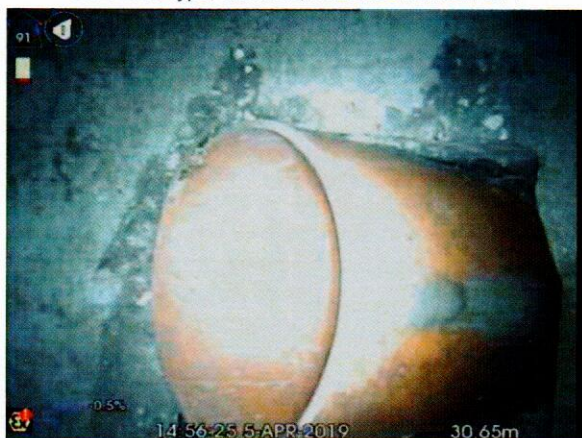
S11X_97e89ff1-cece-4ded-a60d-67b0788aebb6_20190405_155533_720.jpg, 00:03:15, 30.65 m
Connection other than junction at 1 o'clock, diameter: 150mm

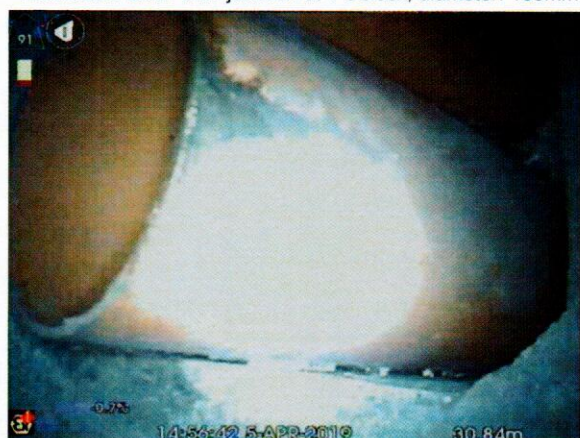
S11X_b51732fa-f87c-498b-98f5-c59dd0c10ad3_20190405_155550_998.jpg, 00:03:25, 30.84 m
Connection other than junction at 1 o'clock, diameter: 150mm

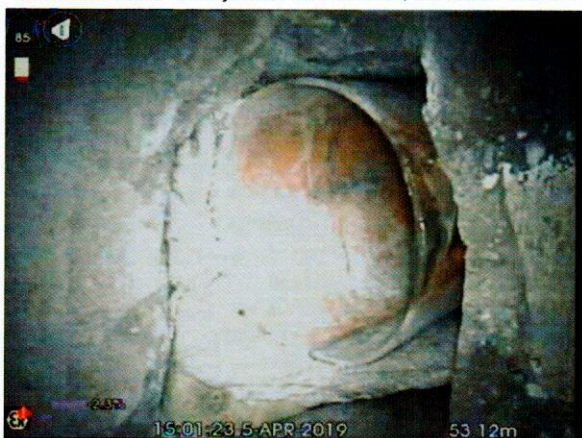
S11X_bced69d4-79c0-4d55-a302-6040b96b55cc_20190405_160032_561.jpg, 00:07:57, 53.11 m
Connection other than junction at 1 o'clock, diameter: 150mm

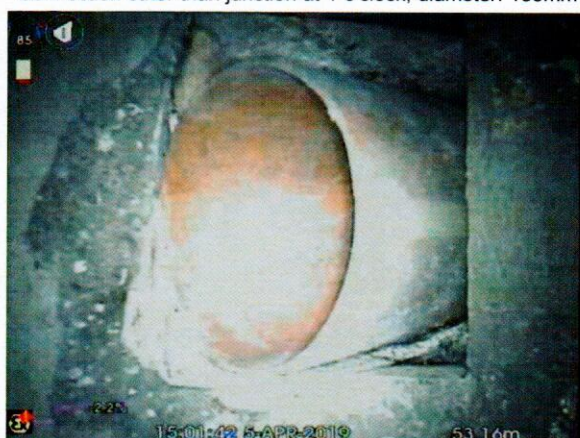
S11X_4159b65c-b355-45a4-92e8-229edce50242_20190405_160051_701.jpg, 00:08:06, 53.16 m
Connection other than junction at 1 o'clock, diameter: 150mm

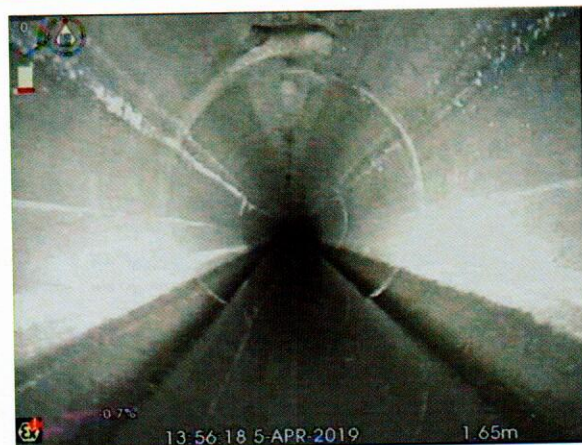
S12X_a4c78e13-8fa1-48da-99c7-0acaecf3be4c_20190405_145527_027.jpg, 00:00:12, 1.65 m
Water level, 10% of the vertical dimension

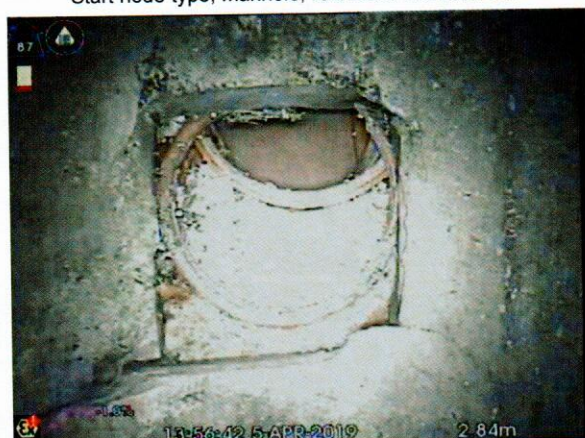
S12X_c8a29280-971f-4478-a52d-44cf951e9945_20190405_145551_027.jpg, 00:00:28, 2.84 m
Connection other than junction at 12 o'clock, diameter:

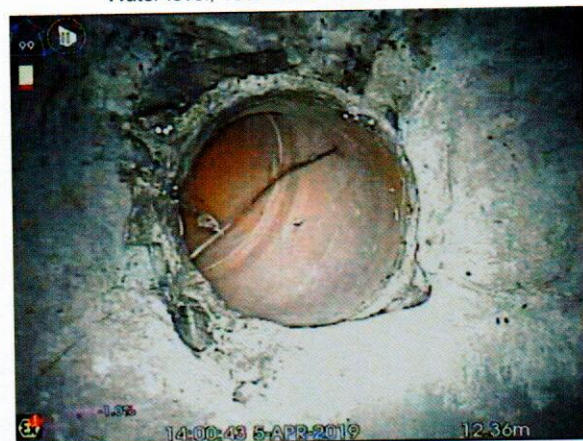
S12X_1bd62a68-ad66-4de4-b315-8e019f14ab10_20190405_145952_710.jpg, 00:04:18, 12.36 m
Connection other than junction at 12 o'clock, diameter:

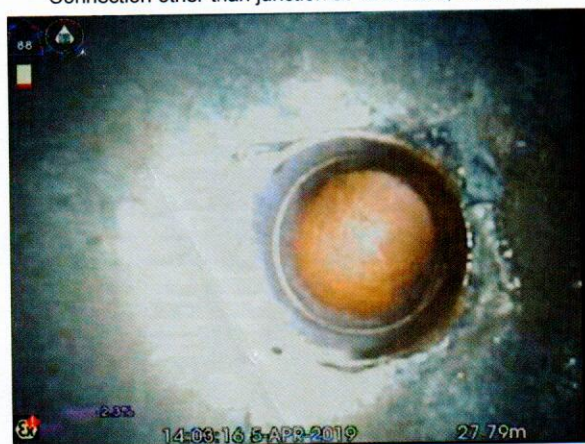
S12X_7c569883-7420-47af-be2e-602fc3a58e52_20190405_150225_562.jpg, 00:06:39, 27.79 m
Connection other than junction at 12 o'clock, diameter:

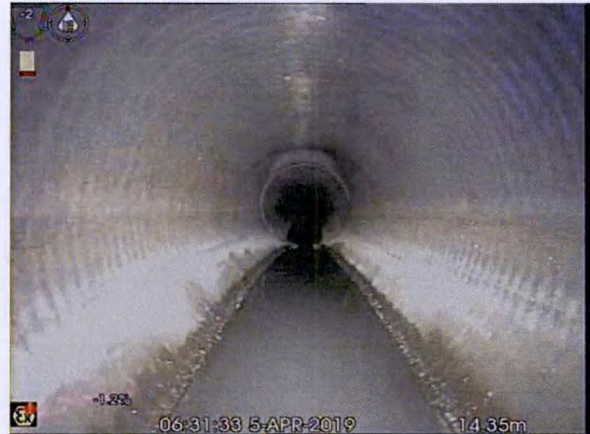
S2X_3c24dd86-e9c2-4854-a02e-26cc4f794fcc_20190405_073041_501.jpg, 00:01:20, 14.35 m
Water level, 5% of the vertical dimension

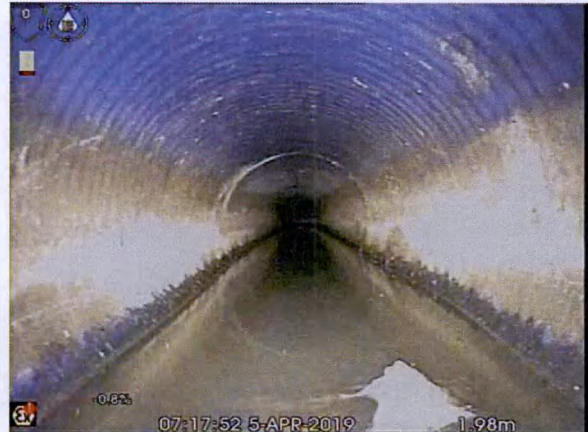
S3X_51ac9785-3074-40fa-9406-ab5ca25e2d2c_20190405_0
81701_604.jpg, 00:00:51, 1.98 m
Water level, 20% of the vertical dimension

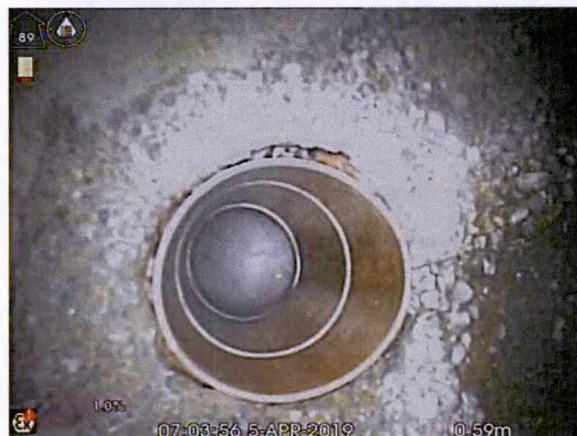
S4X_a5e9ed2b-8f8f-494b-b06d-fe2155b6fd24_20190405_08
304_982.jpg, 00:00:11, 0.59 m
Connection other than junction at 12 o'clock, diameter:

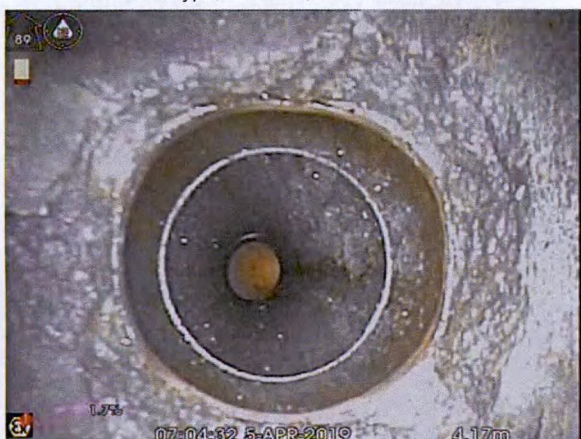
S4X_6021ae2c-959a-4f2c-99e0-d2c84a075fe2_20190405_08
0341_009.jpg, 00:00:38, 4.16 m
Connection other than junction at 12 o'clock, diameter:

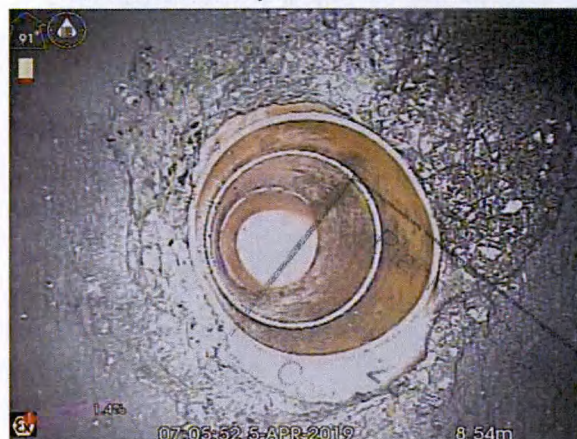
S4X_802735c8-86e0-42c0-8b8c-a67a50e5e5f3_20190405_08
80501_375.jpg, 00:01:12, 8.54 m
Connection other than junction at 12 o'clock, diameter:

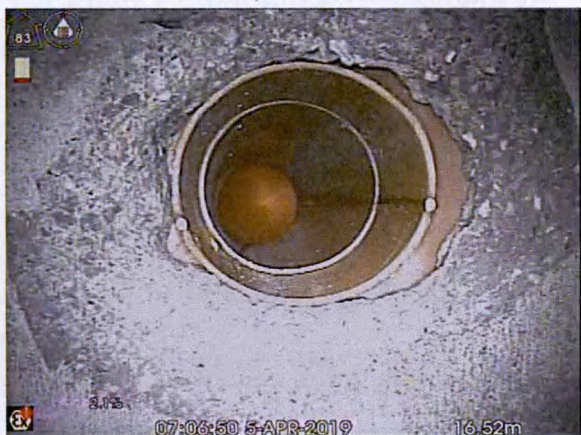
S4X_0a309ee2-7cfd-4233-bd52-868781fad4a2_20190405_08
0558_786.jpg, 00:02:01, 16.53 m
Connection other than junction at 12 o'clock, diameter:

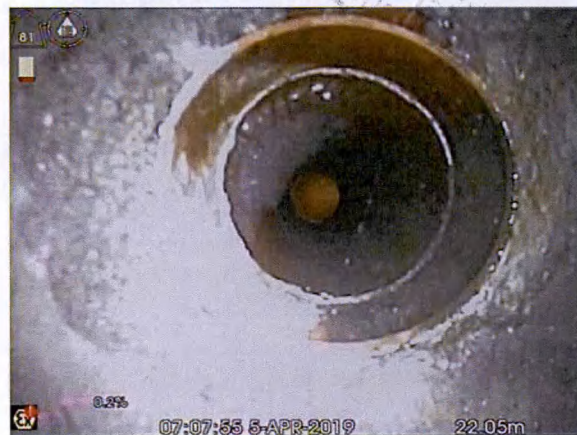
S4X_054fcaef-7066-4d99-b900-6afa1e02cb72_20190405_08
0704_434.jpg, 00:02:52, 22.05 m
Connection other than junction at 12 o'clock, diameter:

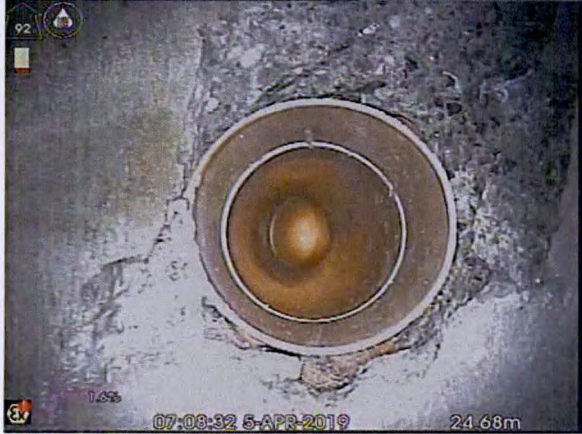
S4X_f6729a63-531b-46b9-9aaf-873fb425f930_20190405_080740_702.jpg, 00:03:25, 24.68 m
Connection other than junction at 12 o'clock, diameter:

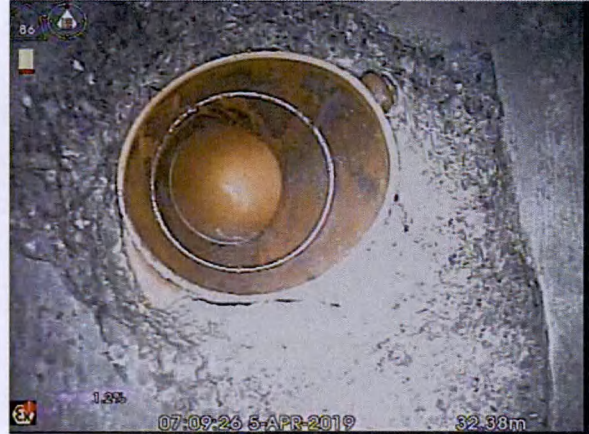
S4X_4dd6337d-9aba-4882-aa9d-5cf20b35e773_20190405_080834_359.jpg, 00:04:12, 32.38 m
Connection other than junction at 12 o'clock, diameter:

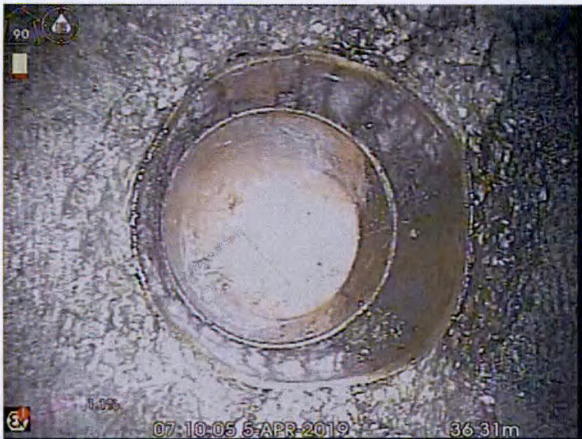
S4X_8113a11a-517e-4edd-8ac4-bde4a3698e20_20190405_080913_677.jpg, 00:04:43, 36.31 m
Connection other than junction at 12 o'clock, diameter:

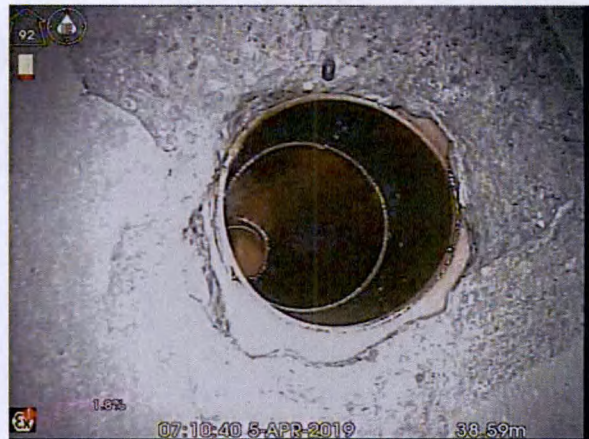
S4X_b34d13cd-a11f-4f5a-83bd-292a71613fec_20190405_080949_148.jpg, 00:05:11, 38.59 m
Connection other than junction at 12 o'clock, diameter:

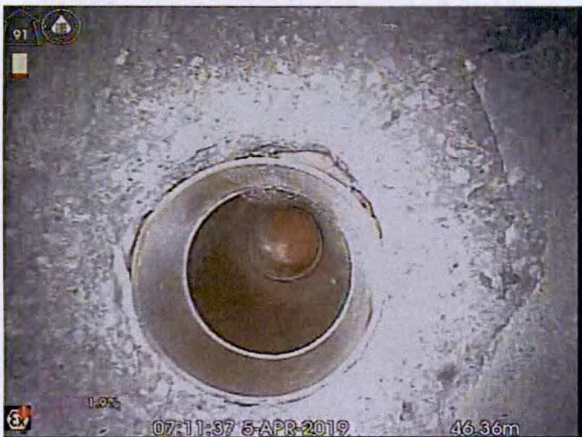
S4X_1c539c1b-af17-430a-a122-eb39745caf70_20190405_081045_894.jpg, 00:05:59, 46.36 m
Connection other than junction at 12 o'clock, diameter:

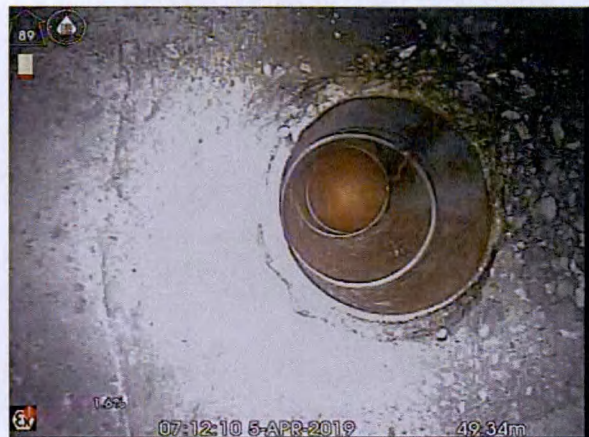
S4X_70a28ef5-6797-4dd6-b806-d4c54aea946f_20190405_081119_111.jpg, 00:06:25, 49.34 m
Connection other than junction at 12 o'clock, diameter:

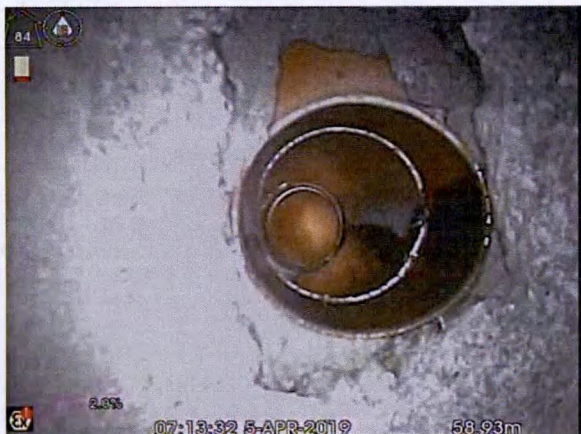
S4X_0e1e6e37-3caa-43e9-b2cf-042f1139d628_20190405_081240_534.jpg, 00:07:39, 58.93 m
Connection other than junction at 12 o'clock, diameter:

58.93	CN	Connection other than junction at 12 o'clock, diameter: 100mm	00:07:39		
	61.19	CN	Connection other than junction at 12 o'clock, diameter: 150mm	00:08:11

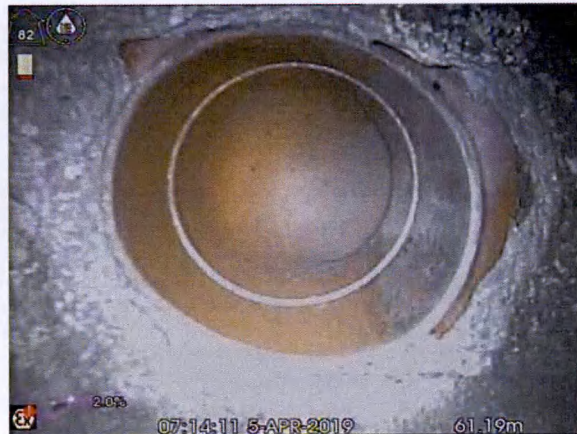
S4X_0a9403e3-fb40-4f72-b1bf-ef6ebd8fc1bf_20190405_081320_079.jpg, 00:08:11, 61.19 m
Connection other than junction at 12 o'clock, diameter:

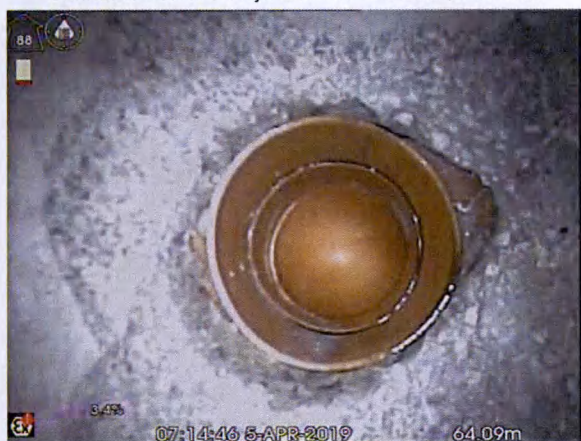
S4X_a38e43f0-4d8b-475b-90dc-9483a57644e7_20190405_081355_262.jpg, 00:08:39, 64.09 m
Connection other than junction at 12 o'clock, diameter:

64.09	CN	Connection other than junction at 12 o'clock, diameter: 100mm	00:08:39

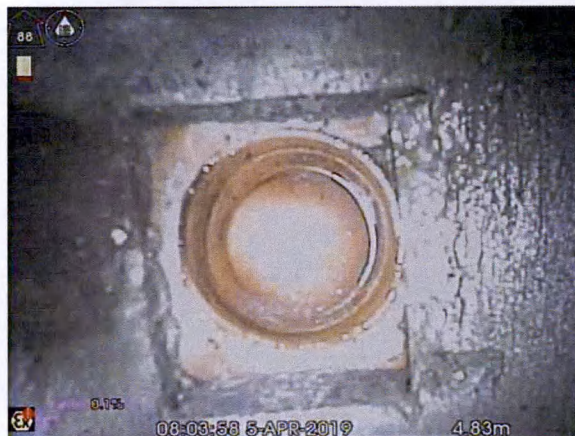
S5X_693240fd-ed56-427d-b066-fe6b68a06725_20190405_090306_660.jpg, 00:00:30, 4.83 m
Connection other than junction at 12 o'clock, diameter:

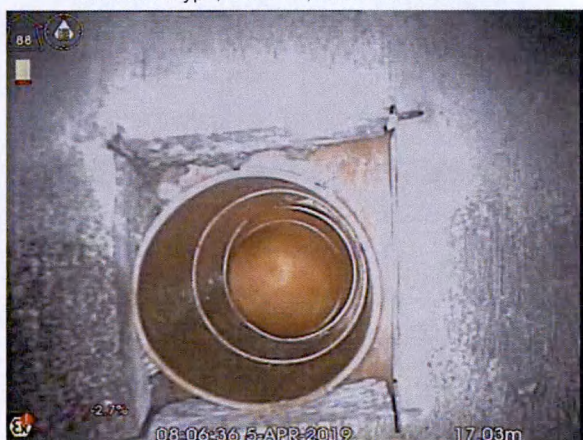
S5X_bd0ee04a-35e7-4a44-b67f-3794dc58536d_20190405_090545_028.jpg, 00:03:01, 17.03 m
Connection other than junction at 12 o'clock, diameter:

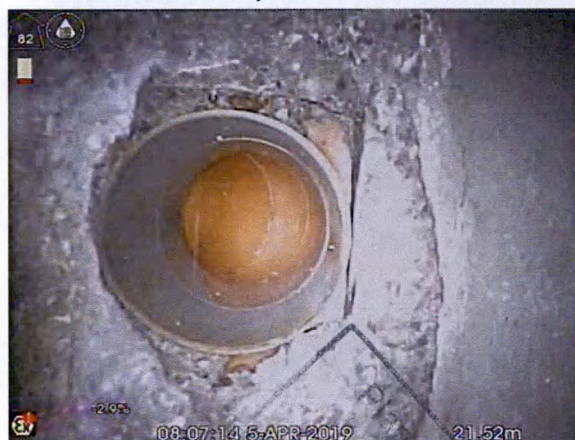
S5X_4b0726a5-1b8e-4719-8026-5574e0baccf4_20190405_090622_341.jpg, 00:03:30, 21.52 m
Connection other than junction at 12 o'clock, diameter:

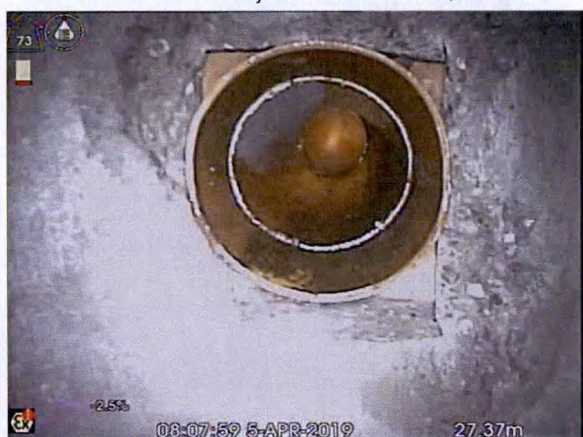
S5X_e997d85e-513a-4c9e-a330-d3a995be0e1e_20190405_090707_939.jpg, 00:04:08, 27.37 m
Connection other than junction at 12 o'clock, diameter:

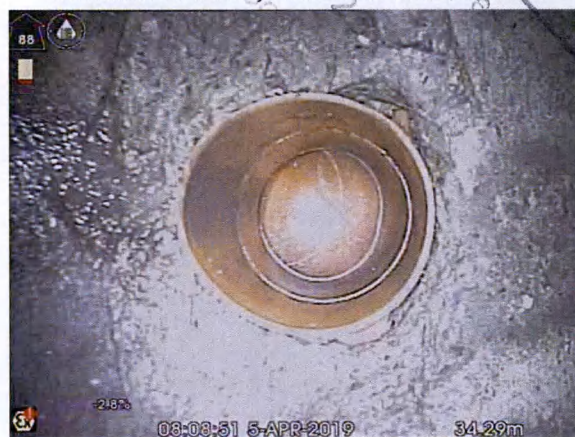
S5X_dc88f43e-10f2-439f-90a0-45b58179b8de_20190405_090759_213.jpg, 00:04:51, 34.29 m
Connection other than junction at 12 o'clock, diameter:

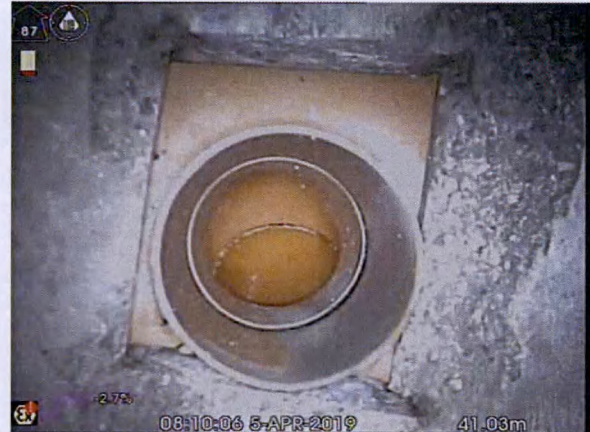
S5X_a2af812d-00a0-49d5-82f5-9c2578d3b00a_20190405_090914_929.jpg, 00:05:45, 41.03 m
Connection other than junction at 12 o'clock, diameter:

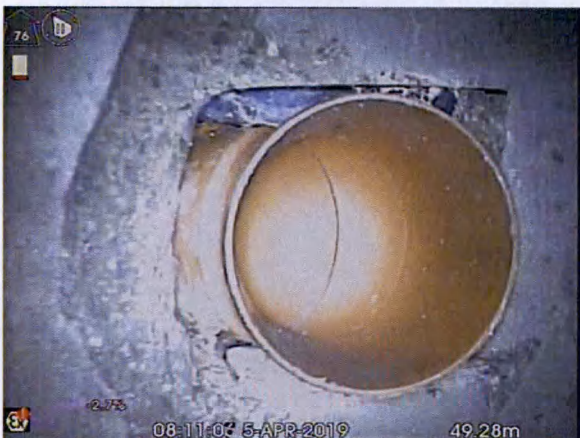
S5X_5188388e-7b81-4df1-9aaa-194757a45e84_20190405_091014_963.jpg, 00:06:34, 49.28 m
Connection other than junction at 11 o'clock, diameter:

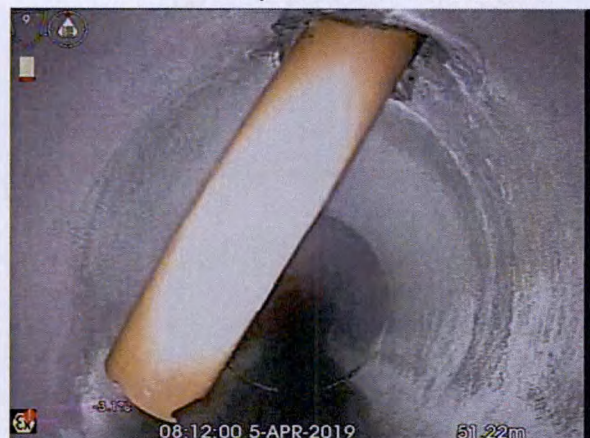
S5X_d9c04386-cfdb-4432-a2e0-6620da3a2084_20190405_091108_192.jpg, 00:06:56, 51.22 m
Connection intruding at 1 o'clock, diameter: 100mm, intrusion:

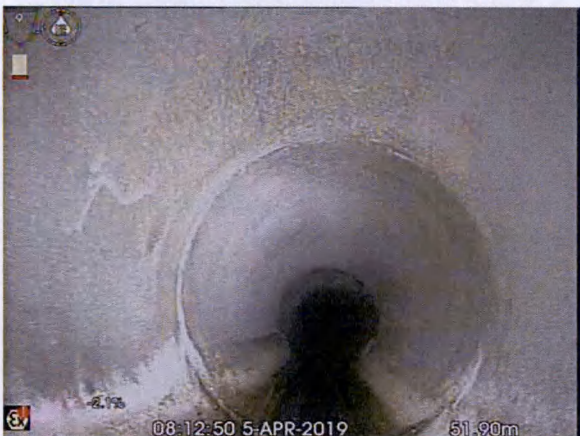
S5X_56b9a2bb-9e90-4269-8e9d-ab53078964d4_20190405_091158_715.jpg, 00:07:24, 51.90 m
Survey abandoned

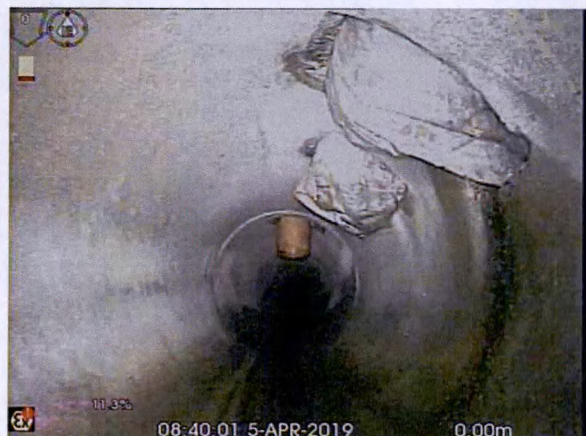
S5X_104bc7a0-720a-47f0-9d37-14bde05d9d88_20190405_093909_790.jpg, 00:00:00, 0.00 m
Start node type, manhole, reference number: S6

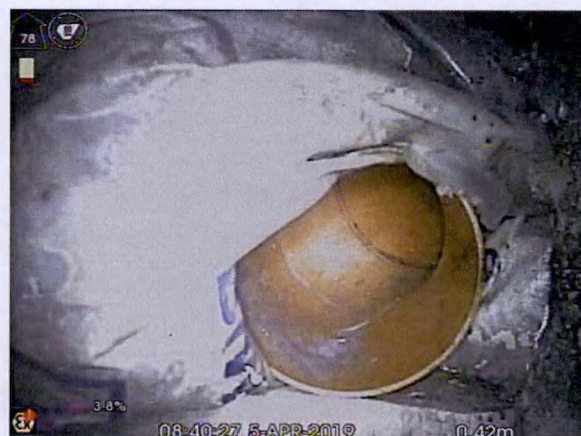
S5X_03b0457f-bb8e-468f-9713-1786b92e3fda_20190405_093935_556.jpg, 00:00:14, 0.42 m
Connection other than junction at 2 o'clock, diameter: 100mm

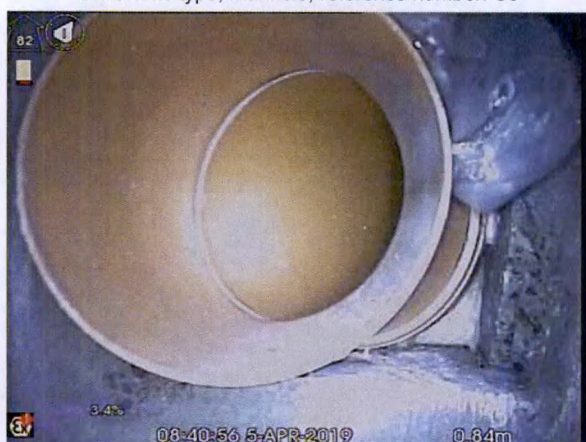
S5X_b7966323-76b6-459a-b1e1-98e9956461e4_20190405_094005_065.jpg, 00:00:28, 0.84 m
Connection intruding at 2 o'clock, diameter: 100mm, intrusion:

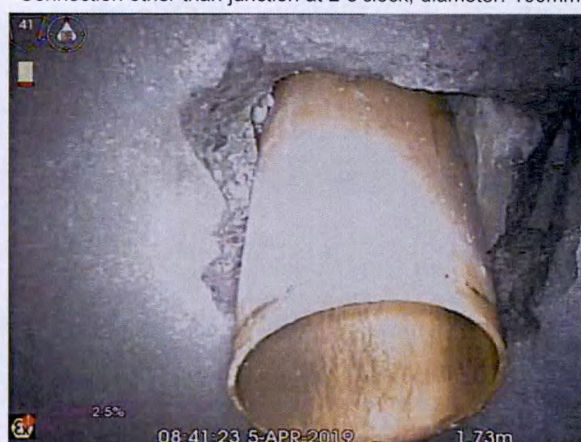
S5X_62aa0cc2-107c-47cd-adfc-3f77a6d3f8cb_20190405_094031_971.jpg, 00:00:43, 1.73 m
Connection intruding at 12 o'clock, diameter: 100mm,

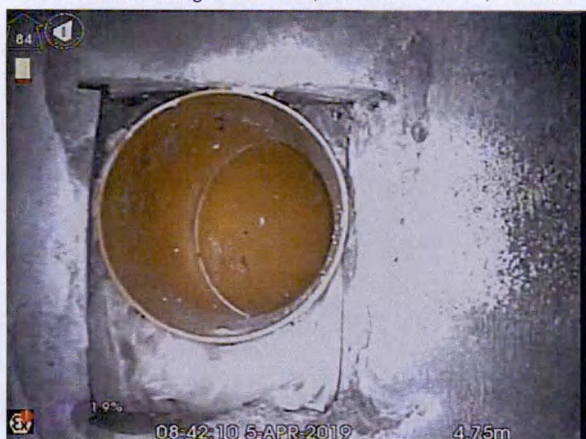
S5X_370e06e4-84f4-4c8a-a3a3-c44a2989c107_20190405_094118_654.jpg, 00:01:18, 4.75 m
Connection other than junction at 1 o'clock, diameter: 100mm

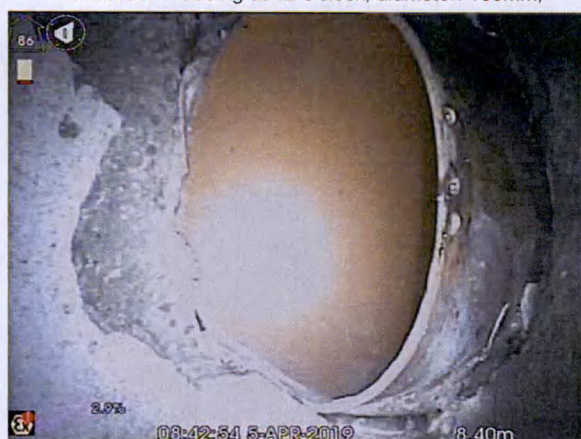
S5X_acceb949-f9b9-48f2-85ef-1e599e766fc5_20190405_094202_125.jpg, 00:01:52, 8.40 m
Connection other than junction at 2 o'clock, diameter: 100mm

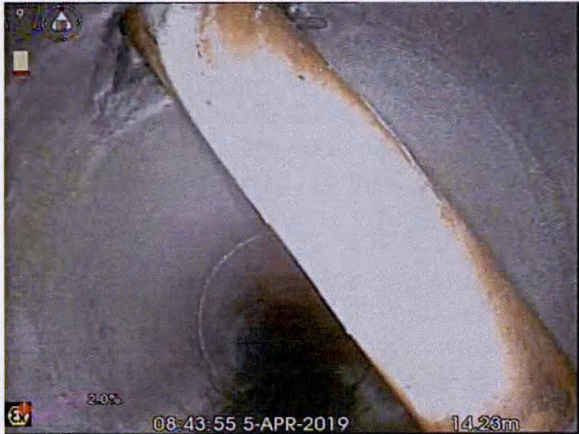
S5X_1b0d48cc-b4e9-416a-a0f1-9fd0bb0d32b9_20190405_094303_328.jpg, 00:02:36, 14.23 m
Connection intruding at 11 o'clock, diameter: 100mm,

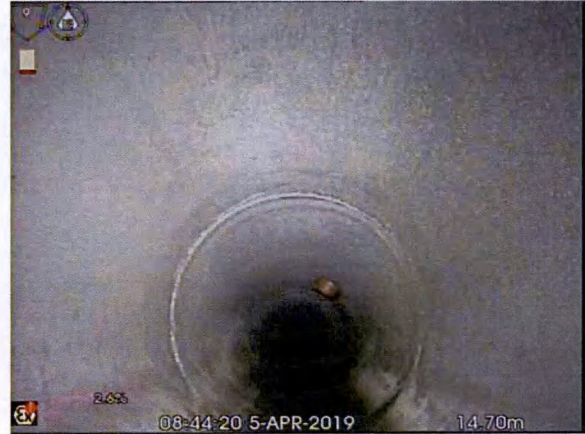
S5X_1d400da9-4a1b-4c68-8818-be19158c9803_20190405_094328_528.jpg, 00:02:45, 14.70 m
Survey abandoned

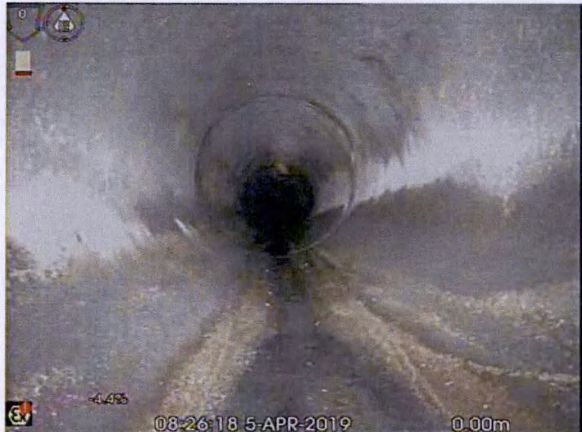
S6X_8127d366-a7dc-4957-9b17-592a26f26520_20190405_092527_372.jpg, 00:00:00, 0.00 m
Start node type, manhole, reference number: S6

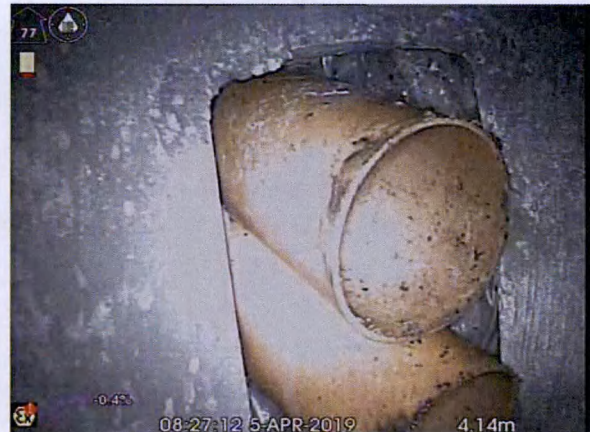
S6X_91b31115-cf97-4745-8a43-0827462e78b0_20190405_092621_053.jpg, 00:00:39, 4.14 m
Connection other than junction at 12 o'clock, diameter:

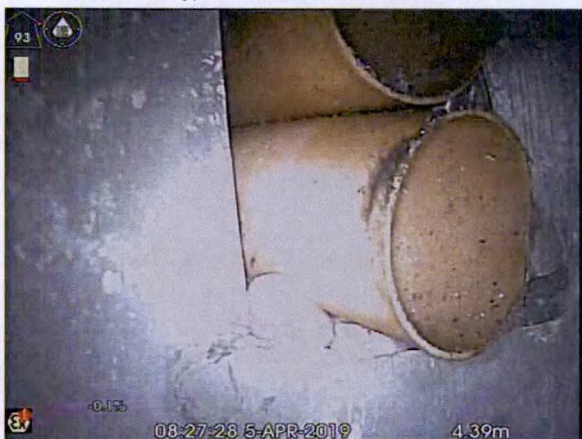
S6X_a4098aa4-0653-4636-a51a-36339279b92e_20190405_092636_205.jpg, 00:00:46, 4.39 m
Connection other than junction at 12 o'clock, diameter:

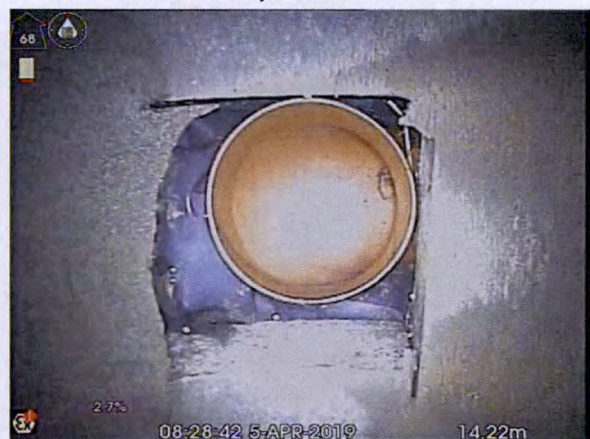
S6X_c9ec7afd-1a4f-4ea7-9098-e3660764c0f2_20190405_092750_886.jpg, 00:01:54, 14.22 m
Connection other than junction at 12 o'clock, diameter:

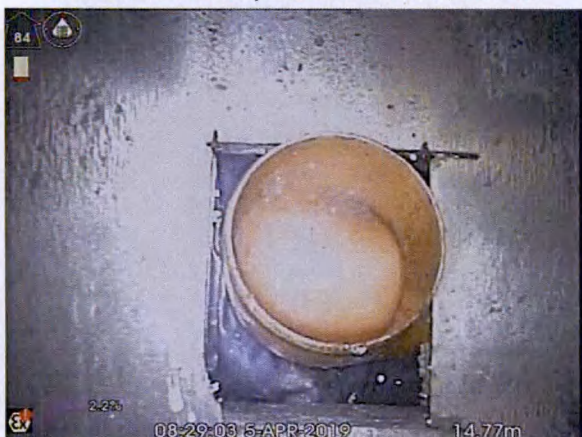
S6X_81383c55-9e7a-4746-8099-ef1c849ac6b8_20190405_092812_269.jpg, 00:02:07, 14.77 m
Connection other than junction at 12 o'clock, diameter:

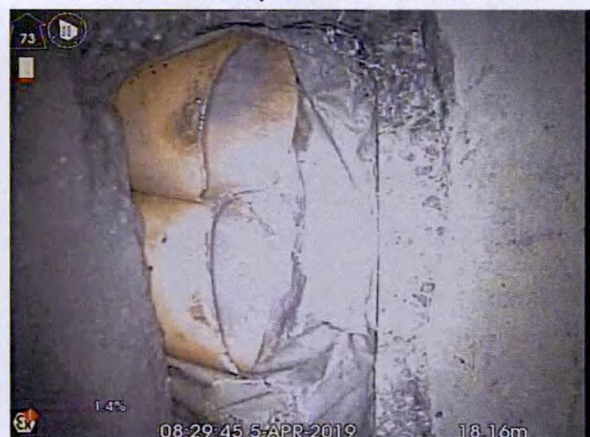
S6X_a74c1424-4840-47fc-b6ea-f90ae8ef89d6_20190405_092853_457.jpg, 00:02:37, 18.16 m
Connection other than junction at 11 o'clock, diameter:

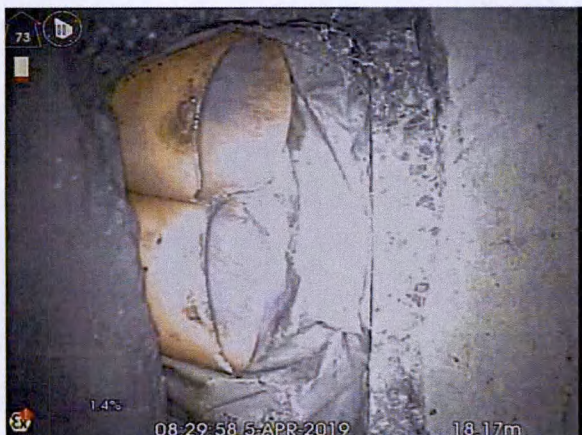
S6X_bdf240ab-03ce-4839-a13b-4a7ff26210f2_20190405_092
906_364.jpg, 00:02:43, 18.17 m
Connection other than junction at 12 o'clock, diameter:

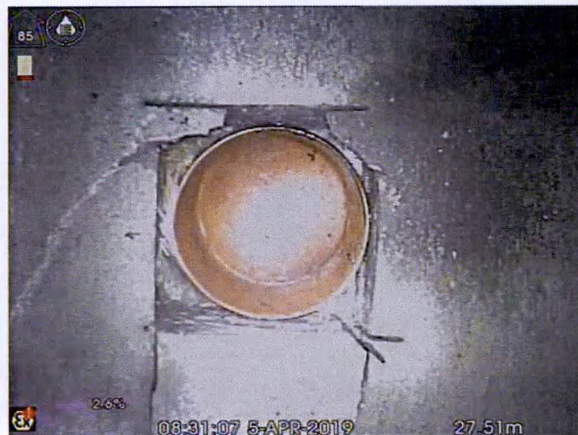
S6X_906c9892-9f70-4388-9326-8bfcfe449905_20190405_09
3015_084.jpg, 00:03:41, 27.51 m
Connection other than junction at 12 o'clock, diameter:

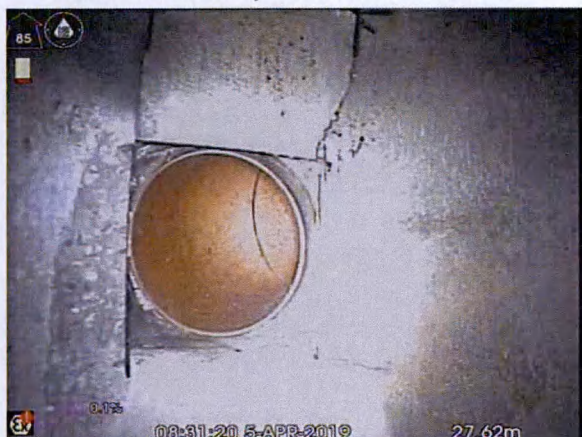
S6X_d6038f54-fdae-433f-a67f-0de6ba9aa6ba_20190405_093
028_351.jpg, 00:03:47, 27.62 m
Connection other than junction at 12 o'clock, diameter:

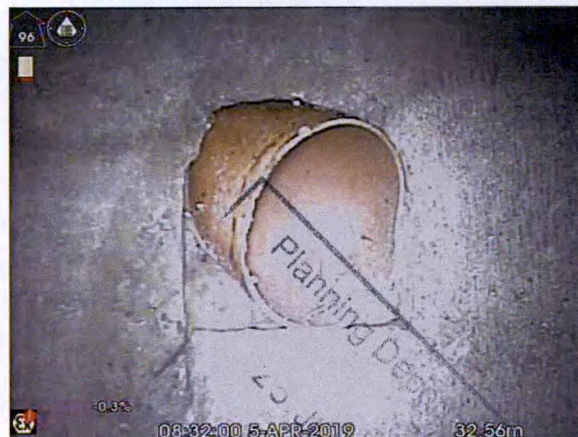
S6X_3f5f0a68-e51d-4e08-a22b-9b6f00ced204_20190405_09
3108_985.jpg, 00:04:26, 32.56 m
Connection other than junction at 12 o'clock, diameter:

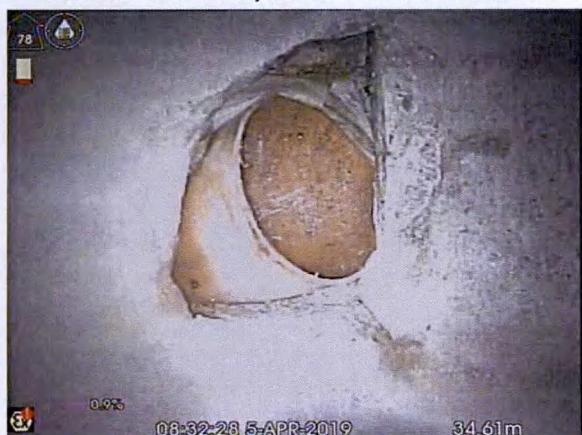
S6X_ddbe4989-b184-447f-9b4f-07cca075102e_20190405_09
3136_478.jpg, 00:04:39, 34.61 m
Connection other than junction at 12 o'clock, diameter:

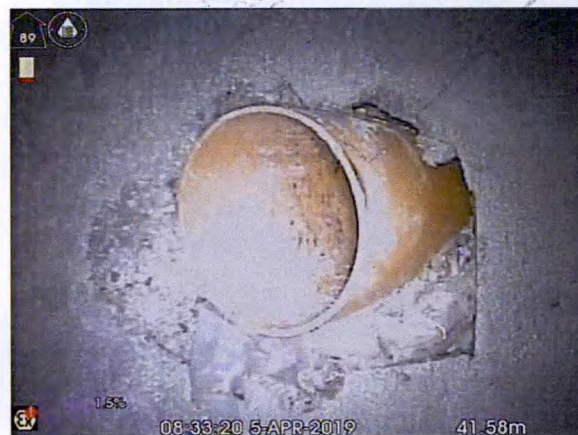
S6X_1735cf16-efdb-4b0a-88ca-38dbbd134ab1_20190405_09
3229_036.jpg, 00:05:23, 41.57 m
Connection other than junction at 12 o'clock, diameter:

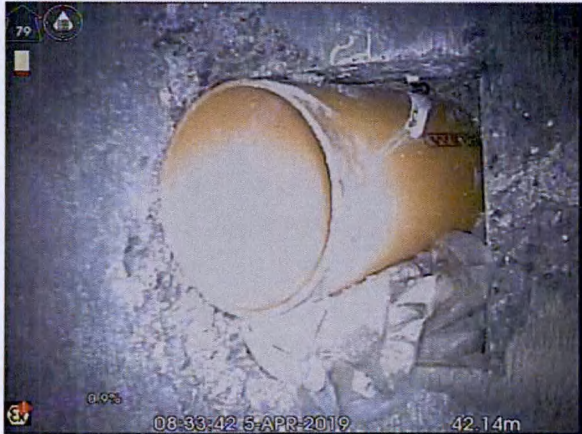
S6X_28dec9d-07d9-44c7-92b2-5de24c9dc43b_20190405_093250_338.jpg, 00:05:35, 42.14 m

Connection other than junction at 12 o'clock, diameter:

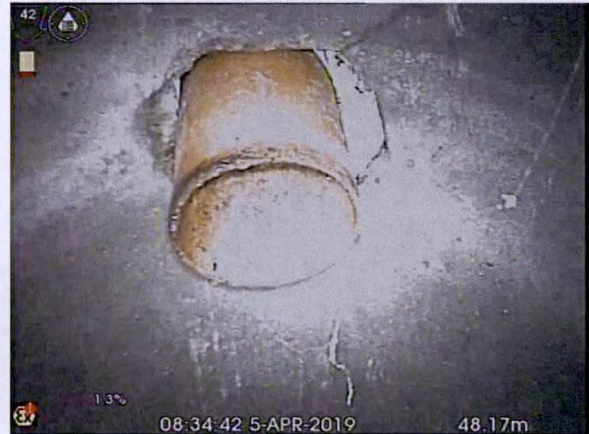
S6X_0d19f72f-ee95-4bcb-a8f3-93b19fae9762_20190405_09350_333.jpg, 00:06:23, 48.17 m

Connection intruding at 12 o'clock, diameter: 100mm,

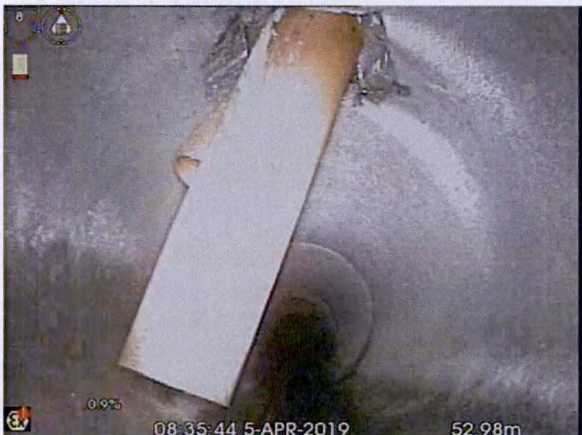
S6X_884f3d3d-f874-4854-8418-3b70886c52c6_20190405_093453_196.jpg, 00:07:02, 52.98 m

Connection intruding at 12 o'clock, diameter: 100mm,

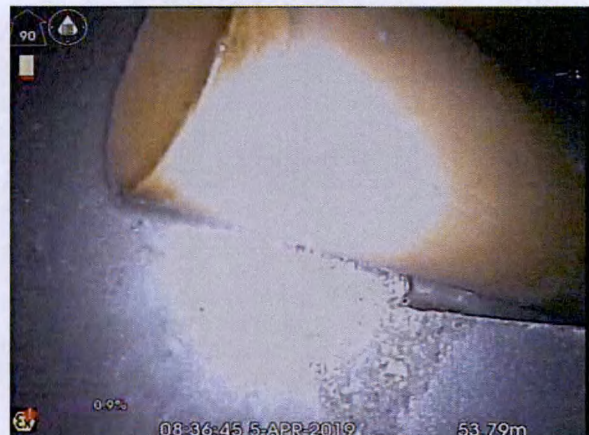
S6X_db2ccba5-02ab-4808-a2f3-f6fb28bc5a34_20190405_093553_252.jpg, 00:07:32, 53.79 m

Connection intruding at 12 o'clock, diameter: 100mm,

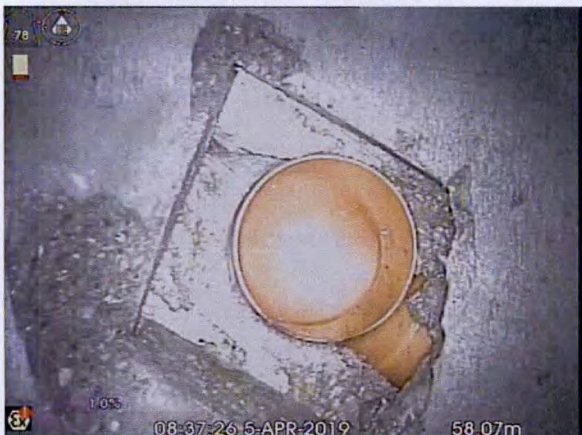
S6X_c5a221d9-8216-4a70-82c9-317fa8dbc8cf_20190405_093635_123.jpg, 00:08:05, 58.07 m

Connection other than junction at 12 o'clock, diameter:

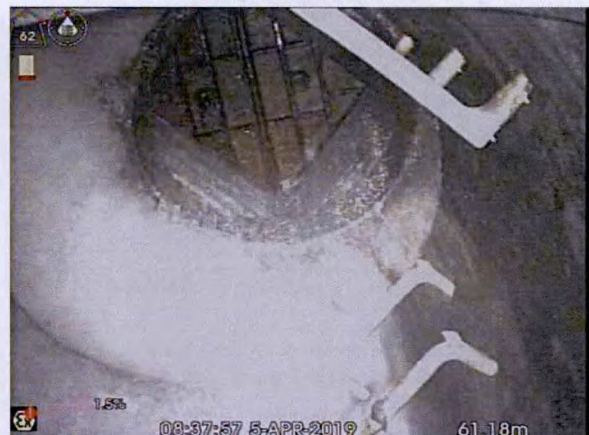
S6X_2600c881-53cf-4c40-b02b-ee08dc7ae9b1_20190405_093705_399.jpg, 00:08:30, 61.18 m

Finish node type, manhole, reference number: S7

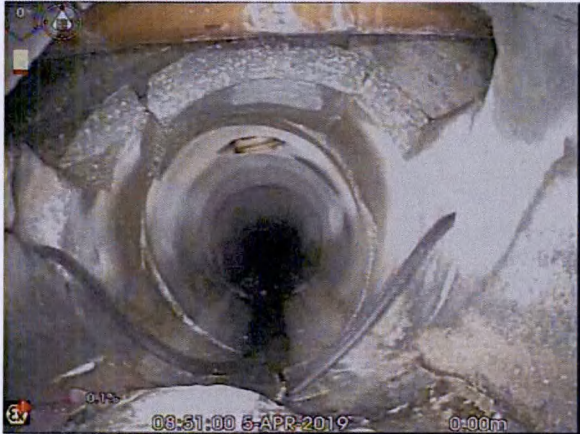
S7X_61b2b2d6-a4dc-436d-b3c1-1745fe7a4a02_20190405_095008_174.jpg, 00:00:00, 0.00 m
Start node type, manhole, reference number: S7

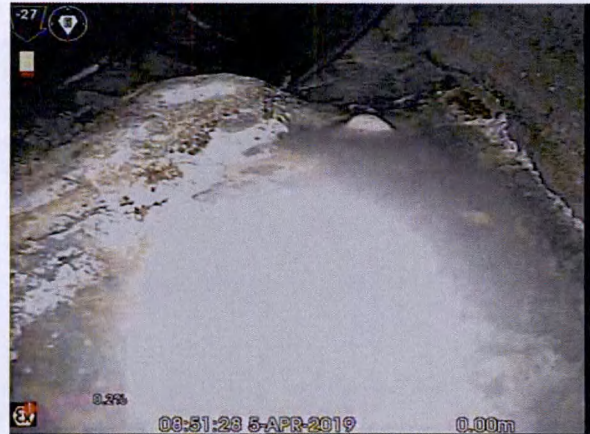
S7X_975bed17-9008-4230-9468-a5f4fb99637b_20190405_095036_538.jpg, 00:00:07, 0.00 m
General photograph taken at this point

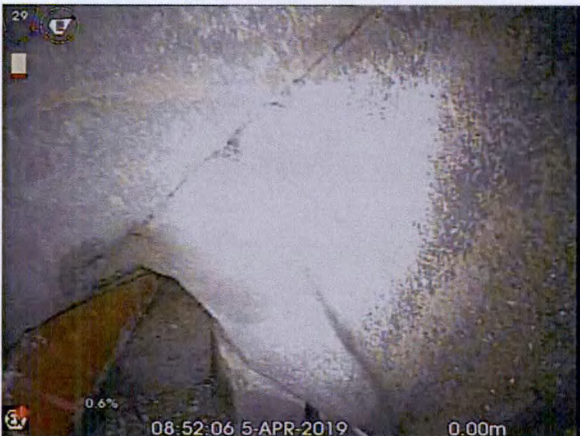
S7X_e95e40db-f421-4224-9e8c-5d1c64228623_20190405_095114_099.jpg, 00:00:24, 0.00 m
Cracks, multiple from 4 o'clock to 6 o'clock

Cracks, multiple from 4 o'clock to 6 o'clock

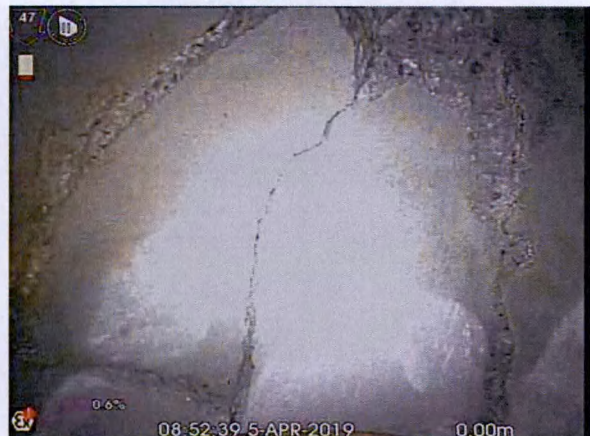
S7X_ca062aaf-6af5-4bed-ad91-987a9282a6d7_20190405_095147_073.jpg, 00:00:40, 0.00 m
Fracture spiral from 9 o'clock to 3 o'clock

Fracture spiral from 9 o'clock to 3 o'clock

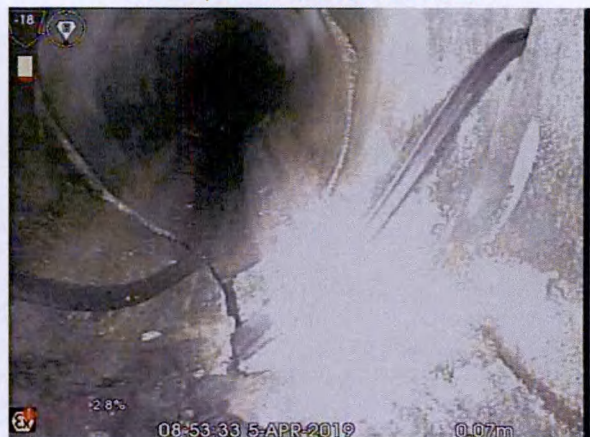
S7X_507b6eab-e483-4ccb-9798-b9840ae9fe90_20190405_095241_489.jpg, 00:01:01, 0.07 m
Sealing ring broken from 3 o'clock to 9 o'clock

Sealing ring broken from 3 o'clock to 9 o'clock

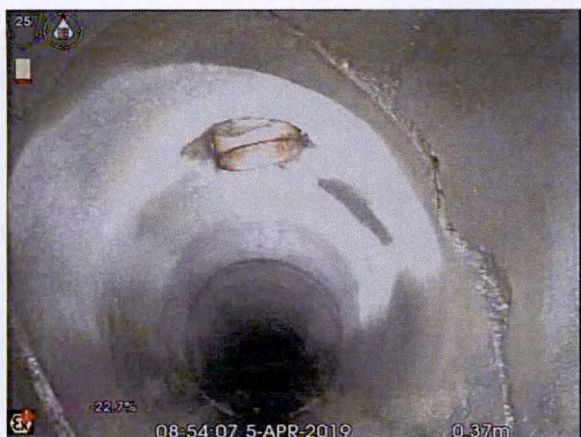
S7X_7668e268-54dd-4054-bff4-0173f5f9763b_20190405_095314_961.jpg, 00:01:21, 0.37 m
Cracks, spiral from 12 o'clock to 12 o'clock

Cracks, spiral from 12 o'clock to 12 o'clock

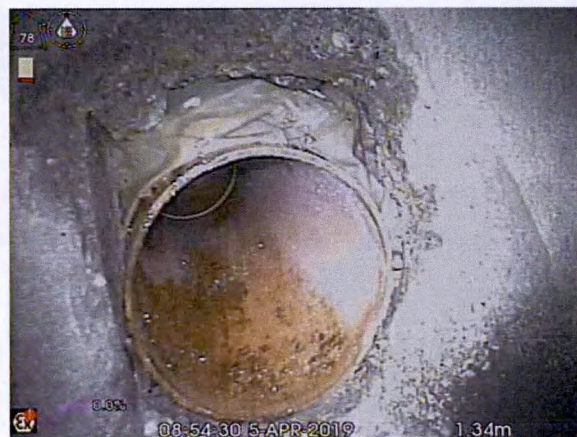
S7X_5389aa5f-4fe3-4cf8-b377-cfb7861908ba_20190405_095338_868.jpg, 00:01:38, 1.34 m
Connection other than junction at 12 o'clock, diameter:

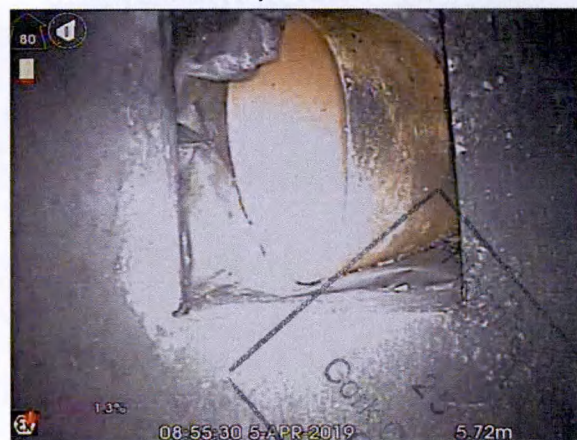
S7X_ff2f0039-0154-4204-b1e9-e659e7926ade_20190405_095439_124.jpg, 00:02:16, 5.72 m
Connection other than junction at 1 o'clock, diameter: 100mm

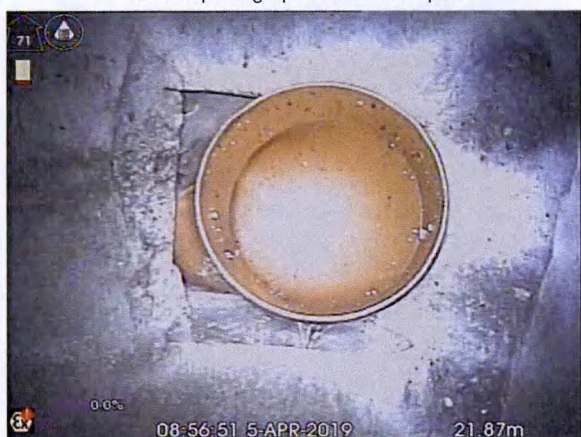
S7X_31436574-988a-4e7e-9a63-8803c35111fa_20190405_095559_947.jpg, 00:03:30, 21.87 m
Connection other than junction at 12 o'clock, diameter:

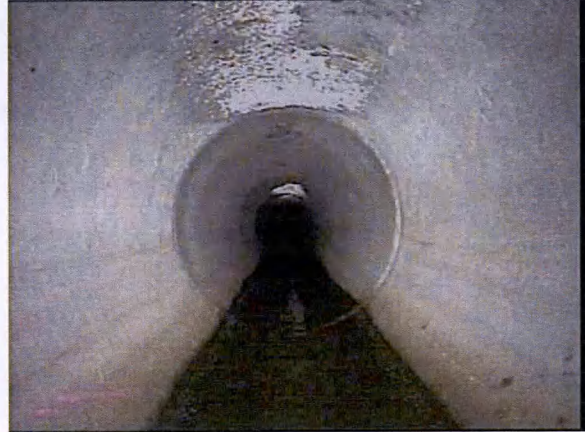
S8X_f3ae3c52-c9e2-435d-85d9-ce996e3978a7_20190405_1
14838_269.jpg, 00:14:34, 78.81 m
Survey abandoned

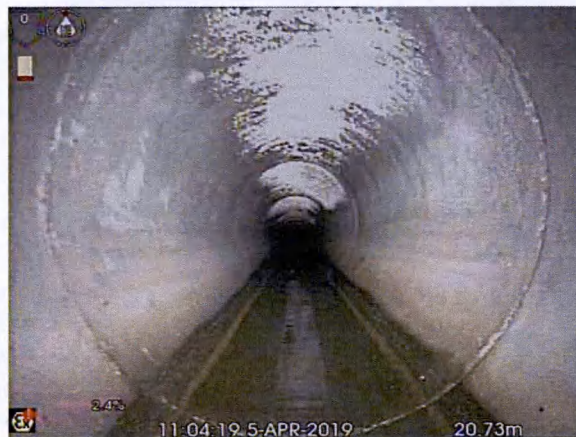
S8X_dd51b15e-55e5-42e3-8028-90a36a45cfef_20190405_12
0328_014.jpg, 00:01:52, 20.73 m
Survey abandoned

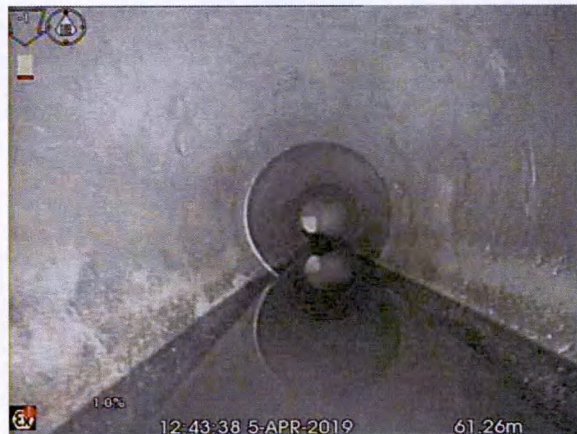
S10X_f3b594ef-ef55-4d79-baf5-181129d52886_20190405_13
4246_959.jpg, 00:05:21, 61.26 m
Water level, 10% of the vertical dimension

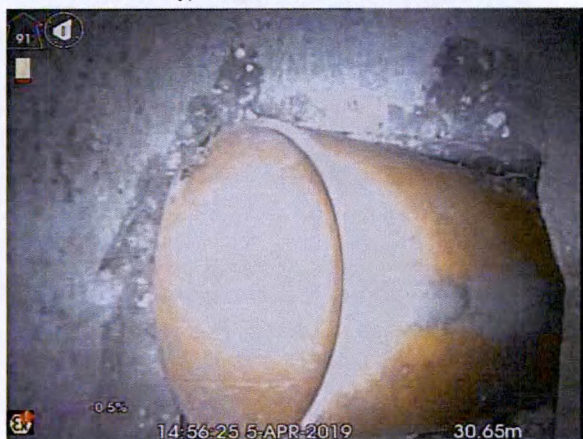
S11X_97e89ff1-cece-4ded-a60d-67b0788aebb6_20190405_155533_720.jpg, 00:03:15, 30.65 m
Connection other than junction at 1 o'clock, diameter: 150mm

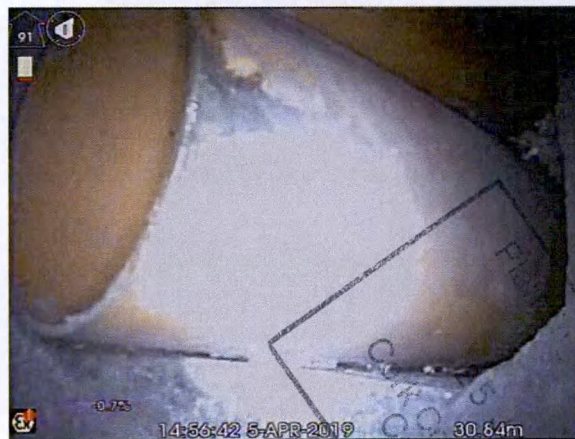
S11X_b51732fa-f87c-498b-98f5-c59dd0c10ad3_20190405_155550_998.jpg, 00:03:25, 30.64 m
Connection other than junction at 1 o'clock, diameter: 150mm

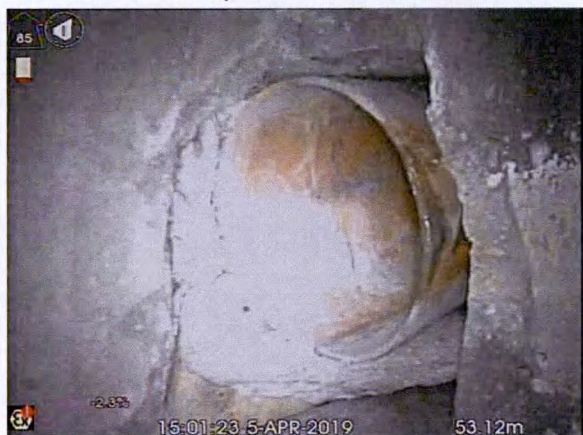
S11X_bced69d4-79c0-4d55-a302-6040b96b55cc_20190405_160032_561.jpg, 00:07:57, 53.11 m
Connection other than junction at 1 o'clock, diameter: 150mm

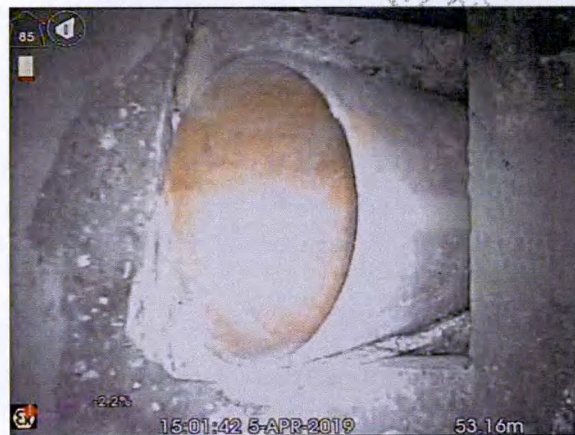
S11X_4159b65c-b355-45a4-92e8-229edce50242_20190405_160051_701.jpg, 00:08:06, 53.16 m
Connection other than junction at 1 o'clock, diameter: 150mm

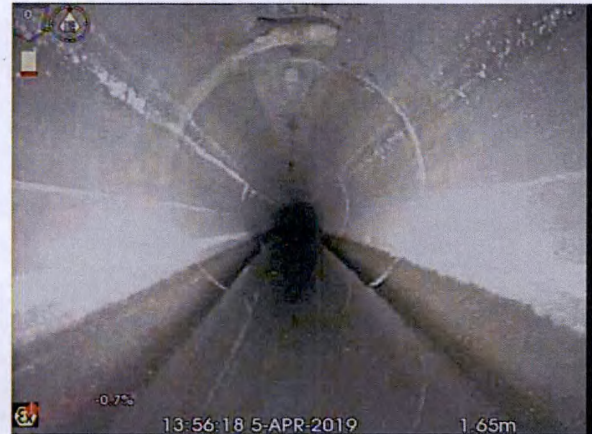
S12X_a4c78e13-8fa1-48da-99c7-0acaecf3be4c_20190405_1
45527_027.jpg, 00:00:12, 1.65 m
Water level, 10% of the vertical dimension

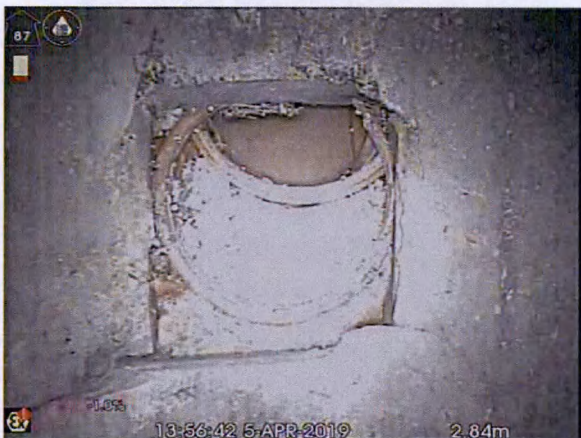
S12X_c8a29280-971f-4478-a52d-44cf951e9945_20190405_1
45551_027.jpg, 00:00:28, 2.84 m
Connection other than junction at 12 o'clock, diameter:

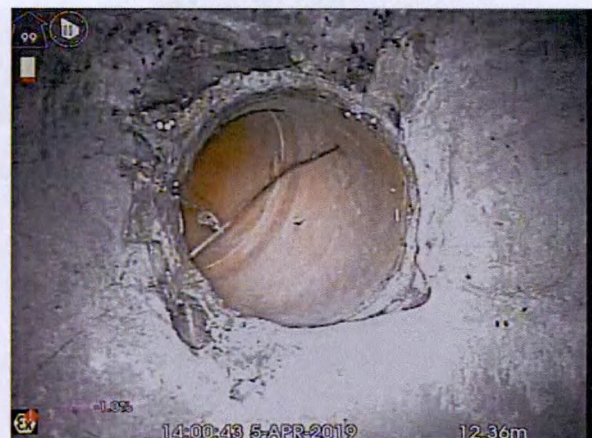
S12X_1bd62a68-ad66-4de4-b315-8e019f14ab10_20190405_1
145952_710.jpg, 00:04:18, 12.36 m
Connection other than junction at 12 o'clock, diameter:
