PLANNING SUBMISSION

Engineering Infrastructure Report for 268 dwellings for Castle Rock Homes (Midleton) Ltd

Broomfield West, Midleton, Co Cork.

Date: 03.05.2023

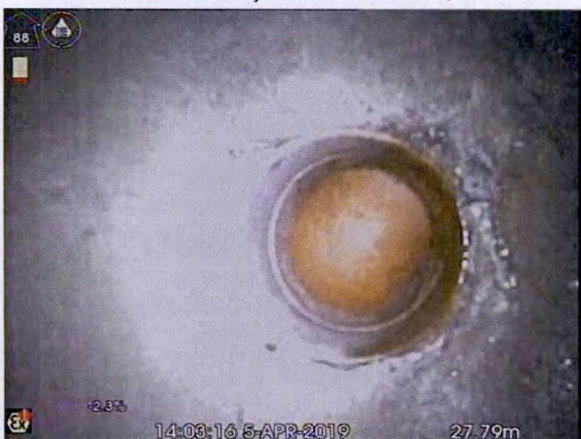
S12X_7c569883-7420-47af-be2e-602fc3a58e52_20190405_1
50225_562.jpg, 00:06:39, 27.79 m
Connection other than junction at 12 o'clock, diameter:

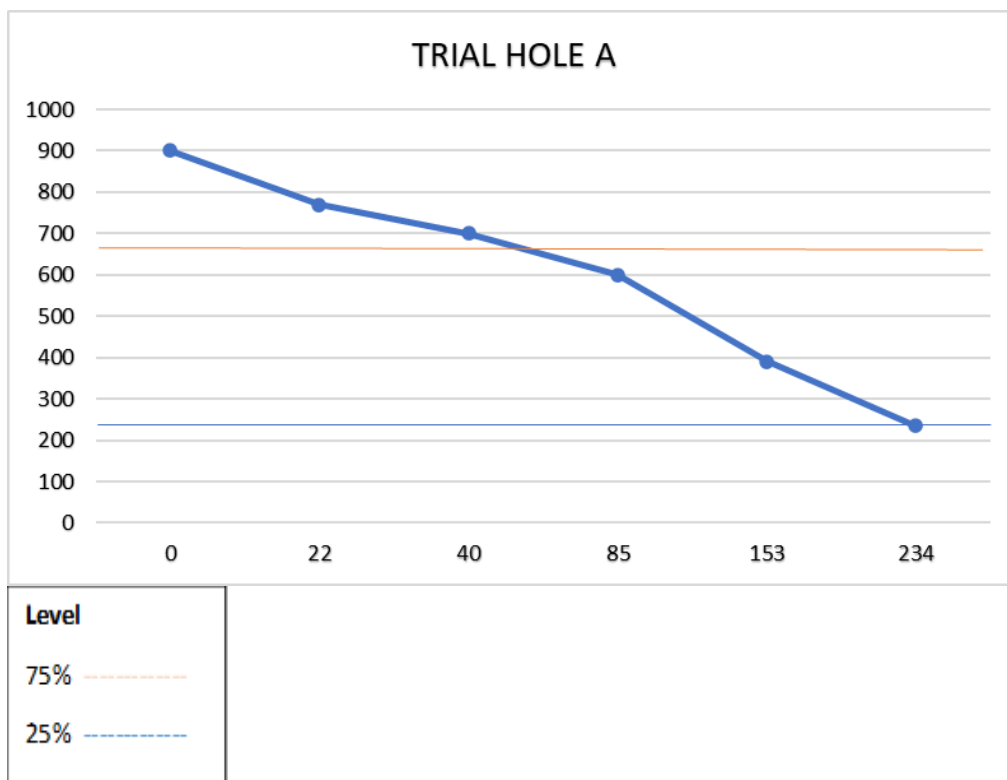
$$T_{p75-25} = 156 \text{ minutes}$$

$$\text{Soil Infiltration Rate } F: \frac{V_{p75-25}}{A_{p50} \times t_{p75-25}} = \frac{0.792}{3.036 \times 156 \times 60} = 2.8 \times 10^{-5} \text{m/s}$$

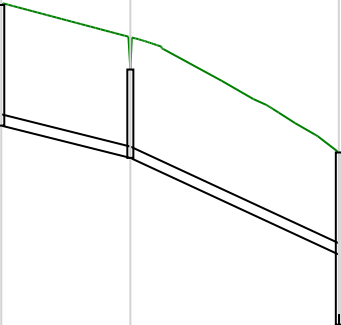
Node Name	11	12	13

A3 drawing			
Hor Scale 1500			
Ver Scale 100			
Datum (m) 55.000			
Link Name	7.000	7.001	
Section Type	150mm	150mm	
Slope (1:X)	60.0	32.4	
Cover Level (m)	66.750	65.897	64.800
Invert Level (m)	65.155	64.728	63.450
Length (m)	25.616	41.369

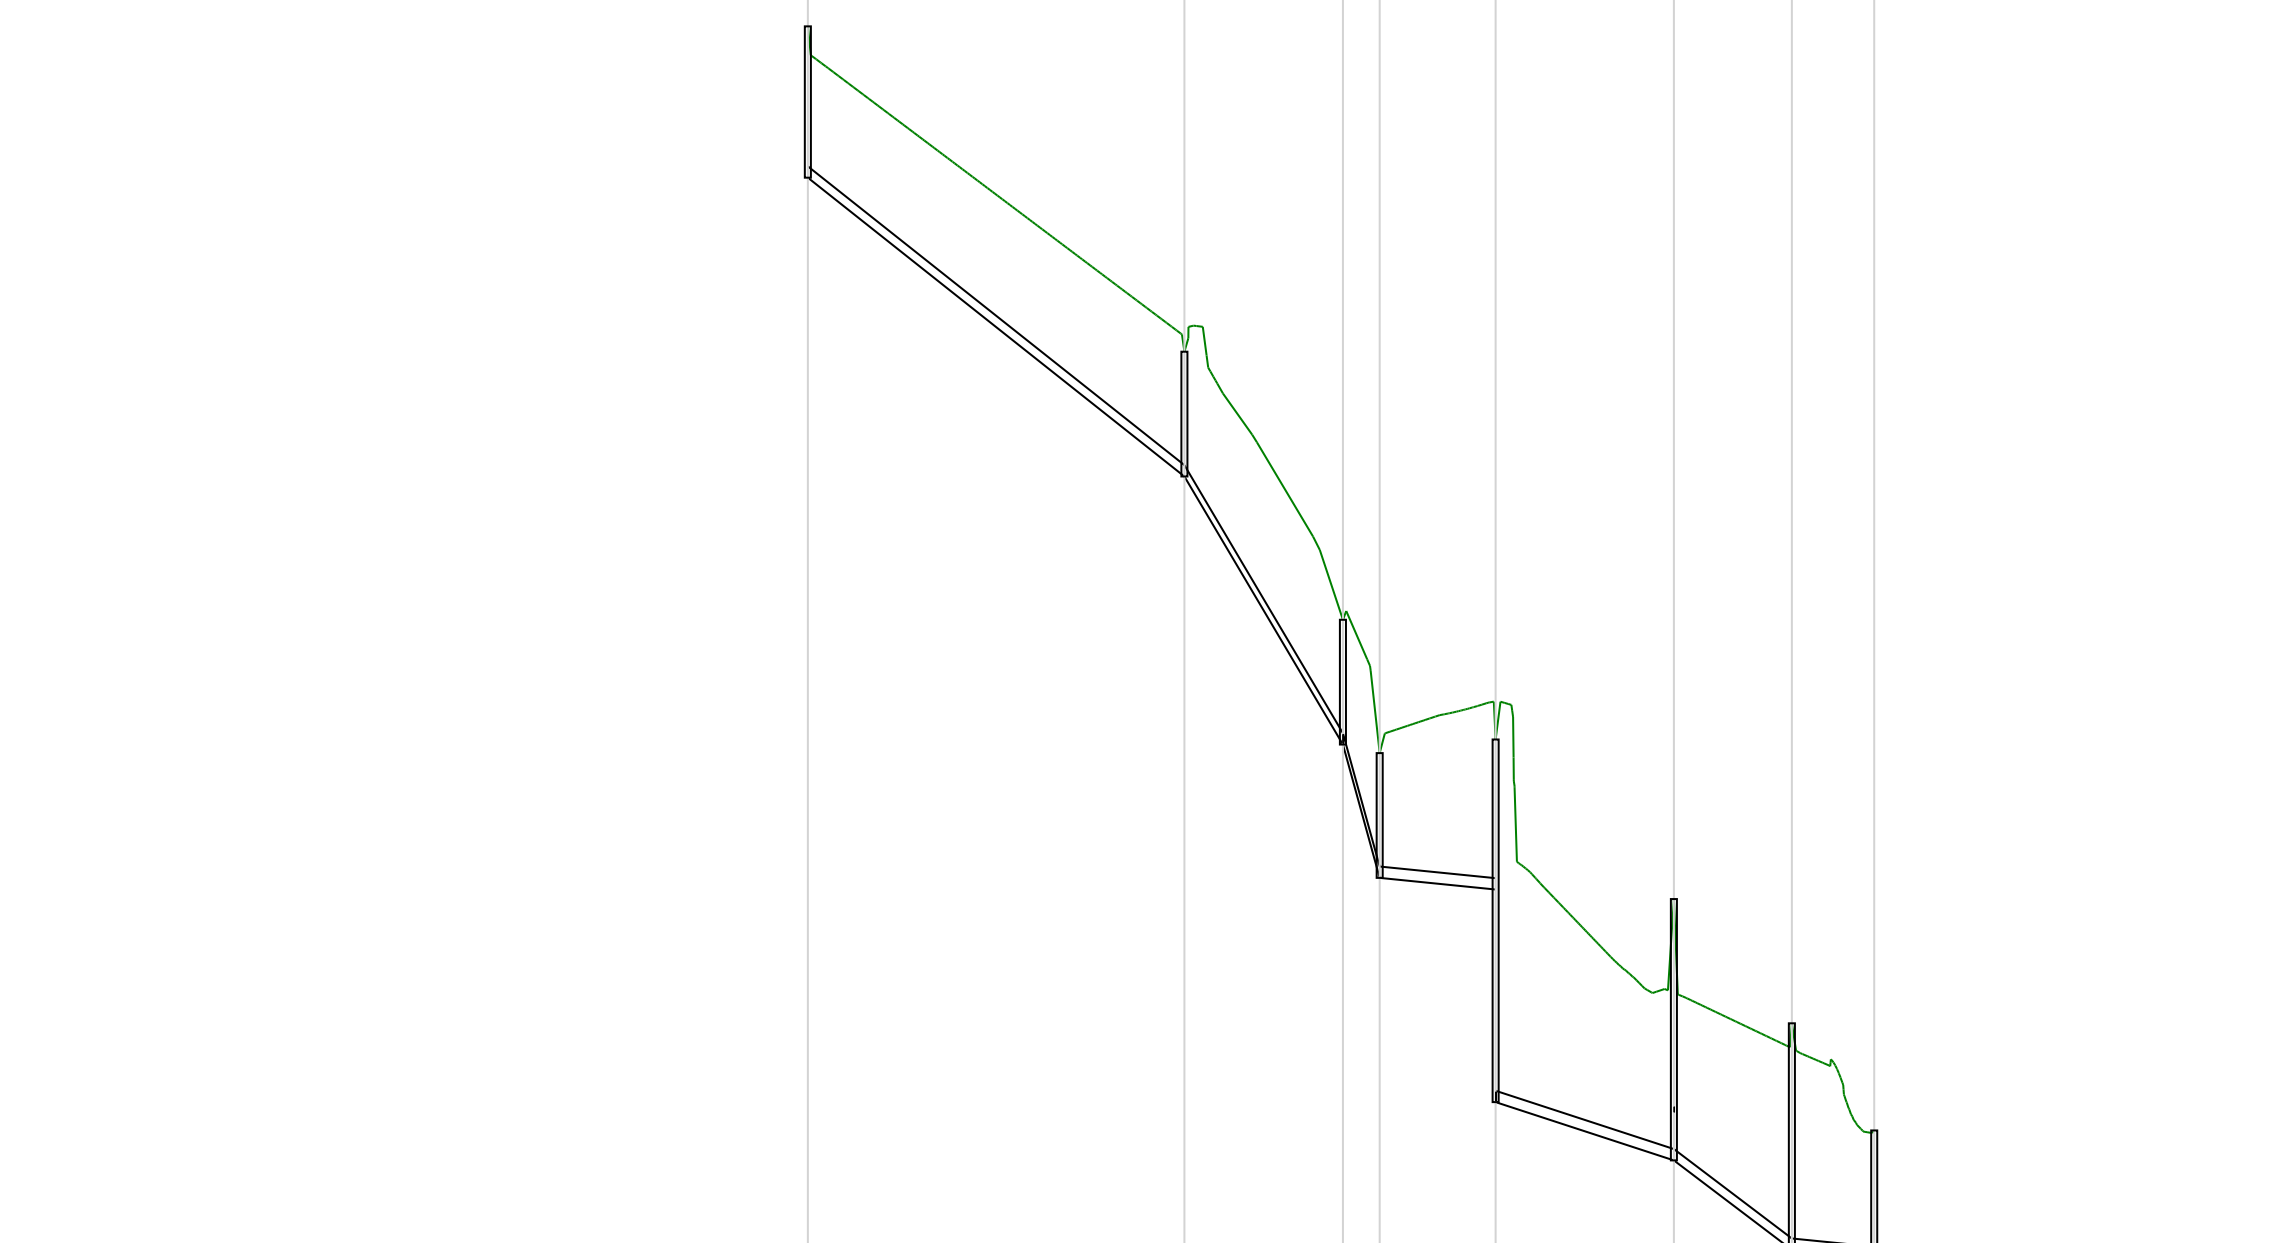
Node Name		42	43	44	45	46	47	48	49	
<div>A3 drawing</div> <div>Hor Scale 1500 Ver Scale 100</div> <div>Datum (m) 27.000</div>

Link Name		1.010	1.011	1.0	1.013	1.014	1.015	1.016	
	Section Type		150mm	150mm	150	150mm	150mm	150mm	150mm	
	Slope (1:X)		18.9	8.9	4.1	149.4	45.9	19.8	149.9	
	Cover Level (m)		45.000	40.698	37.153	35.390	35.570	33.460	31.817	30.400
Invert Level (m)		42.999	39.048	35.503	33.740	33.586	30.004	28.821	28.712	
Length (m)		74.718	31.454	7.2	23.006	35.373	23.410	16.339

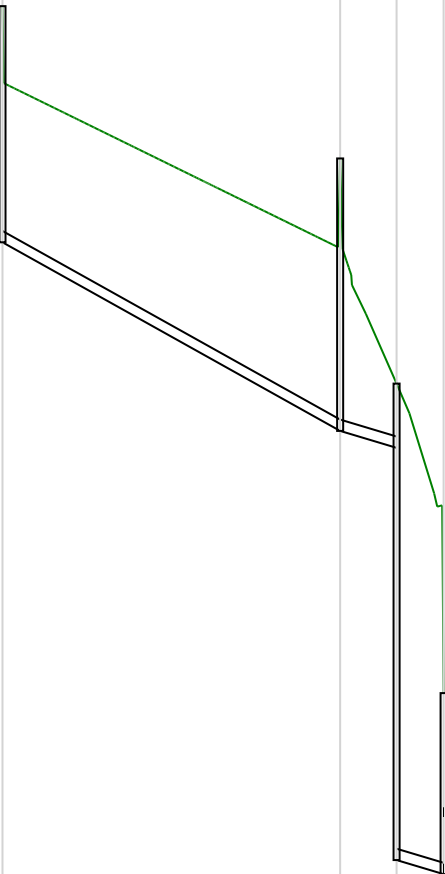
Node Name	50	51	63	52

A3 drawing				
Hor Scale 1500				
Ver Scale 100				
Datum (m) 46.000				
Link Name	5.000	5.00	15.00	
Section Type	150mm	150mm	150mm	
Slope (1:X)	26.9	50.0	50.2	
Cover Level (m)	61.464	59.450	56.473	52.380
Invert Level (m)	58.341	55.847	55.623	50.986
Length (m)	67.000	11.11	19.33

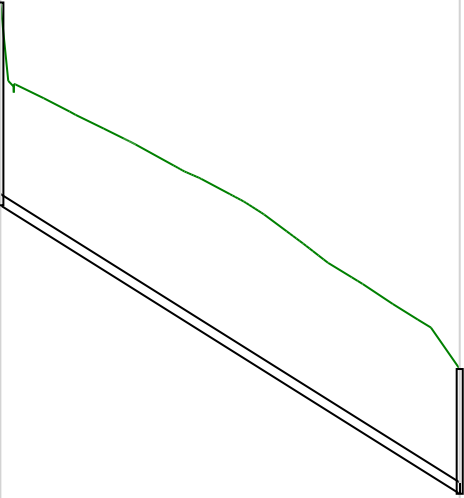
Node Name	58	44

A3 drawing		
Hor Scale 1500		
Ver Scale 100		
Datum (m) 29.000		
Link Name	6.000	
Section Type	150mm	
Slope (1:X)	23.9	
Cover Level (m)	42.000	37.153
Invert Level (m)	39.318	35.503
Length (m)	91.143

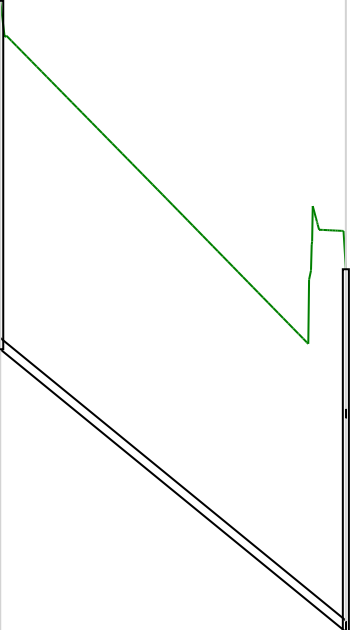
Node Name	59	46

A3 drawing		
Hor Scale 1500		
Ver Scale 100		
Datum (m) 25.000		
Link Name	7.000	
Section Type	150mm	
Slope (1:X)	18.4	
Cover Level (m)	39.120	35.570
Invert Level (m)	34.512	30.775
Length (m)	68.582
