SUMMARY OF PROPOSED VEGETATION REMOVALS

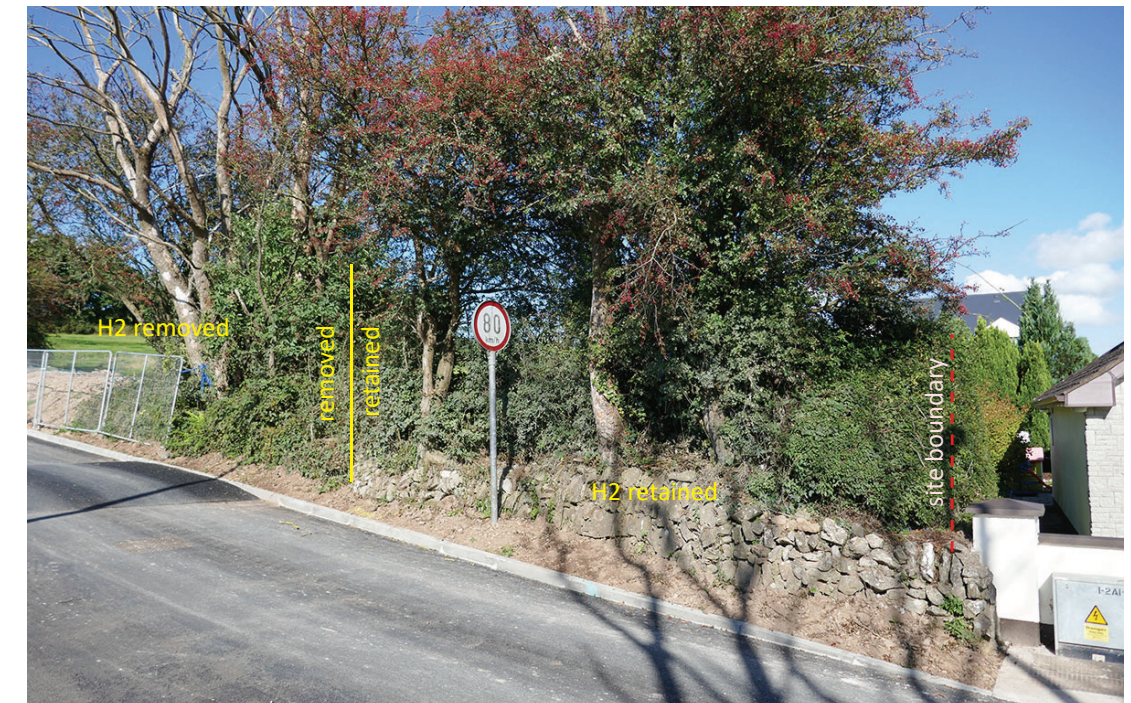
View from public road at southwest corner of site. Image illustrates the 10m segment of stone ditch and Hawthorn hedge to be retained at H2, plus diseased Elm and Ash trees to be removed and gap in ditch where there is no vegetation (also to be removed).

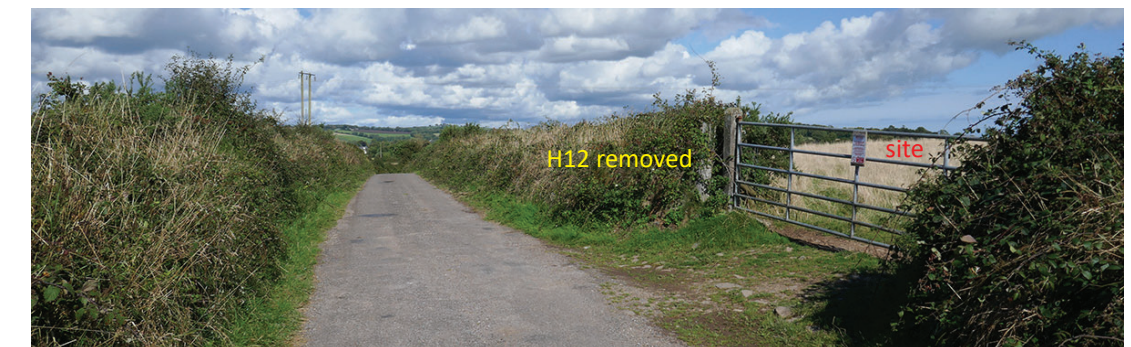
View from public road at northwest end of the site (right side of image). This photo illustrates the uniform character of Bramble and grass to Hedgerow H12. It is void of trees or shrubs along the entire H12 and consequently proposed for removal to facilitate road widening and a footpath.

Along the northwest boundary, the Bramble and grass ditch H12 will be removed in its entirety to facilitate road widening. The central hedgerow H11 will be removed to facilitate housing. H11 is in fair condition, but with no loss of exemplary habitat. It can be compensated for by means of reinstating a contiguous east/west band of native planting.
