Verified View Photomontages and CGI's for Proposed Residential Development at Broomfield, Midleton, Co. Cork

February 2024

Document at A3 prepared by G-Net 3D

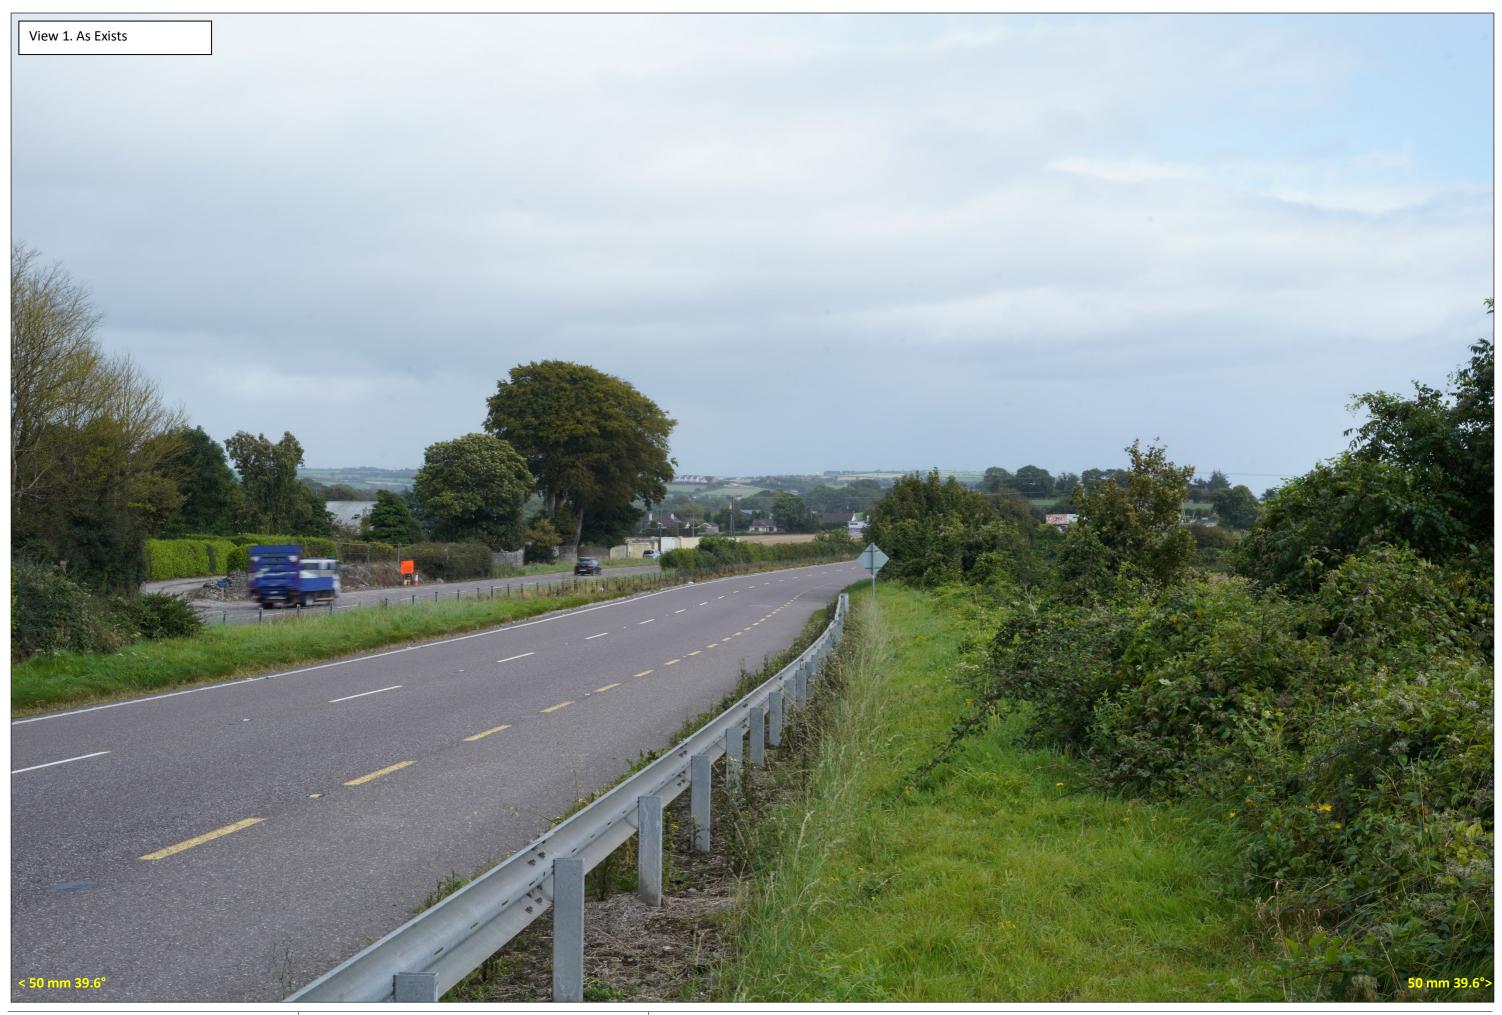
Photo Date: 18.09.2023 Photo Time: 13:19 Camera: Sony a7RIII

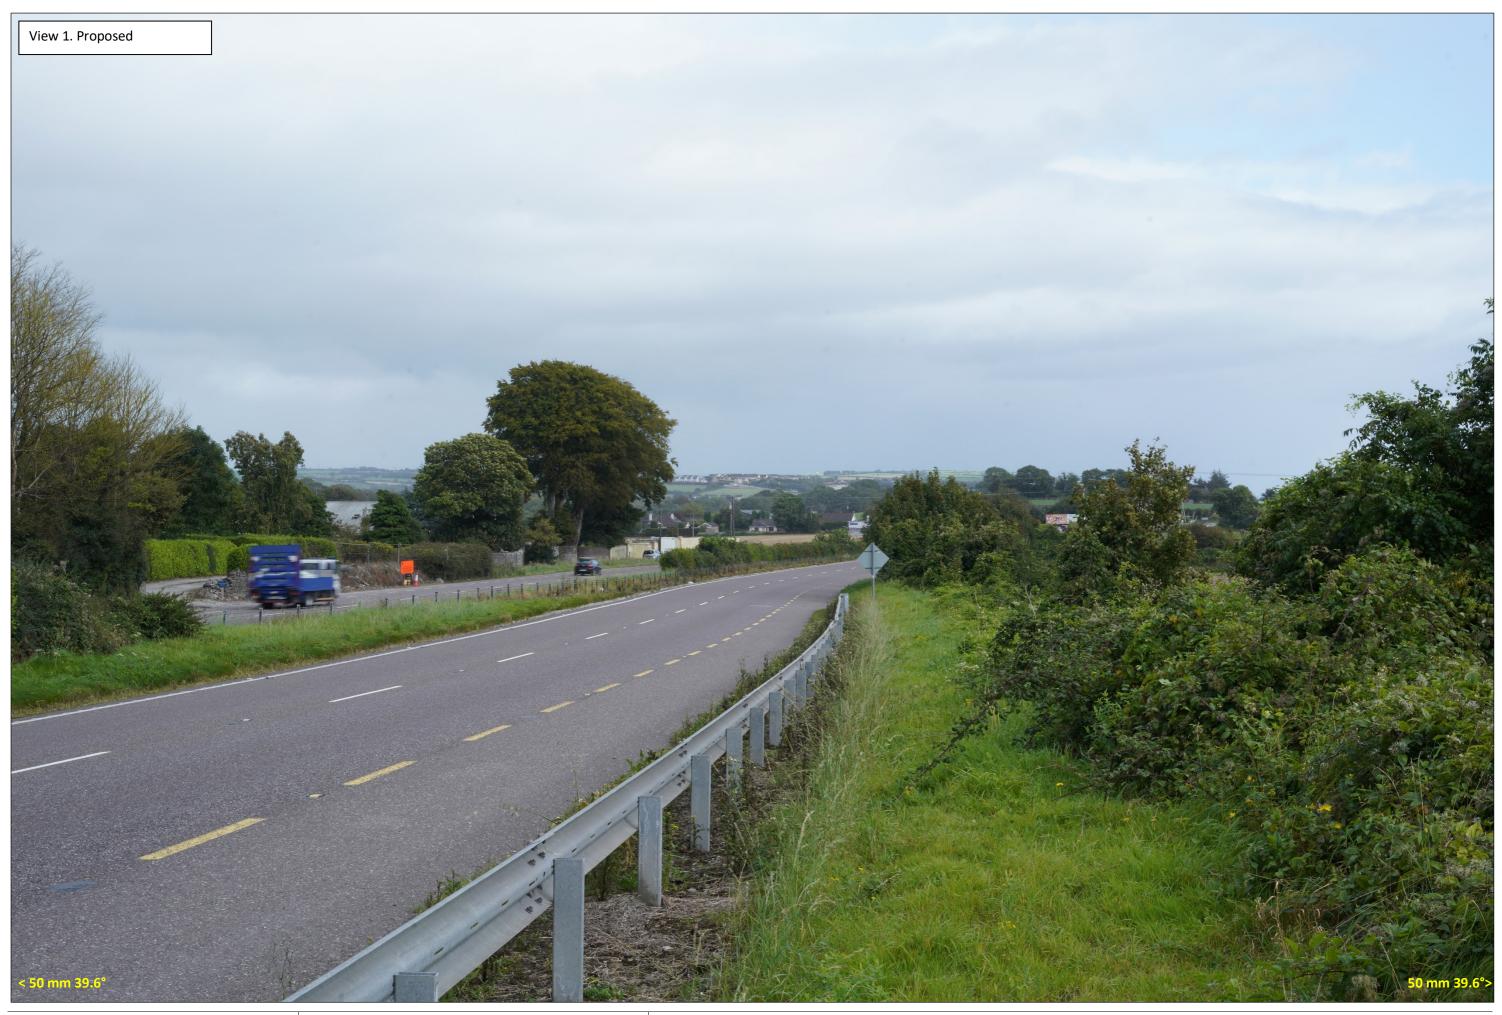
Photo Date: 18.09.2023 Photo Time: 13:19 Camera: Sony a7RIII Viewpoint location: View from N25 Eastbound at Glebe House Viewpoint Coordinates (ITM): 585099.142;573629.445;18.451

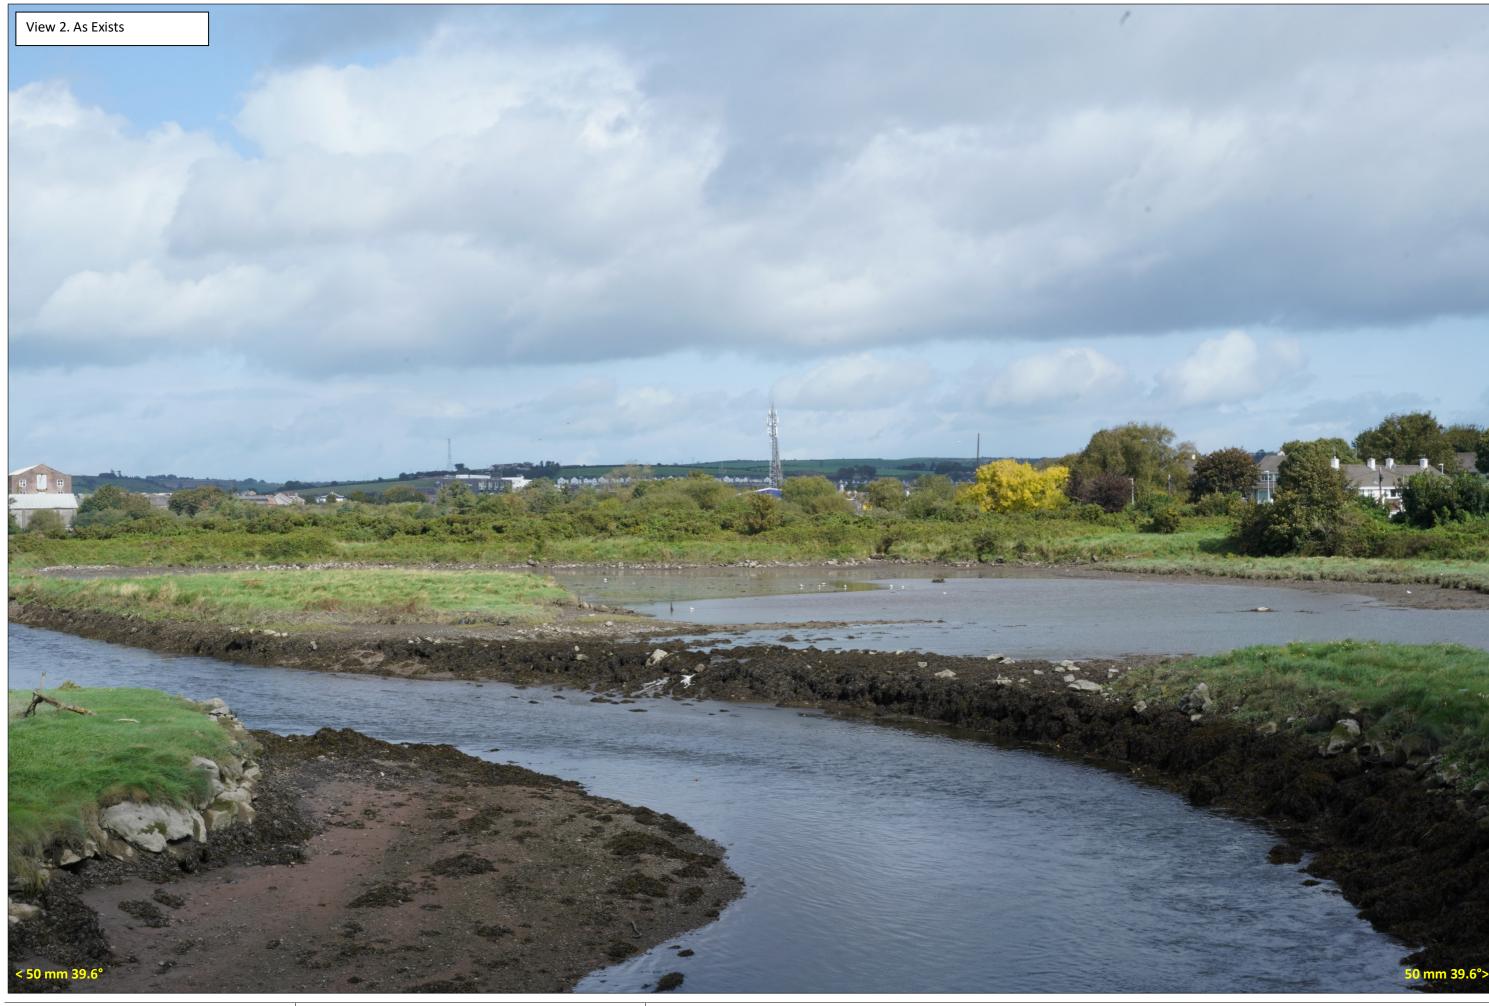
Photo Date: 18.09.2023 Photo Time: 12:09 Camera: Sony a7RIII Viewpoint location: View from N25 at Estuary (Cork Harbour SPA 4030) Viewpoint Coordinates (ITM): 587863.438;572671.345;5.324

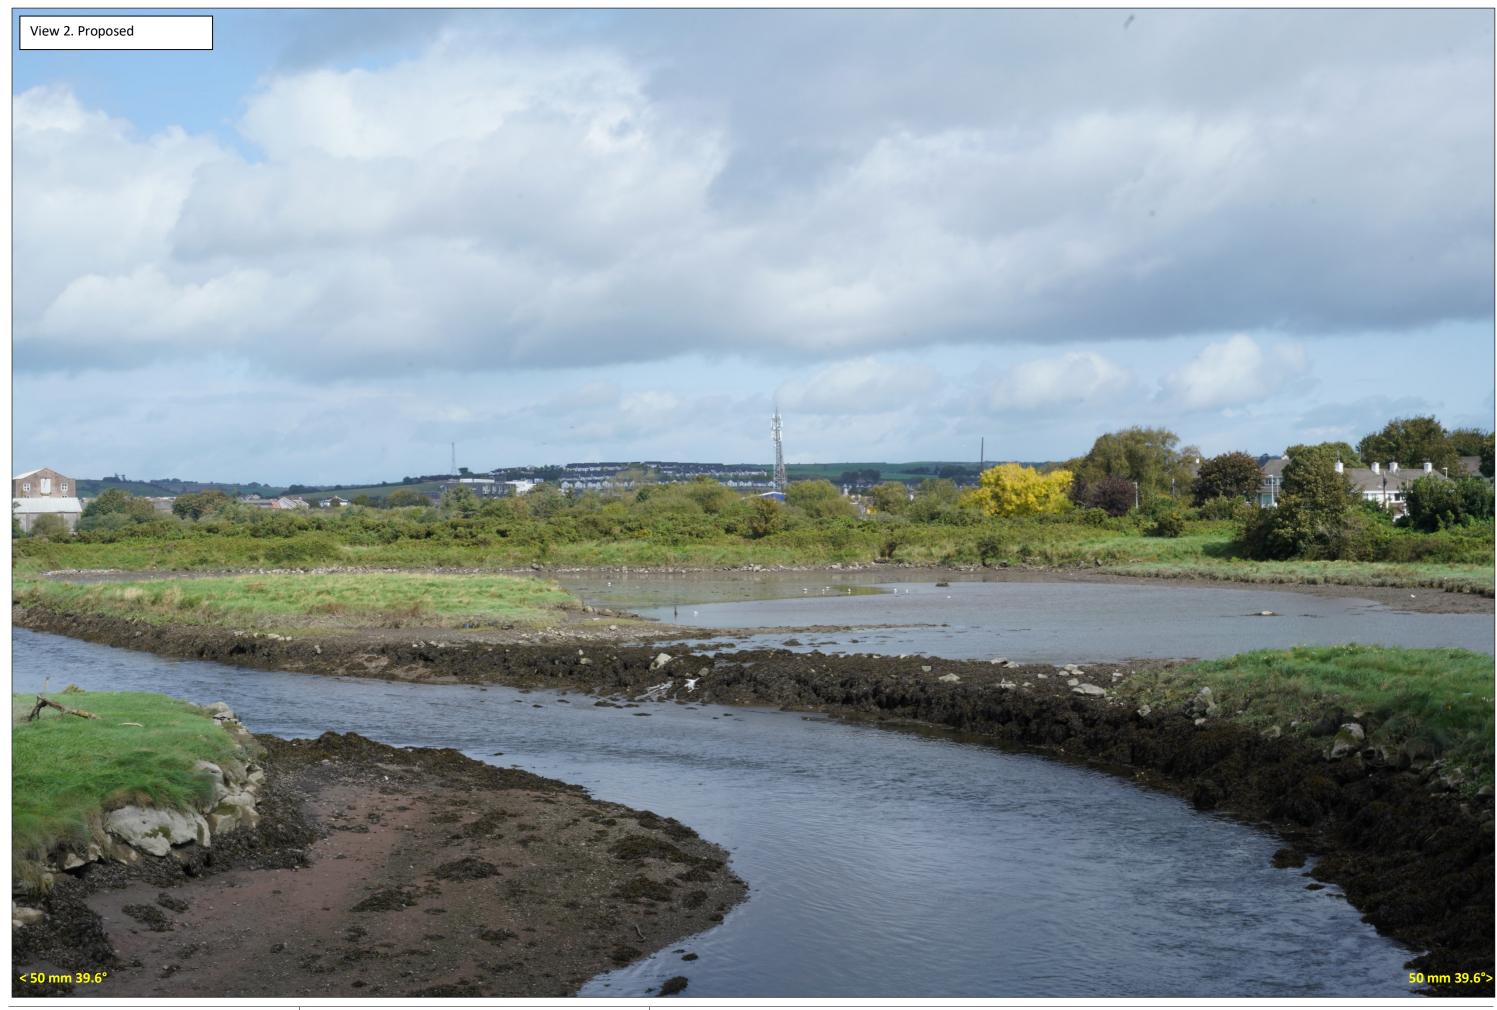
Photo Date: 18.09.2023 Photo Time: 12:09 Camera: Sony a7RIII Viewpoint location: View from N25 at Estuary (Cork Harbour SPA 4030) Viewpoint Coordinates (ITM): 587863.438;572671.345;5.324

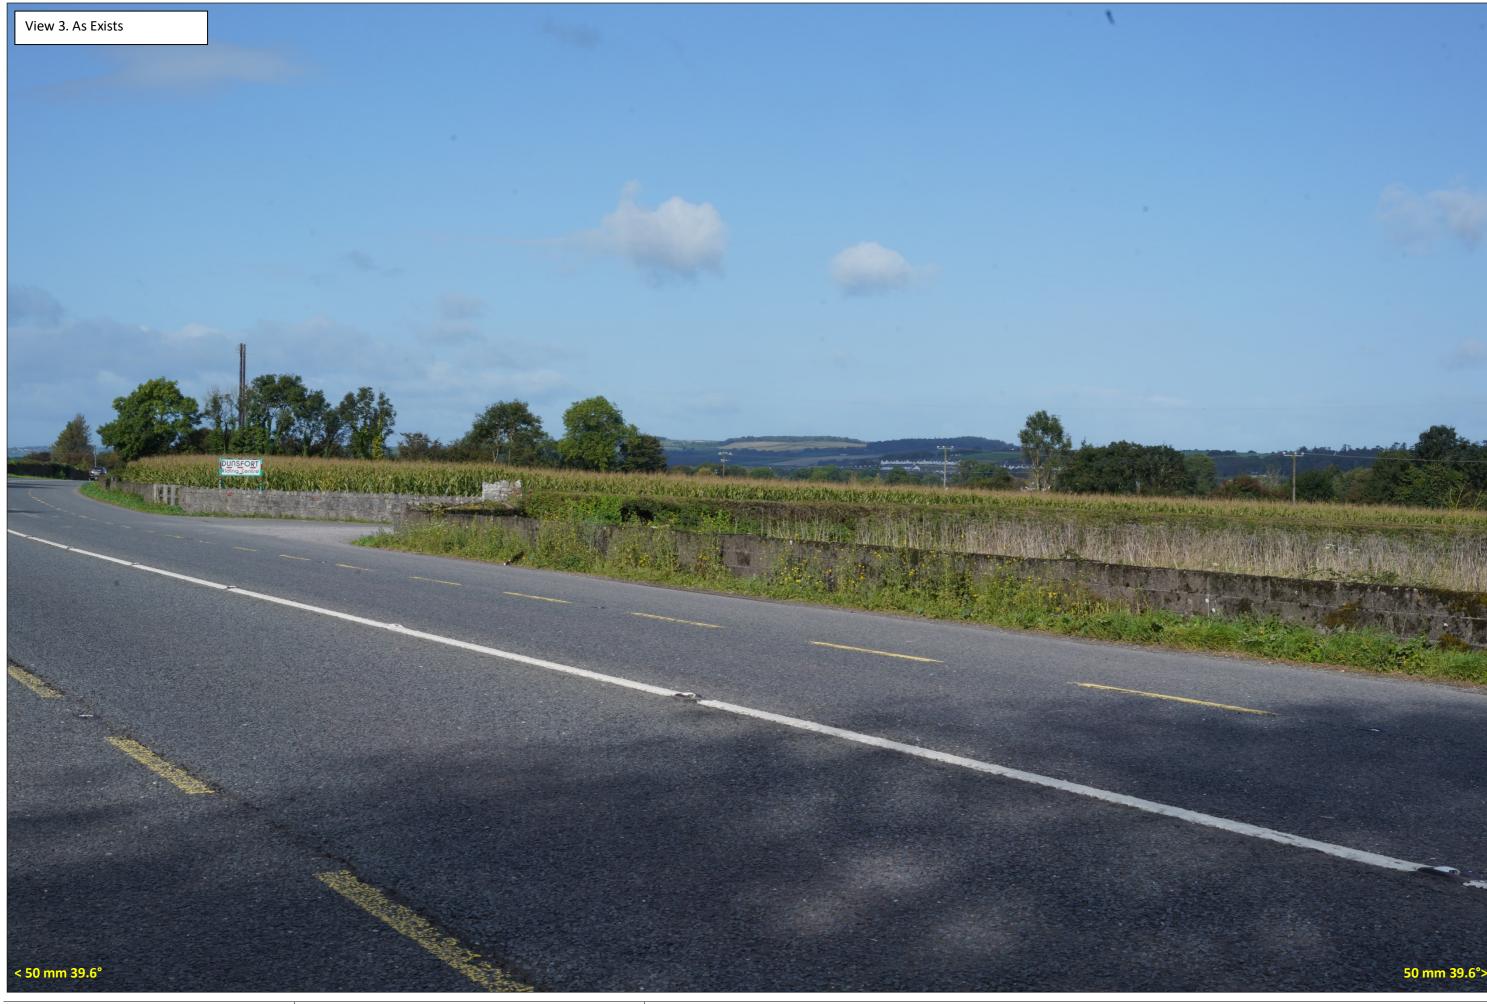
Photo Date: 18.09.2023 Photo Time: 10:42 Camera: Sony a7RIII Viewpoint location: View from N25 Westbound at Dunsfort Viewpoint Coordinates (ITM): 590685.356;573514.870;20.067

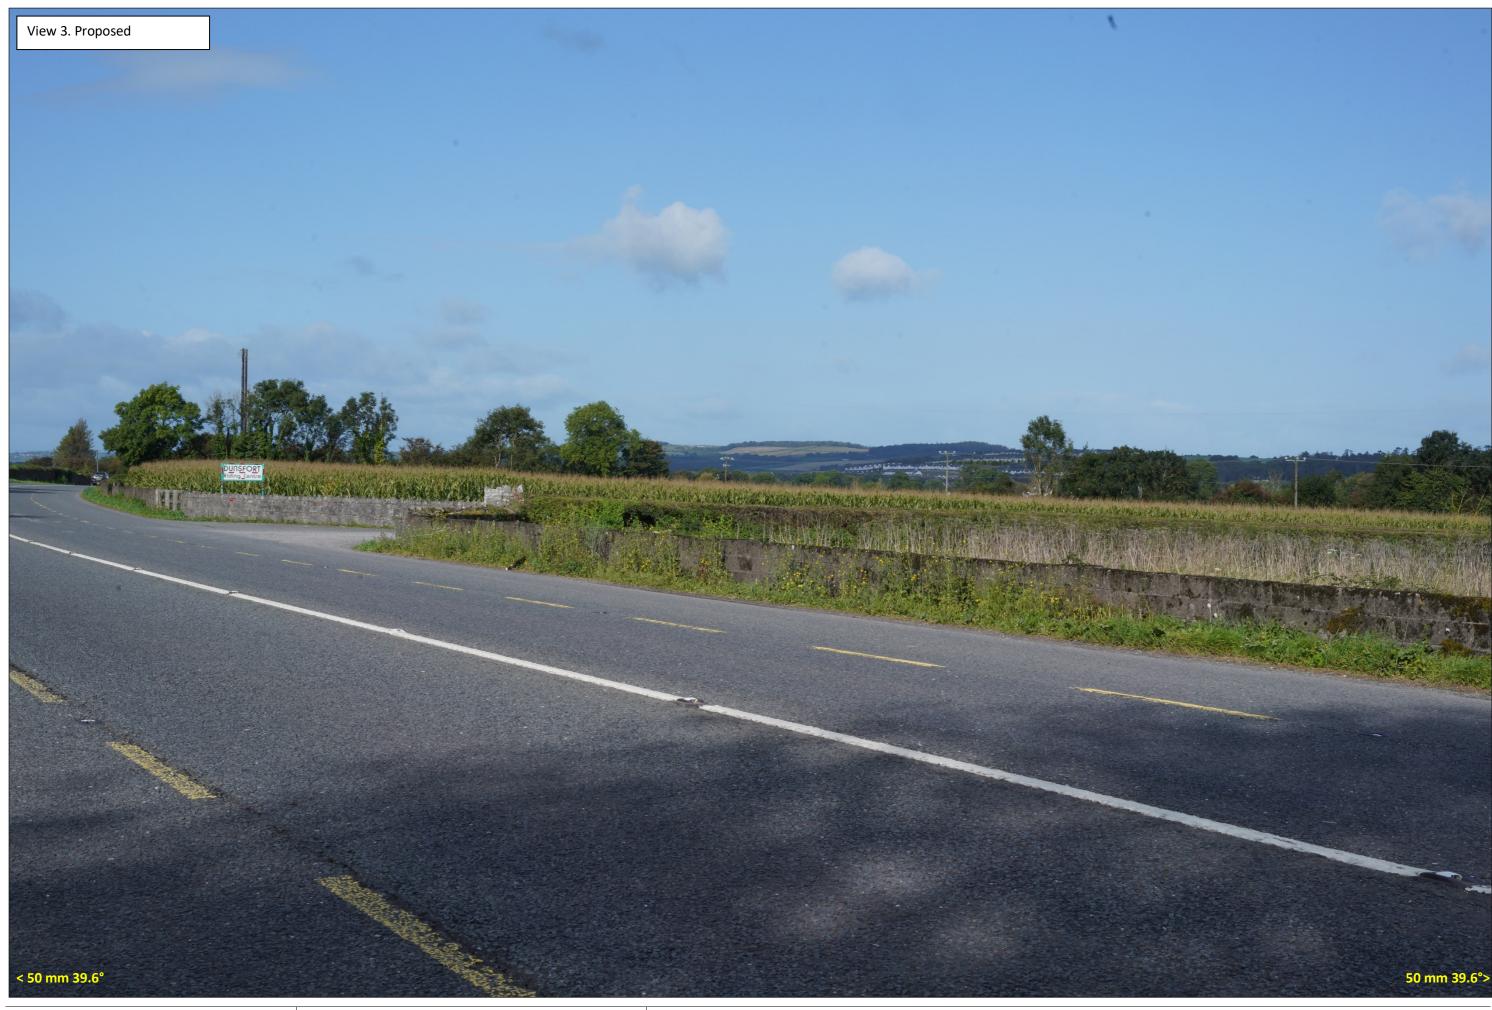
Photo Date: 18.09.2023 Photo Time: 10:42 Camera: Sony a7RIII Viewpoint location: View from N25 Westbound at Dunsfort Viewpoint Coordinates (ITM): 590685.356;573514.870;20.067

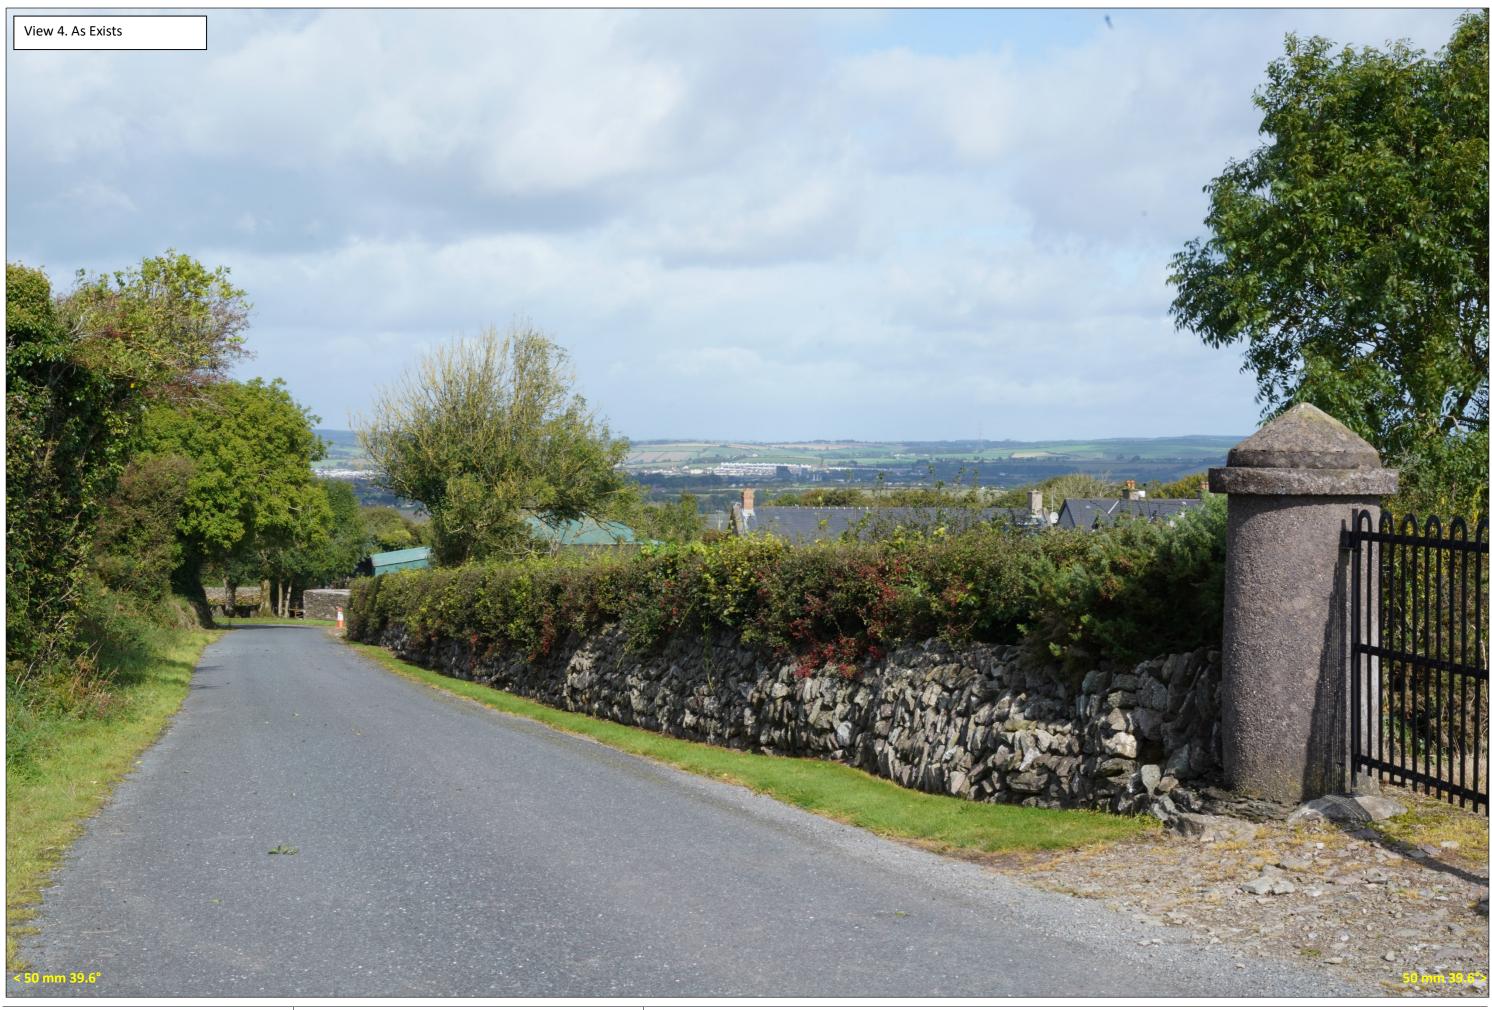
Photo Date: 18.09.2023 Photo Time: 11:24 Camera: Sony a7RIII Viewpoint location: View from L76592 at Scariff Viewpoint Coordinates (ITM): 590096.633;569773.237;83.690

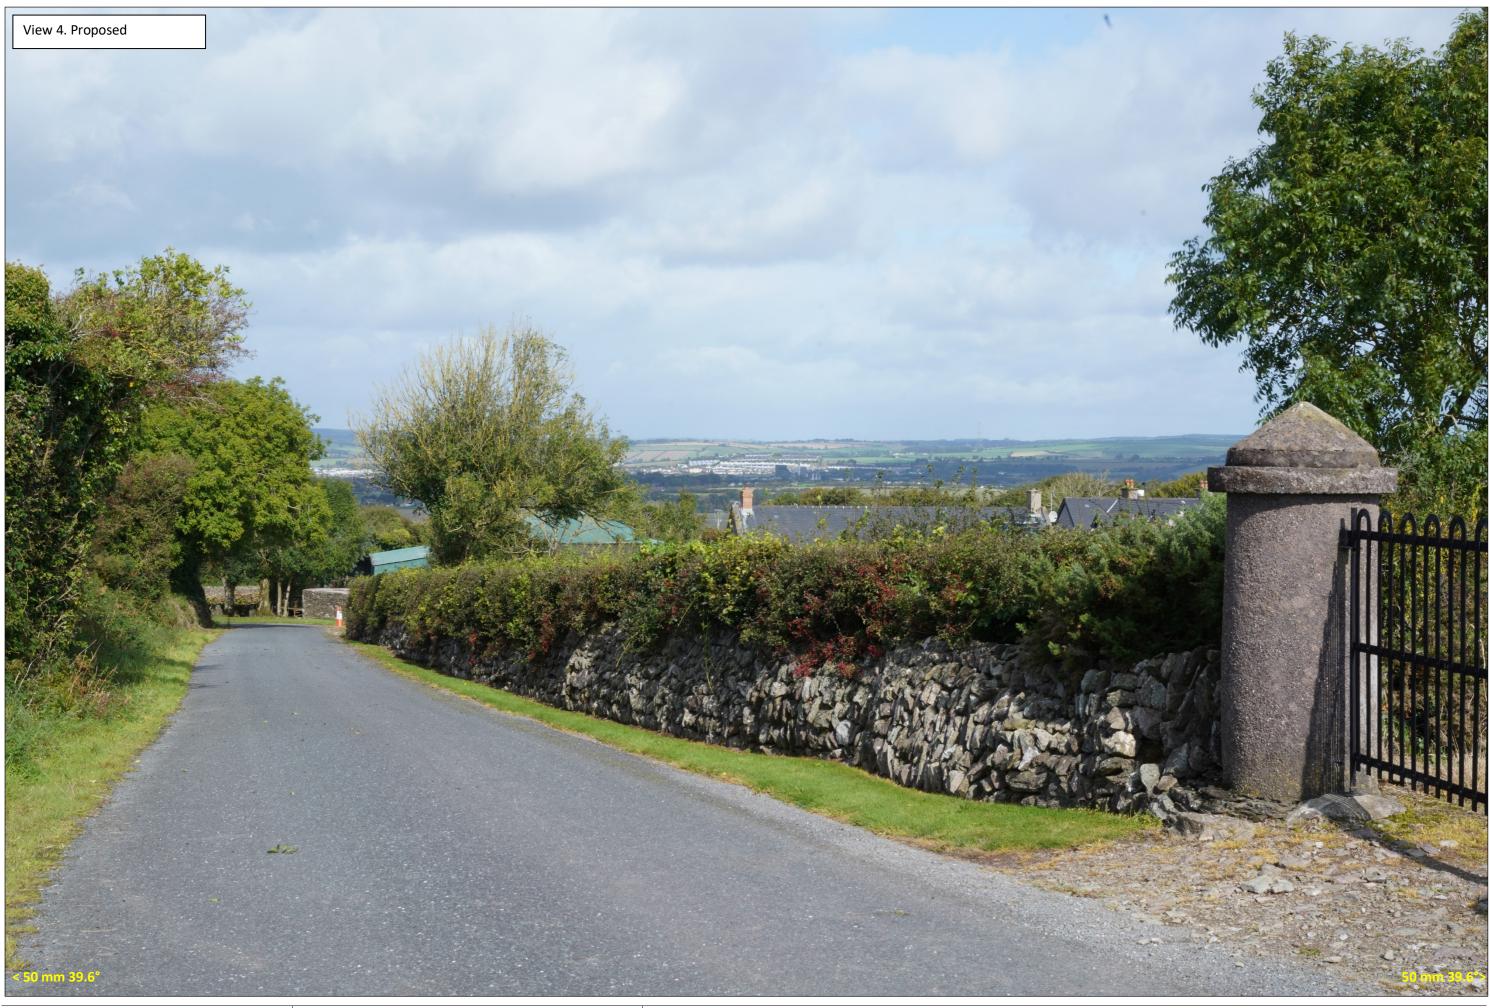
Photo Date: 18.09.2023 Photo Time: 11:24 Camera: Sony a7RIII Viewpoint location: View from L76592 at Scariff Viewpoint Coordinates (ITM): 590096.633;569773.237;83.690

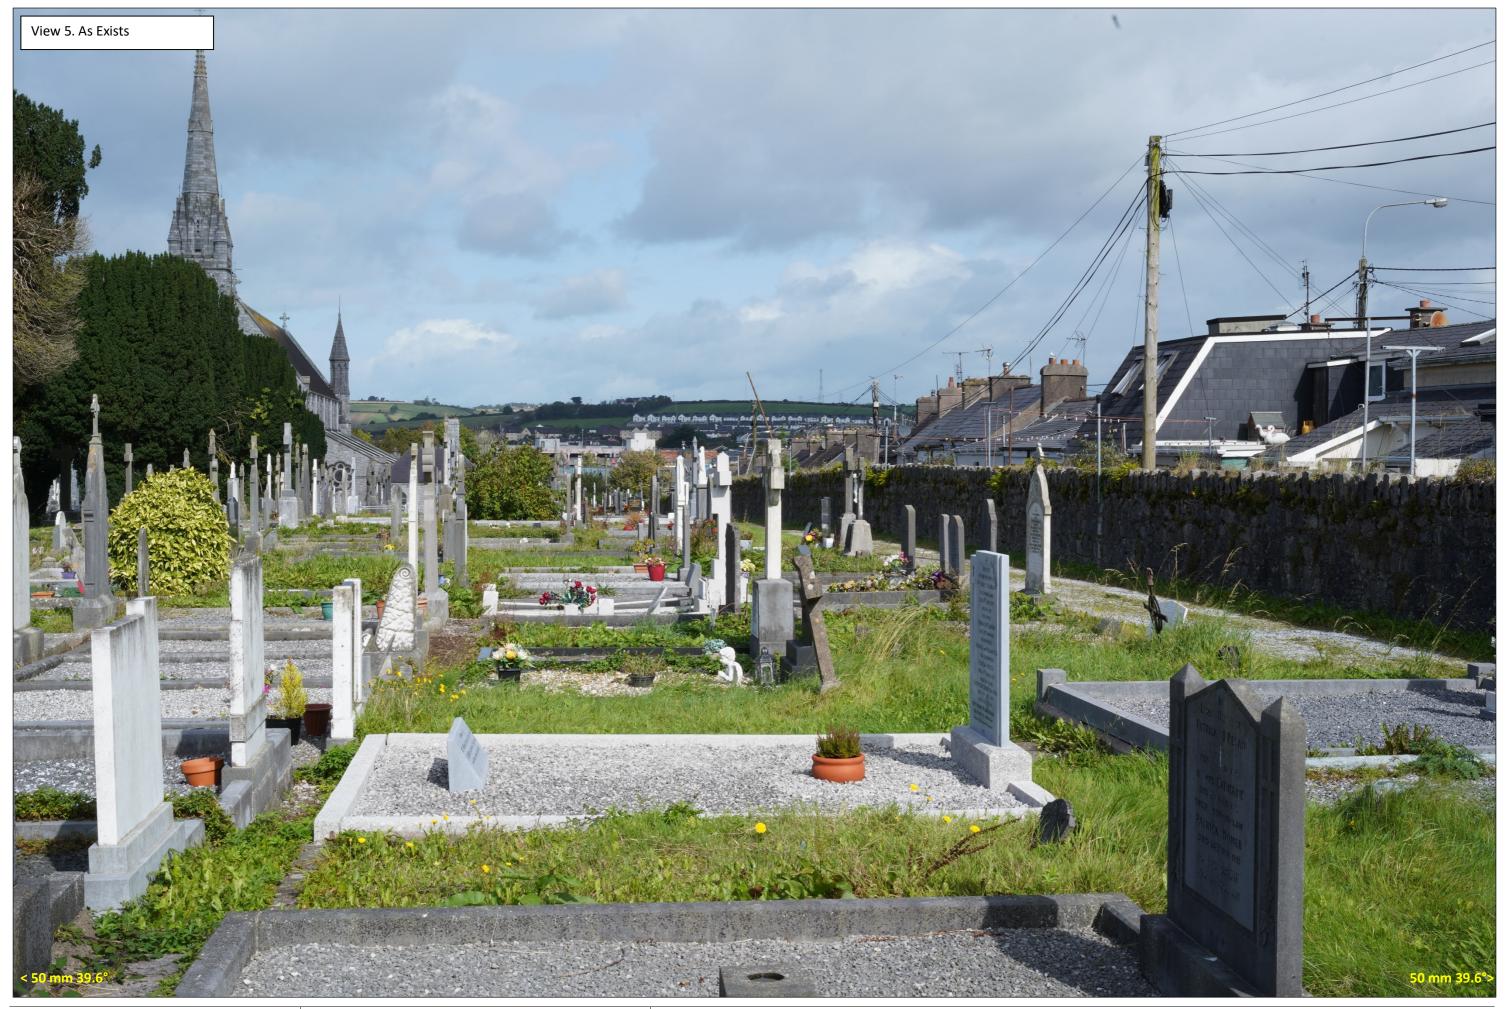
Photo Date: 18.09.2023 Photo Time: 11:44 Camera: Sony a7RIII

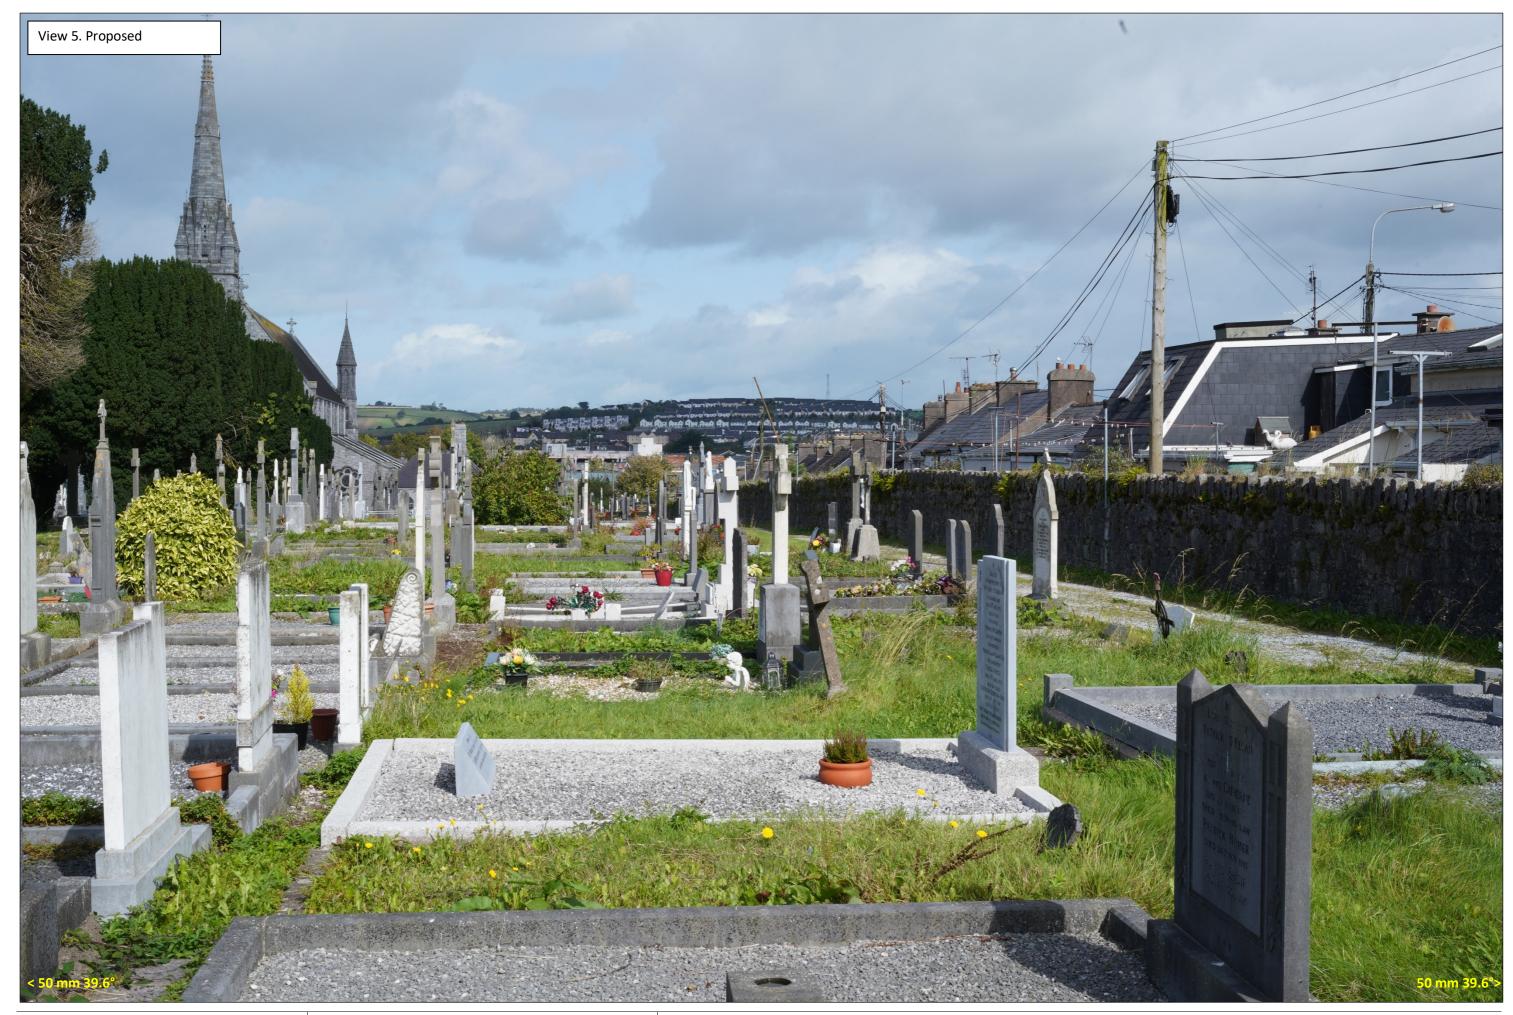
Photo Date: 18.09.2023 Photo Time: 11:44 Camera: Sony a7RIII

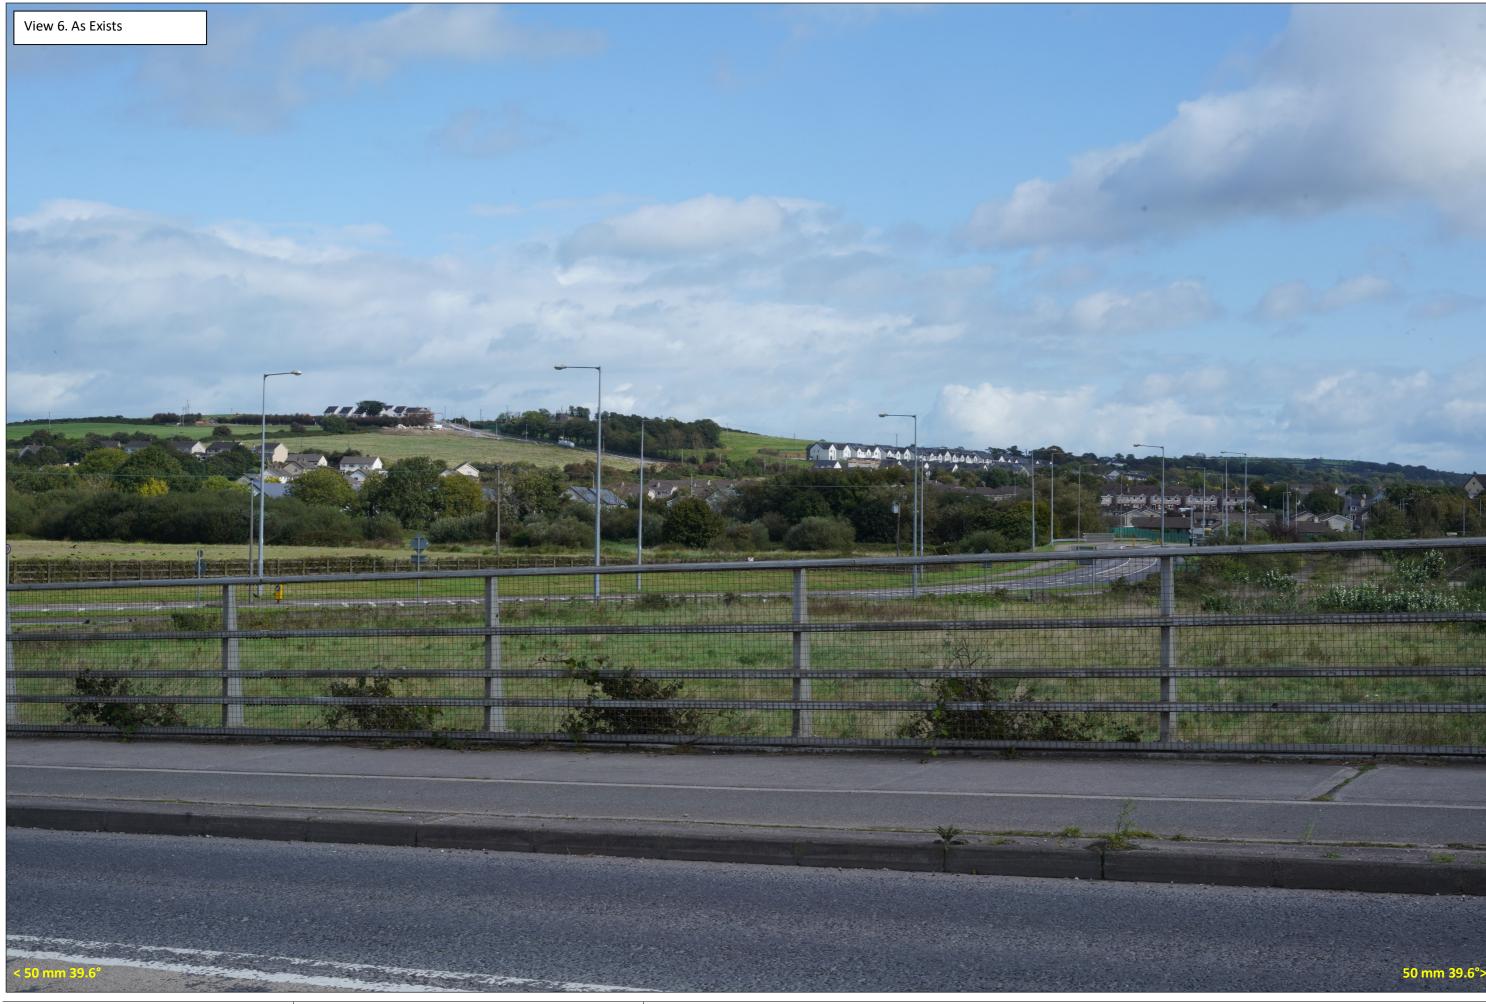
Photo Date: 18.09.2023 Photo Time: 12:45 Camera: Sony a7RIII

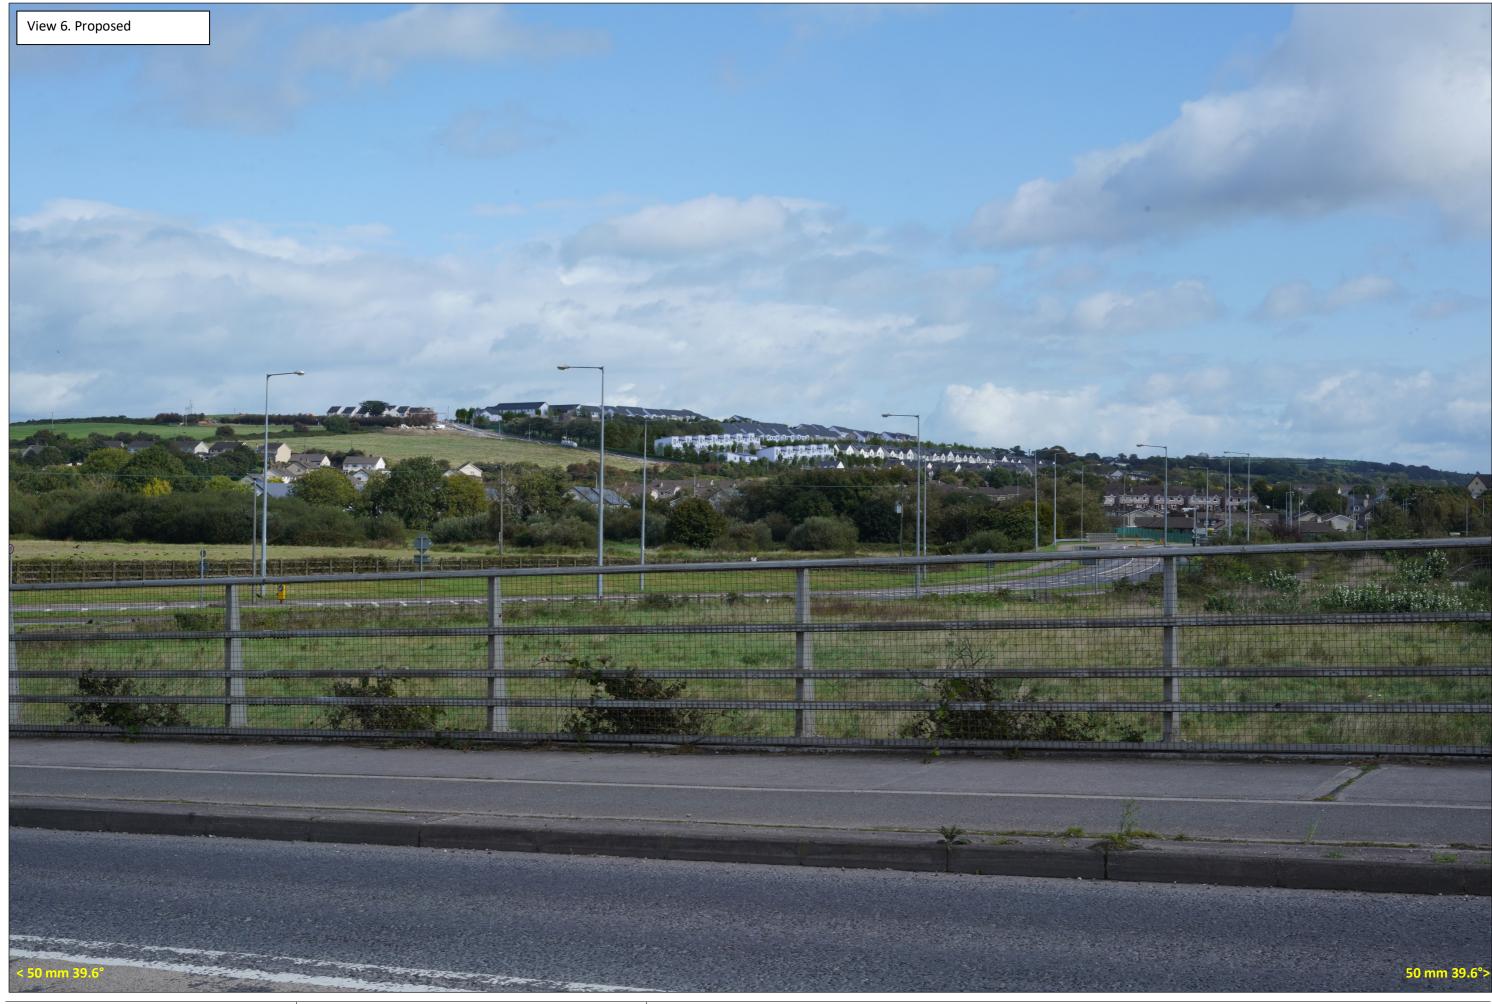
Photo Date: 18.09.2023 Photo Time: 12:45 Camera: Sony a7RIII Viewpoint location: View from Northern Relief Road (L3288) above Railway Track Viewpoint Coordinates (ITM): 587173.684;574328.796;13.443

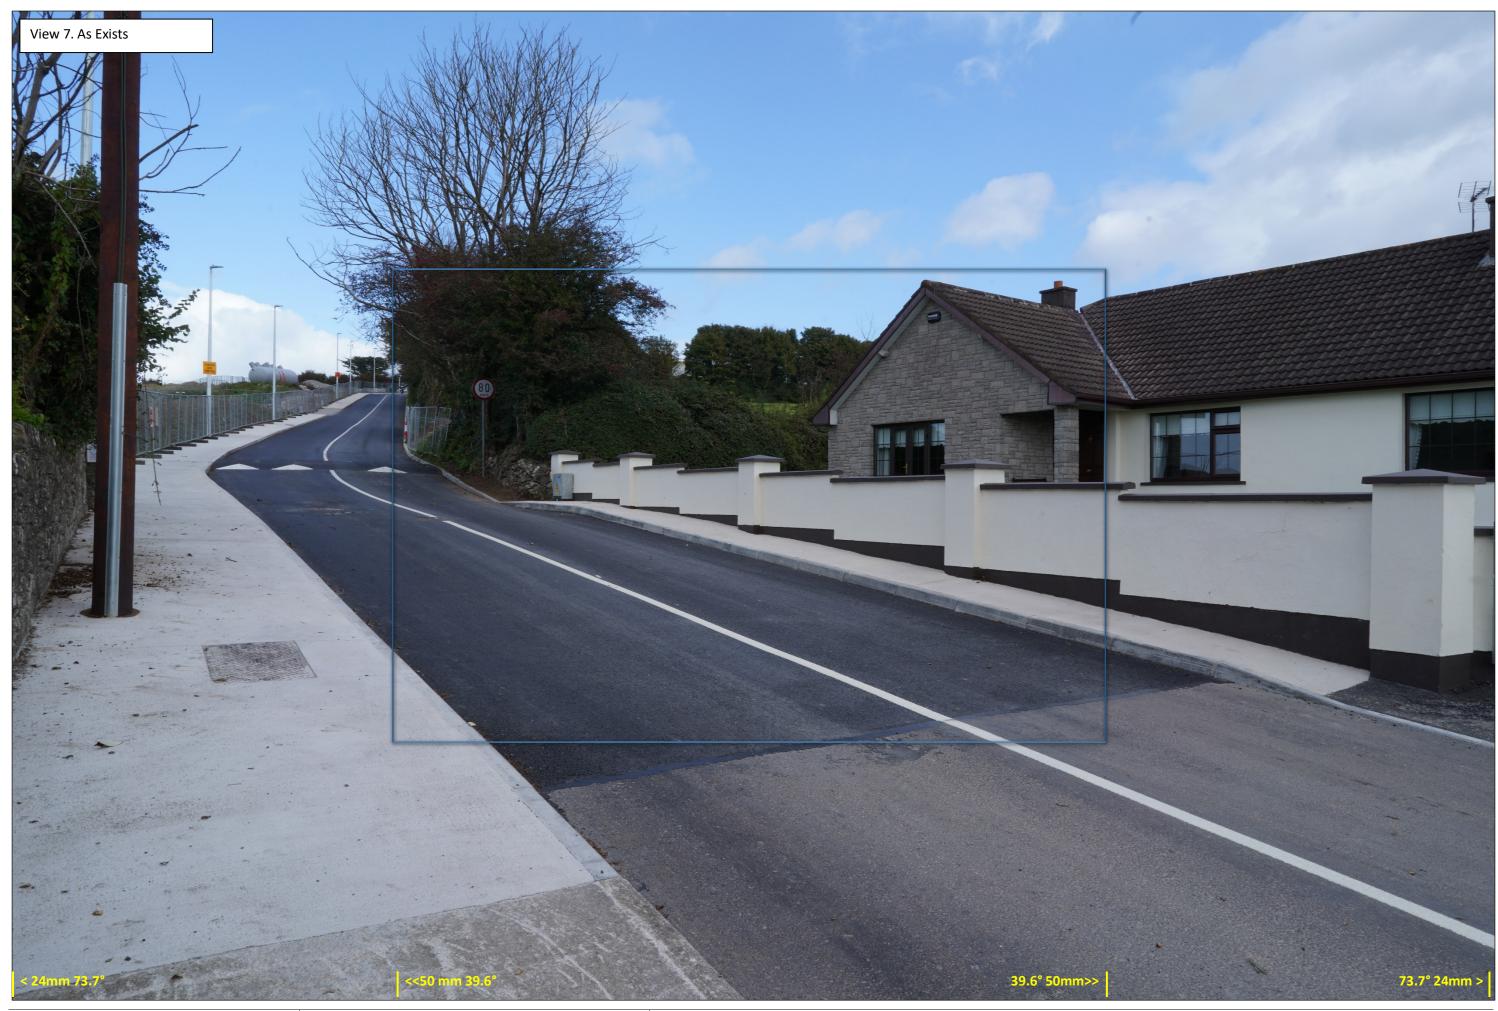
Photo Date: 18.09.2023 Photo Time: 12:30 Camera: Sony a7RIII

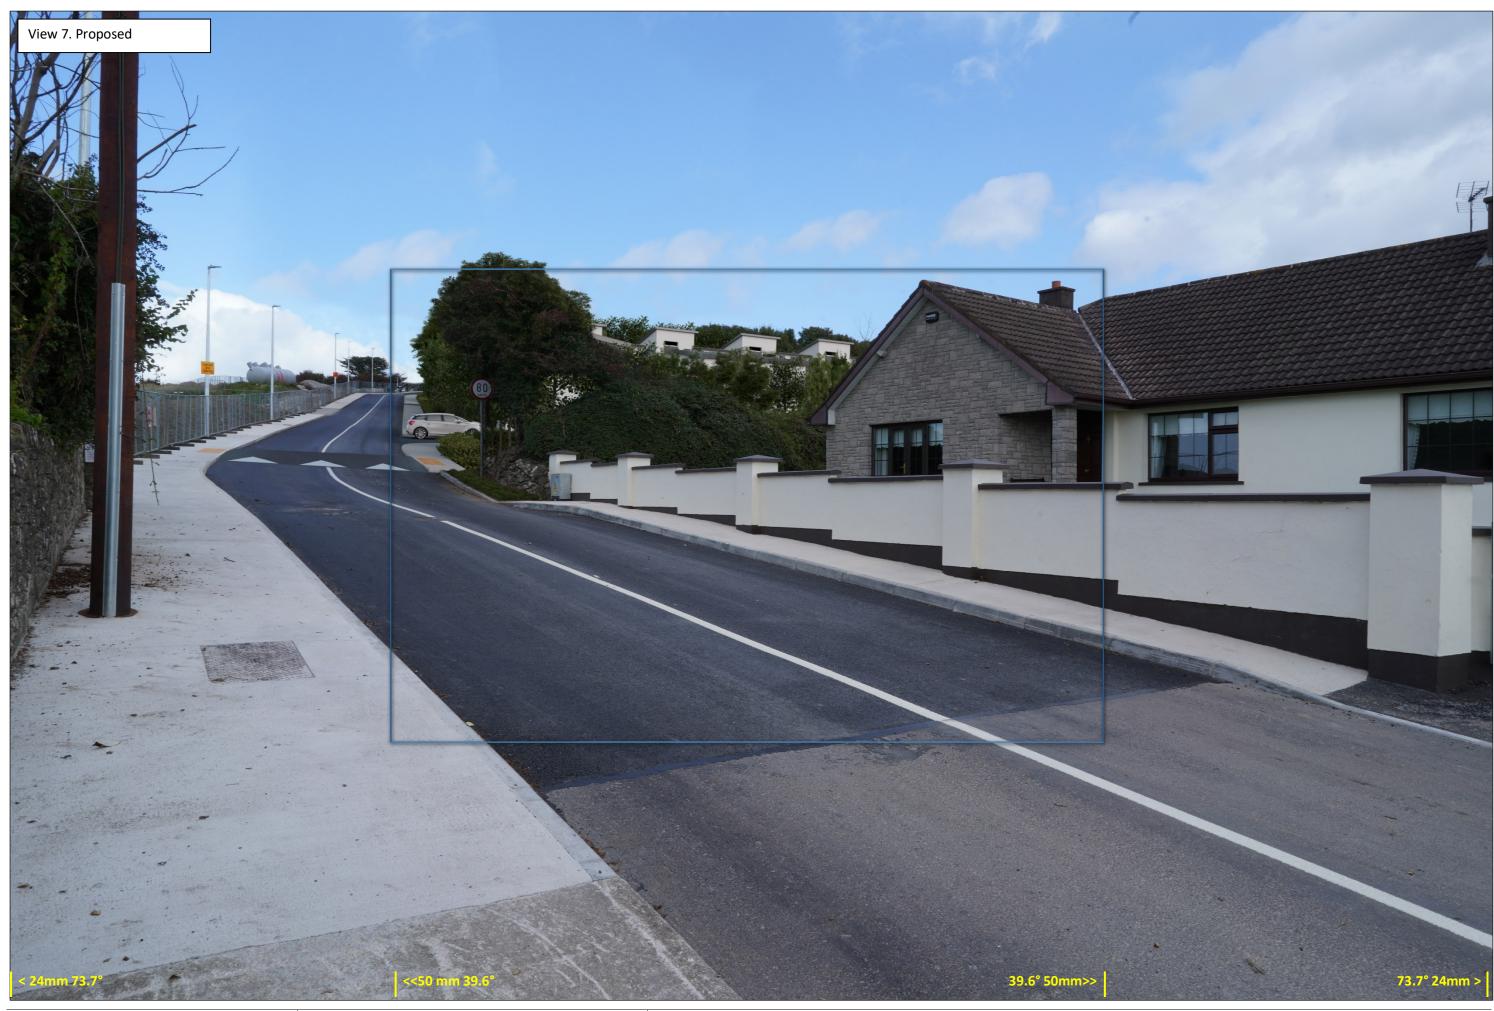
Photo Date: 18.09.2023 Photo Time: 12:30 Camera: Sony a7RIII Viewpoint location: View from Local Road L7630 Southwest of Site Viewpoint Coordinates (ITM): 587882.256;574820.458;26.960

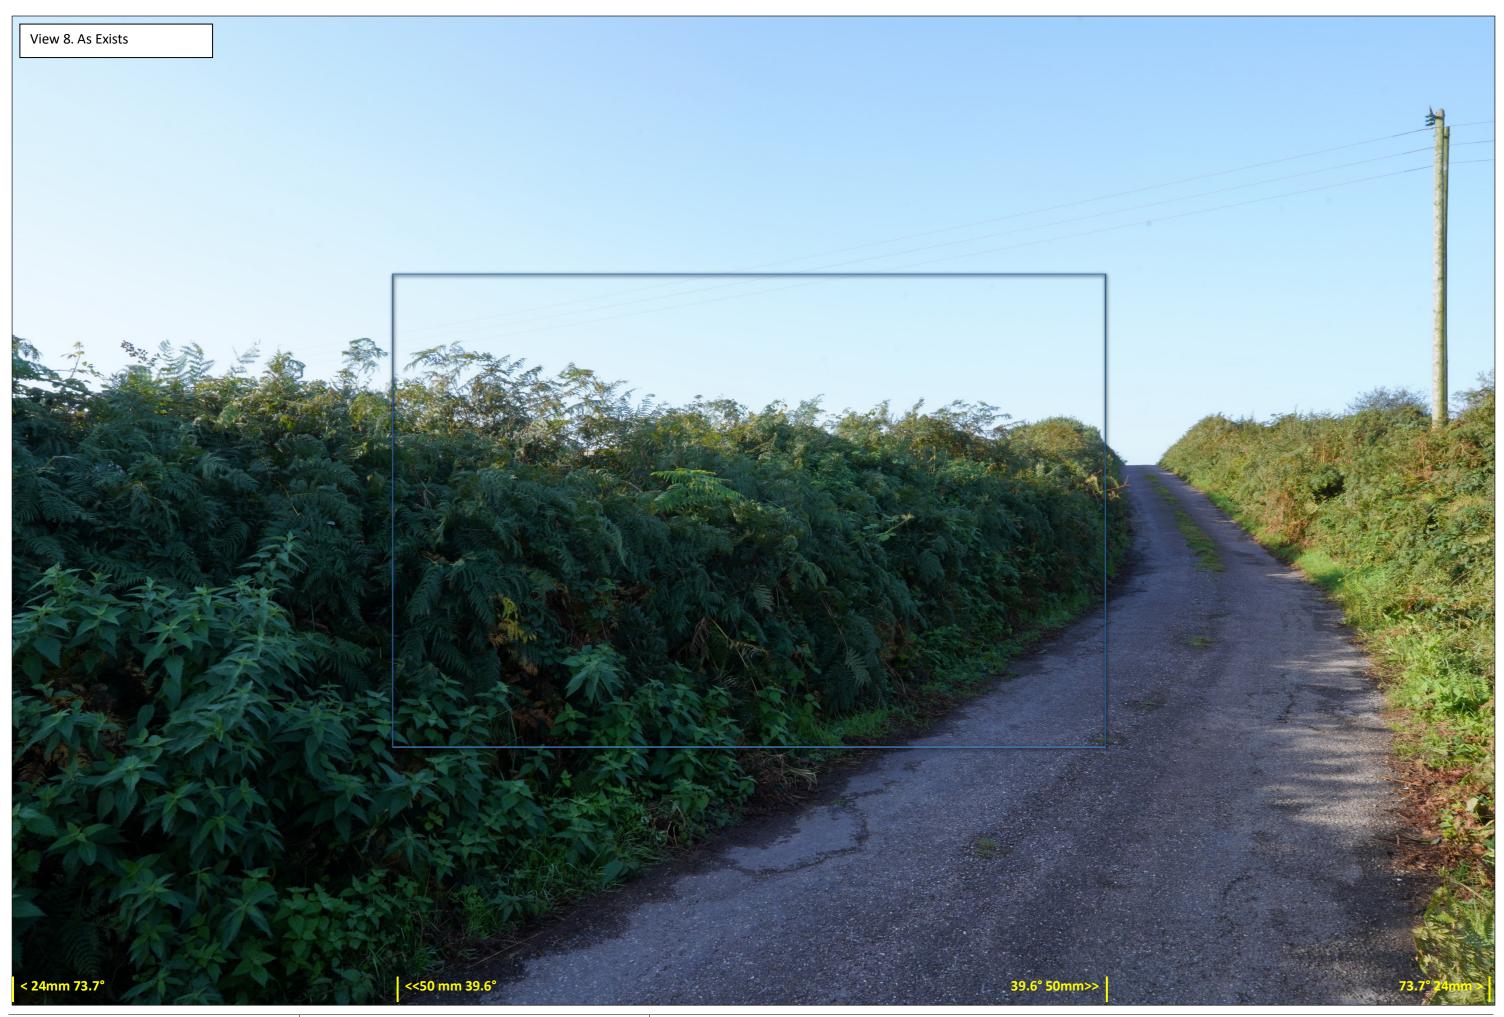
Photo Date: 18.09.2023 Photo Time: 09:32 Camera: Sony a7RIII
