Verified View Photomontages and CGI's for Proposed Residential Development at Broomfield, Midleton, Co. Cork

February 2024

Document at A3 prepared by G-Net 3D

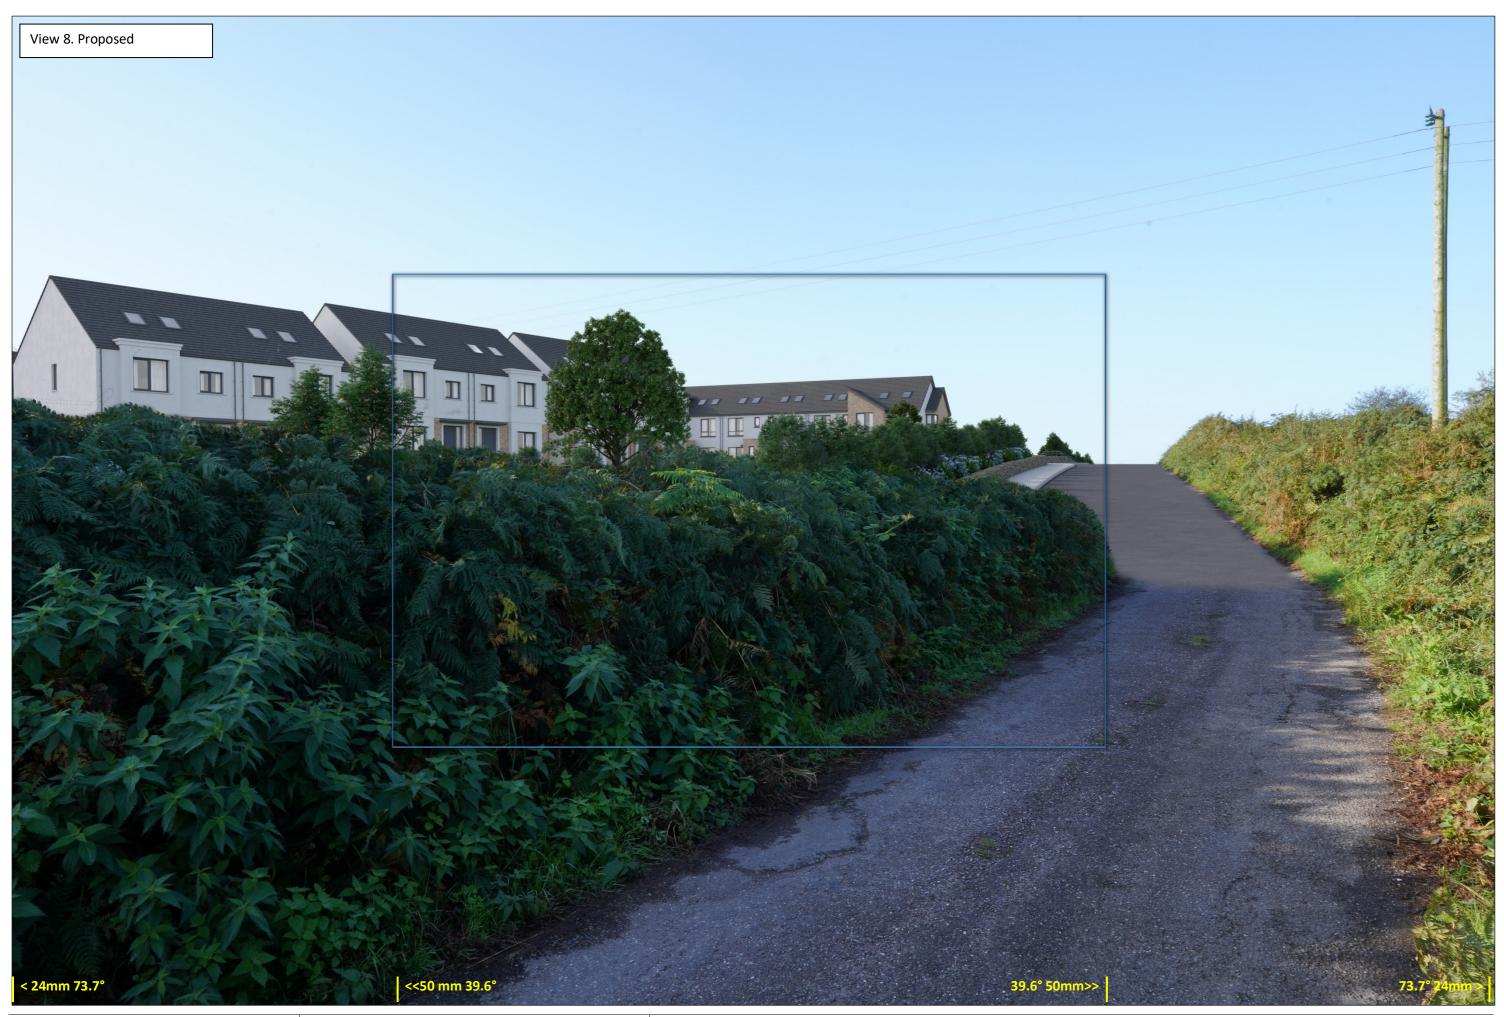
Photo Date: 18.09.2023 Photo Time: 09:32 Camera: Sony a7RIII
